# Wood Fibre Prefabricated Exterior Energy Retrofits

# HSS DESIGN BUILD

## 1 Detailed background of existing building

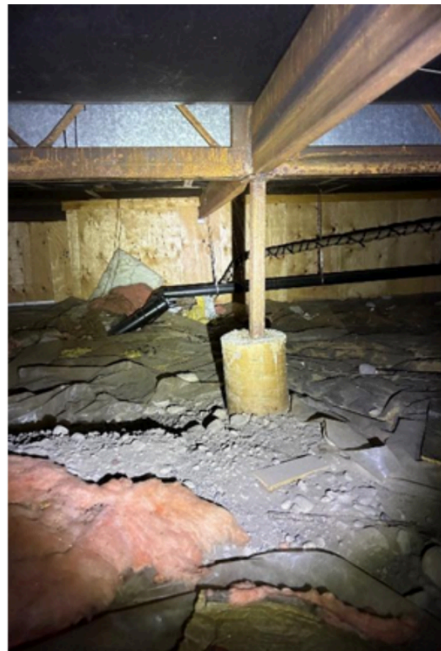
The exterior of the building sits on a concrete stem wall foundation creating a roughly 4' deep semi conditioned crawlspace. Three concrete piles down the center of the crawl space support steel columns connected to a steel truss to support the center of the building. The stem wall is lined with EPS insulation for an effective R-value of 9.

*Figure 1. Vented crawlspace features a dirt floor, concrete walls covered with Styrofoam and plywood, steel structural elements, heating system ductwork, and the sewer drain system.*

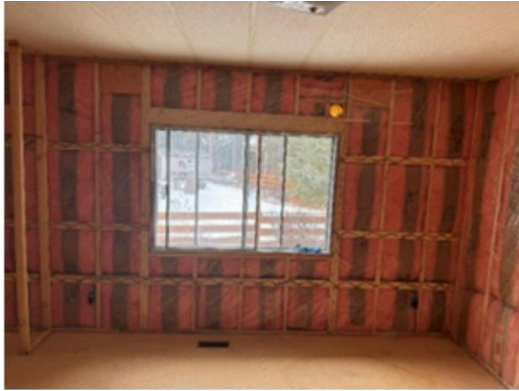
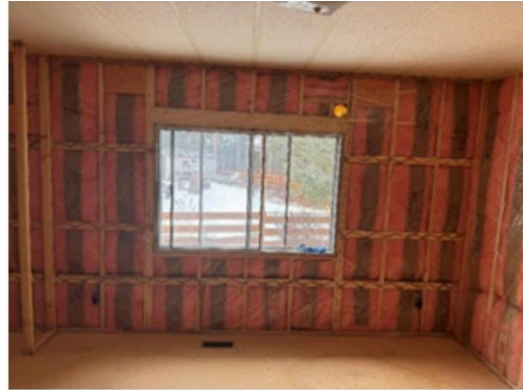
*Figure 2. 2" by 4" stud wall construction with 1" by 4" notched in above polyurethane vapour barrier. Aluminium windows had poor energy performance and leaked air.*

The most significant deficiency was the poorly performing windows. This was most clearly demonstrated by the extent of heat loss attributed to them in the EnerGuide evaluation. This was due in part to the low insulating properties of the aluminum frames and glazing, as well as significant air leakage observed during the blower door test. This issue was resolved when the windows were replaced as part of the PEER retrofit.

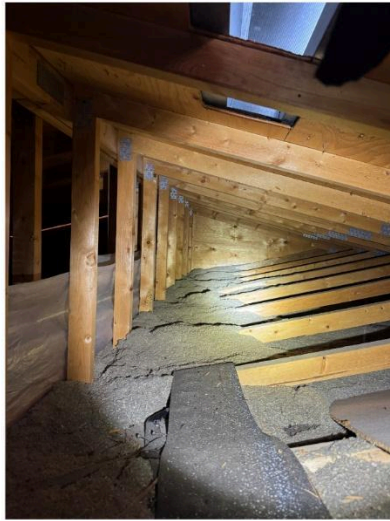
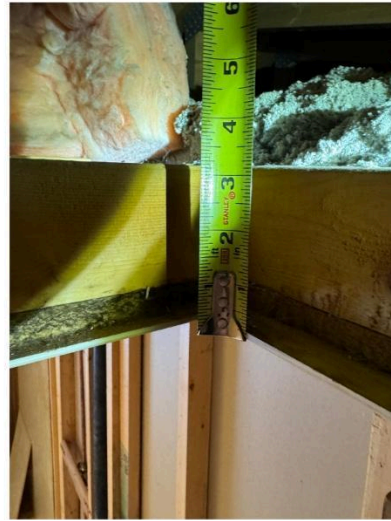
*Figure 3. Standard attic build up with minimal insulation. Leaks were repaired and blow-in wood fibre to be added.*

An additional R-17 of blown in wood fibre was added to the attic bringing the total R value up to R-44.4. If space permitted, we would have added more but this allowed us to maintain adequate ventilation and was a significant improvement.

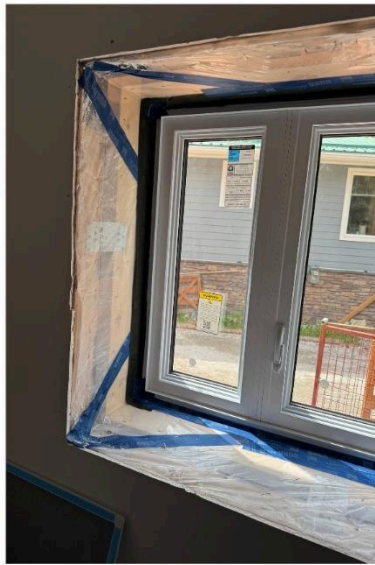
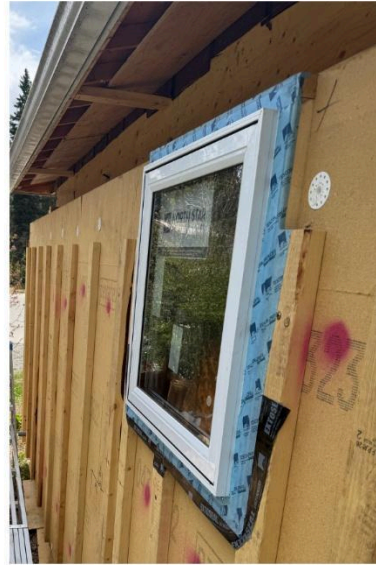
*Figure 7. The interior of the window is connected to the existing polyethylene air/vapour barrier with high quality tapes. The exterior of the window is connected to the weather resistive barrier with high quality tapes.*

Northstar, series 1000, triple glazed, Low E, Argon filled, flanged windows fitted to the exterior of the PEER panel. R values ranged from 3.9 to 5.4. High quality glue and tape was used to tie windows to the WRB on the exterior and the 6mm poly air/vapour barrier on the inside.

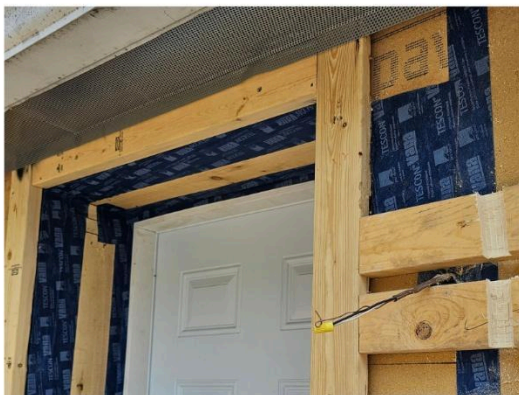
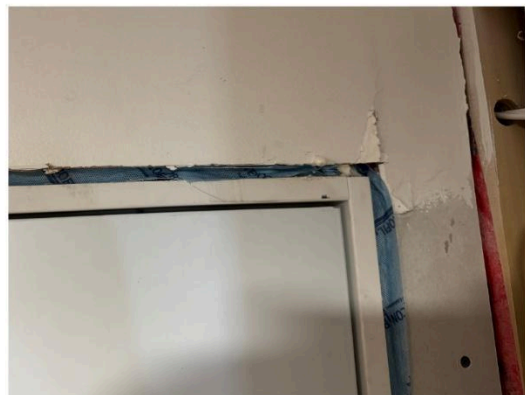
*Figure 8. Doors are connected to the Air/vapor barrier on the inside and the weather resistive barrier on the outside using high quality tapes.*

Two new standard quality doors with polystyrene cores were installed at the same position as the originals, centered within the existing 2" by 4" stud wall. High quality tapes were used to seal the wall as the existing sheathing and to the air/vapour barrier on the interior.

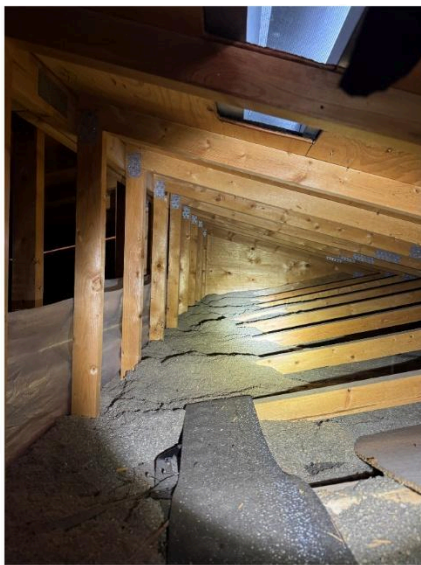
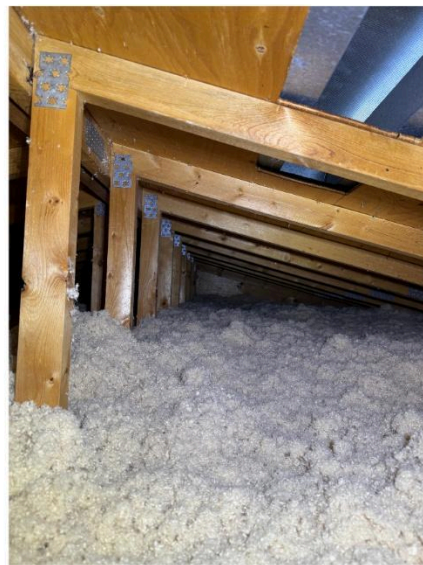
*Figure 9. Leaks in the air/vapour barrier were repaired and wood fibre was blown into the attic making sure to maintain ventilation.*

The attic insulation was improved from R-27.4 to R-44.4 by adding blown in wood fibre. This work was completed in a day without a major roof intervention. Air/vapour barrier leaks, primarily the hole left after the removal of the chimney, were sealed. The existing attic eave ventilation system was maintained. While more extensive interventions would yield better results this was affordable and effective.

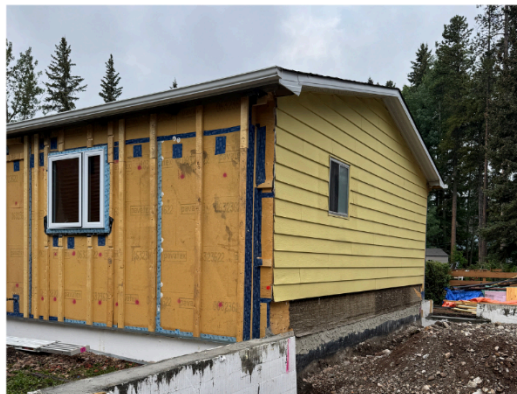
*Figure 10. The PEER panel installation is completed except for siding, the foundation for the ADU is poured, the untouched wall was addressed when the ADU was completed.*

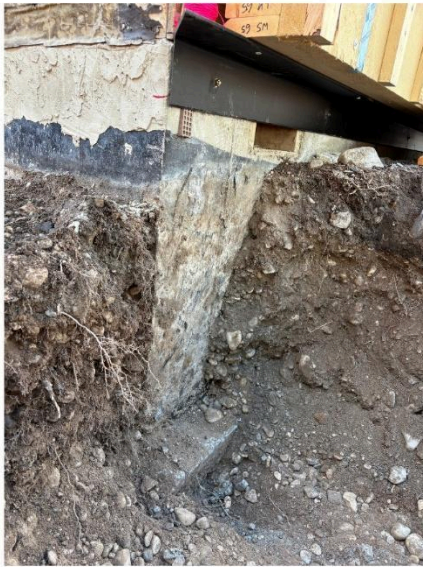
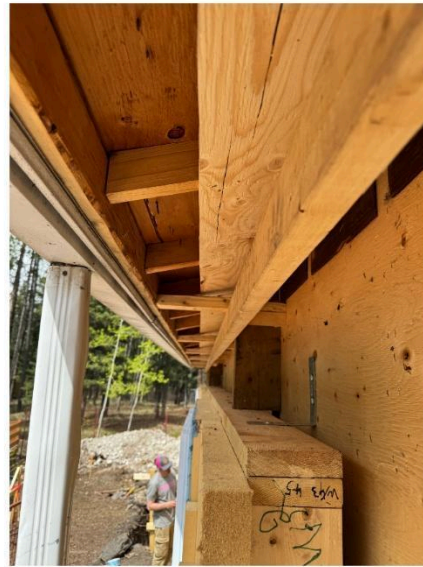
*Figure 12. The steel ledger was fixed to the concrete foundation; the ledger was screwed to the PEER panel through pre-drilled holes. The top of the panel was fixed to the existing structure using angle brackets. Plywood and framing were attached to the roof truss.*

The panels were only connected to the structure at the top and at the bottom of the panel to minimize thermal bridging. The panel was fixed to the ledger at the bottom using screws, and at the top using an angle bracket.

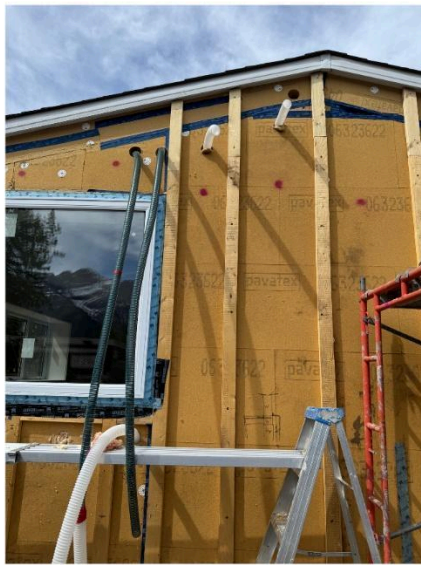
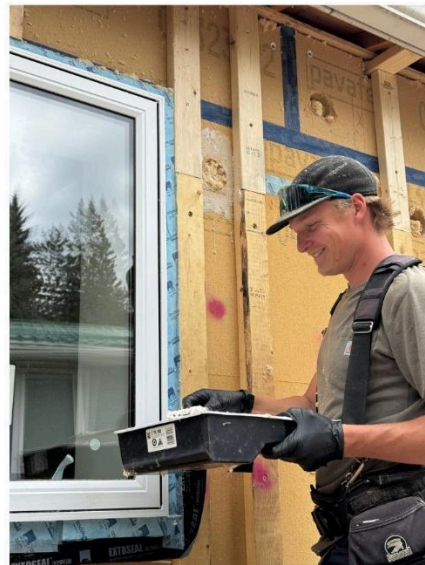
*Figure 13. Holes are drilled through the rigid wood fibre panel into each cavity and into the space above each panel. Hoses are inserted in 3 or 4 cavities ahead of the one being filled. As each cavity is filled the hose is leap frogged ahead and the panel is filled with dense packed wood fibre. Afterwards a glue and a tape are applied to seal up the holes.*

The space between the top of the panel and the Attic needs to be filled separately as you move across. We installed blocking to break this space into ~10' sections that could be filled individually. We marked the location of the blocking on the rigid wood fibre. To patch the holes the rigid wood fibre around the hole must be glued and high-quality tape applied over the hole.

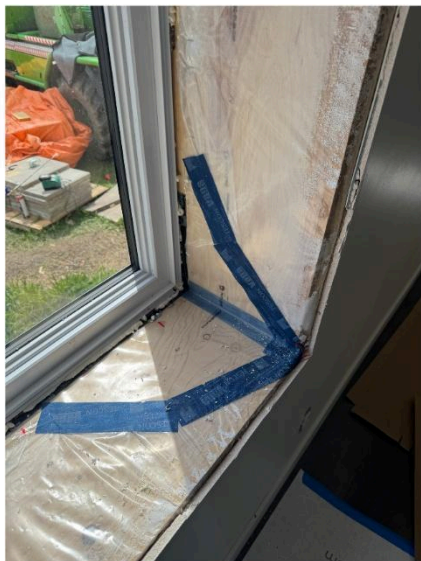
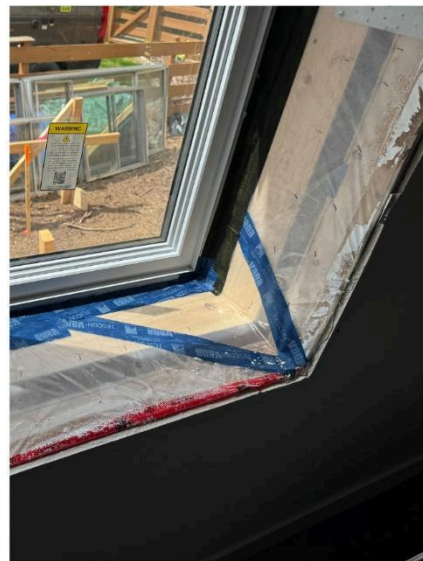
*Figure 16. Two different strategies for window interiors. One featured plywood, while the other featured metal mending plates. The mending plates were quicker and just as effective.*

Installation went well. We like to install flangeless windows near the center of the wall and over insulate them for improved energy performance, but budgetary constraints pushed us to a standard window detail. This was more affordable, went quickly, and was airtight. In the future we would leave the strapping off around the window so it could be taped to the wood fibre rather than the strapping. We experimented with fitting the entire interior of the window with plywood and with using small mending plates, the mending plates worked better with the MDF window returns providing the backing for the blow in wood fibre.

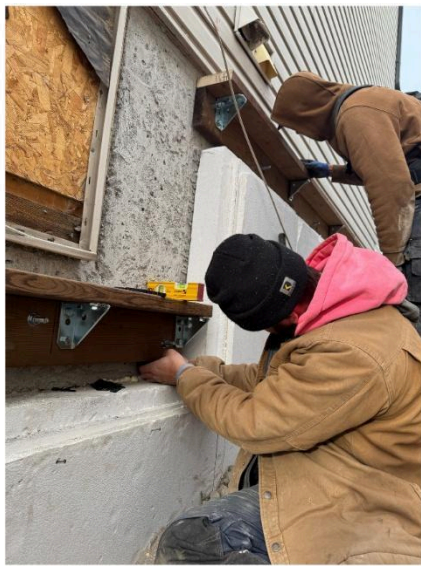
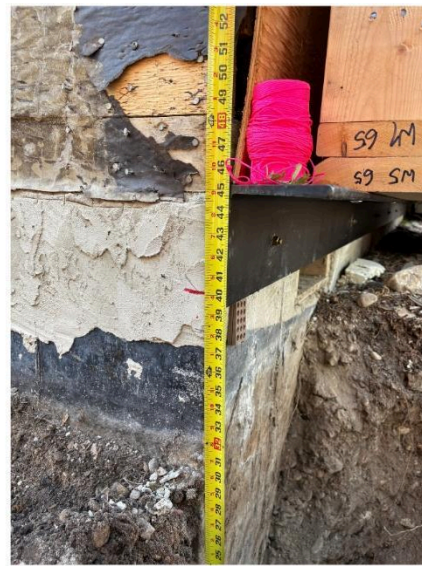
*Figure 17. The new ledger design (left) featuring treated wood and over the counter hardware is better than the steel one (right) used on this project. It was cheaper, easier, and has lower embodied carbon.*

We have changed the ledger design since completing this project. The steel design was difficult to install and required a subcontractor to build it; it was also high in embodied carbon. After consulting a structural engineer, we developed a gusseted wood design that was light, could be built in house with over-the-counter parts, and was easier to install. It also had much less embodied carbon.
