PANELIZED DEEP RETROFITS OF MUNICIPAL BUILDINGS

Debert Water Utility Building Case Study Report

Issue Date: September 30, 2023

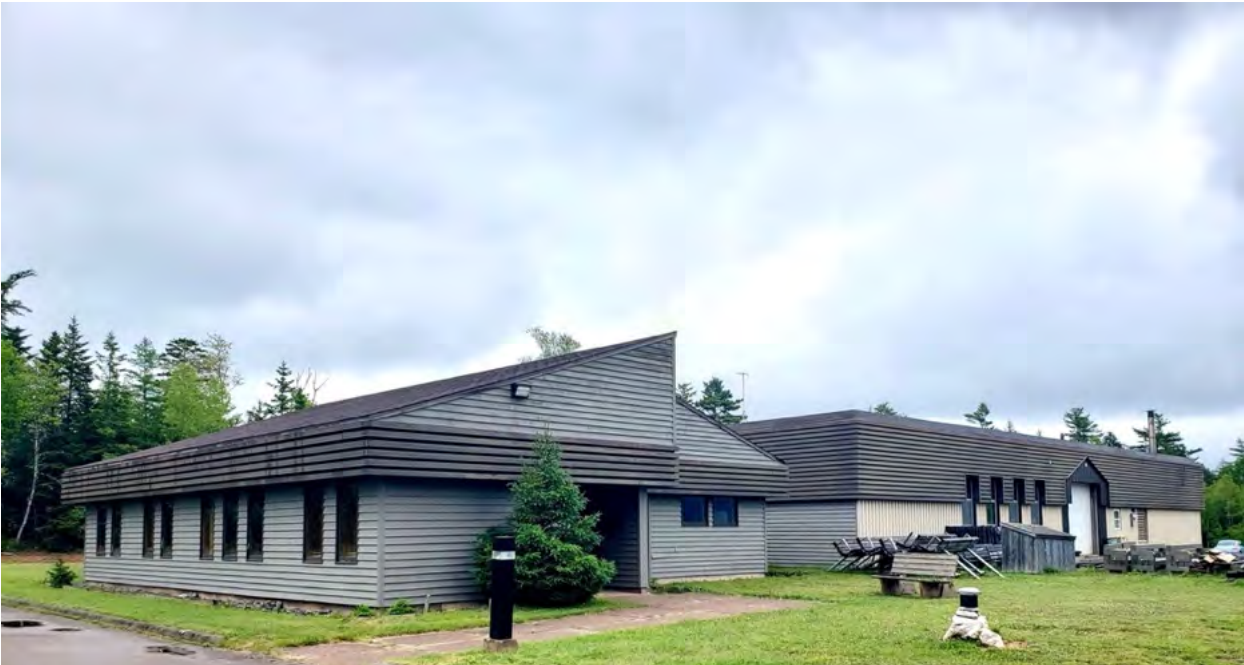
Figure 1 Debert Water Facility

The Debert Water Utility Building is a one-storey structure with a gross floor area of 718m² (7,728 sq. ft) consisting of two wings connected by an enclosed walkway.

Building A is a 181m² (1,948 sq.ft.) office space which is rented out to an engineering company. Building B is a 537m² (5,780 sq.ft.) maintenance facility used for servicing and storage of equipment and contains an office area.

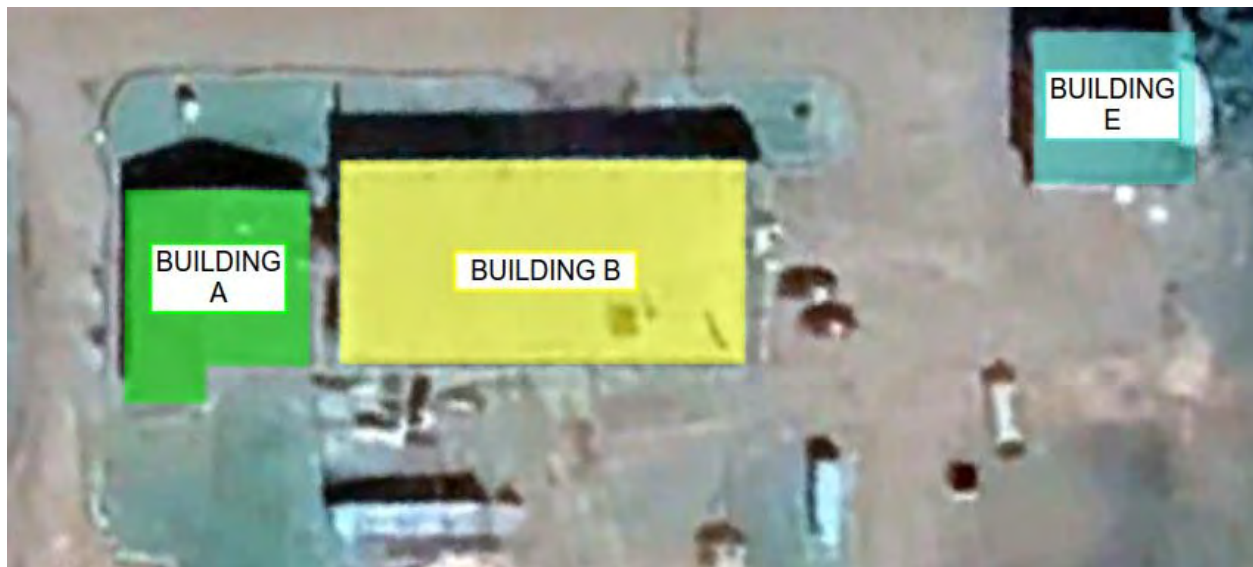
Figure 1: Existing Debert Water Utility buildings.

The Colchester site consists of 5 buildings, labelled A through E. The usage of the buildings is currently unknown to DesignPoint; however, it appears as though Building A & B are the primary buildings, while Building E is a garage and Buildings C & D are greenhouses which appear to be no longer be present based on recent Google Earth imagery. It is understood that only Building A and Building B will be considered for the purposes of this feasibility study. A site plan with each building is shown below in Figure 1.

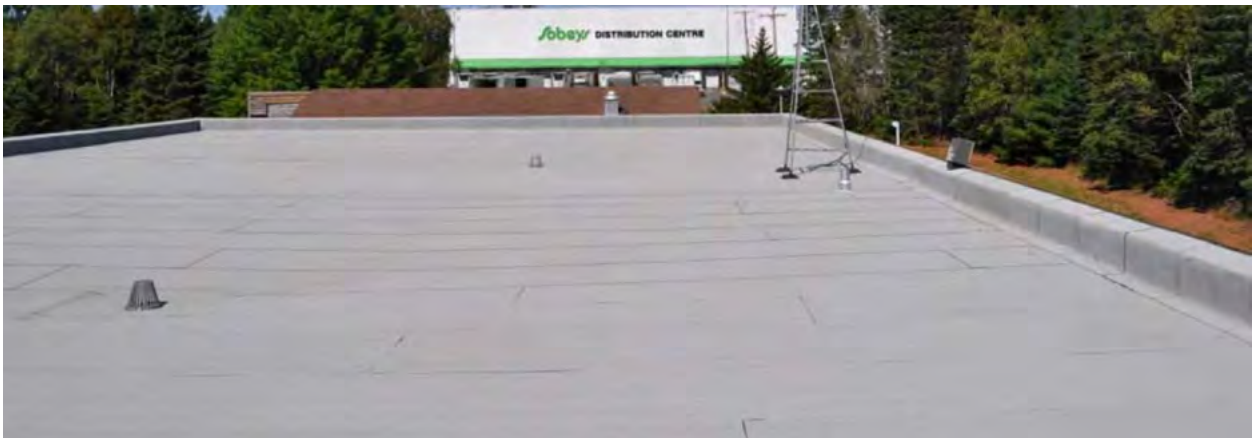
Figure 1 Roof drains over service area of building

Above the office section, a sloped, asphalt, shingle roof drains rainwater. The back service section consists of a modified bitumen flat roof sloped to internal roof drains, refer to Figure 1.

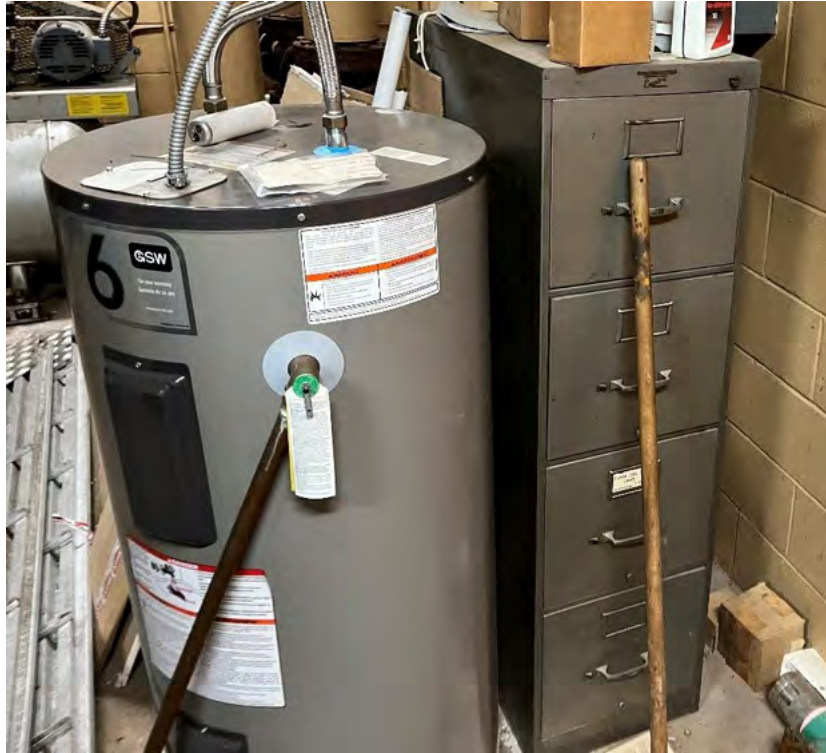
Figure 2 Electric domestic hot water heater

Hot water is supplied by an electric water heater located in the mechanical room. The tank has a nominal capacity of 48 gallons and maximum allowable load rating of 11kW, shown in Figure 2. It was noted that there is no backflow preventor installed on the incoming water service.

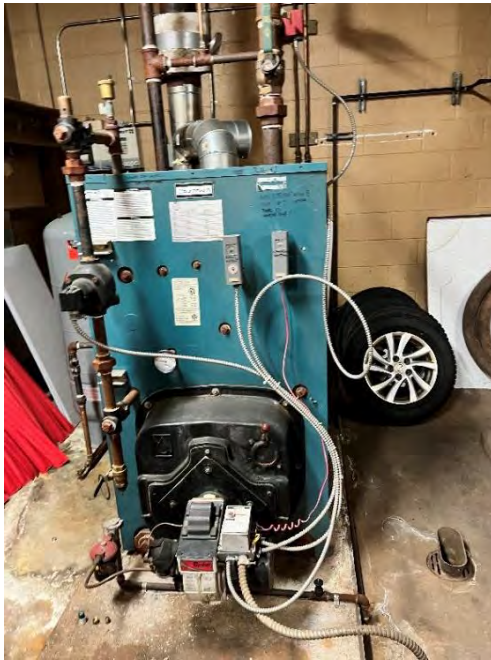
Figure 9 Oil-fired boiler

All spaces in the existing building are heated using hot water baseboard heaters or unit heaters. Hot water is provided by one 483 MBH output oil-fired boiler with a single stage burner, as shown in Figure 9. The boiler cuts in at 170°F and cuts out at 200°F. Previous records indicate that there were originally three boilers installed, however the heating equipment was likely reduced when the greenhouse was removed. Figure 11 depicts the 6,000 gallon exterior double walled storage tank stores the heating oil on site.

The boiler has a single speed circulation pump and two single speed pumps (P12/P13) operate as duty/standby circulating heat around the building. We were unable to gather information on the building circulators, but the original design called for ½ HP pumps operating at 28gpm and 20ft head. Pumps P1 through P10 are no longer in operation as the greenhouse was removed from the building. P11, P14, and P15 are no longer in operation as the DHWT is provided by an electric water heater. Heating piping is generally insulated but some piping is uninsulated in the boiler room and at some unit heaters.

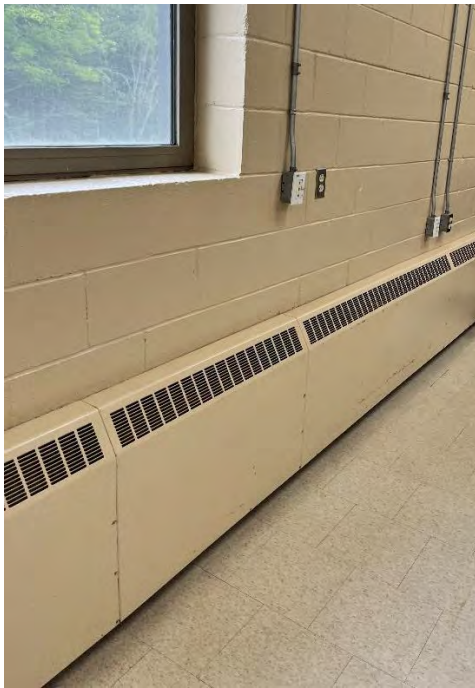
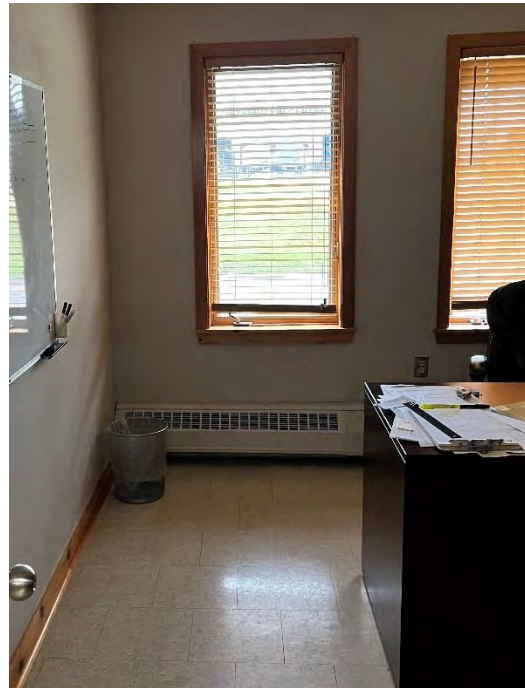
Baseboard heaters are installed in all areas of the building except for the north office area of the maintenance facility which has an electric baseboard heater (depicted in Figures 12 and 13).

Figure 12 Baseboard heater in meeting room

Figure 13 Baseboard heater in north office

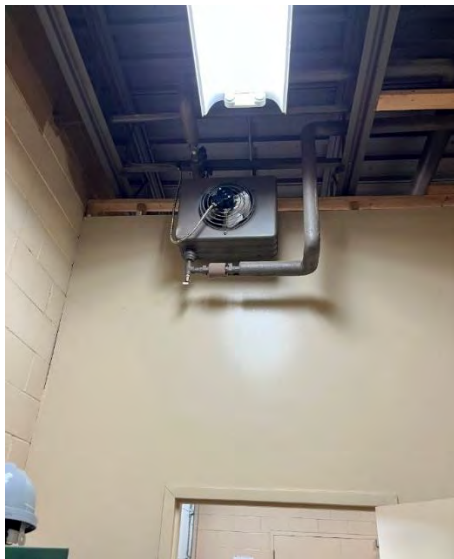
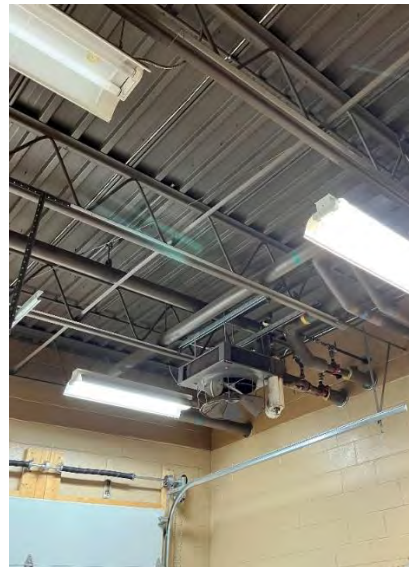
Supplemental hot water unit heaters have also been installed in the work area on the south side of the building and outside the mechanical room.

Figure 14 Unit heater outside mechanical room

Figure 15 Unit heater in work area

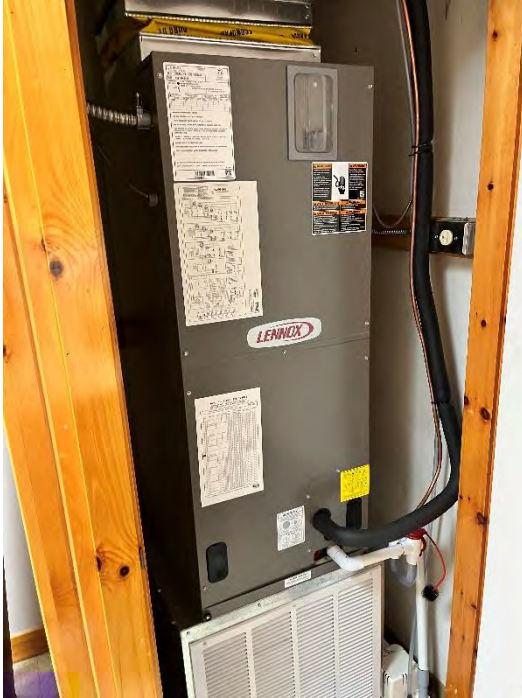
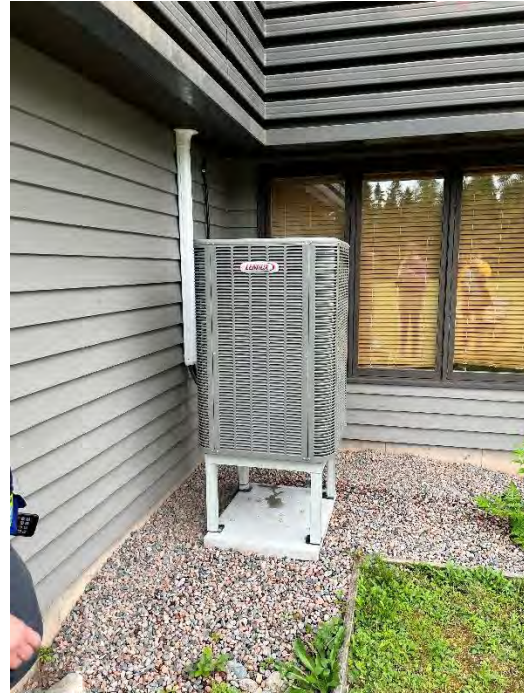
A 2.5-ton heat pump has also been installed in the office area to provide heating and cooling. The unit was only installed in June 2022. The office area was previously cooled with a ducted air conditioner. The indoor and outdoor heat pump units are shown in Figures 16 and 17.

Figure 16 Indoor heat pump unit

Figure 17 Outdoor heat pump unit

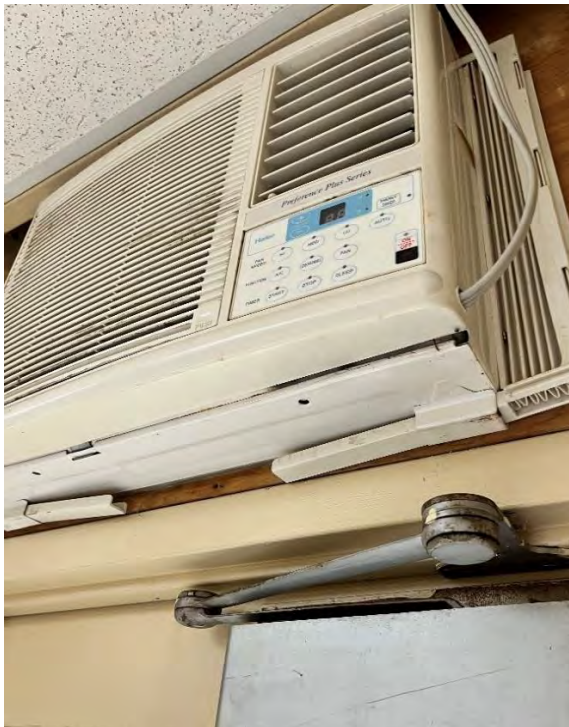
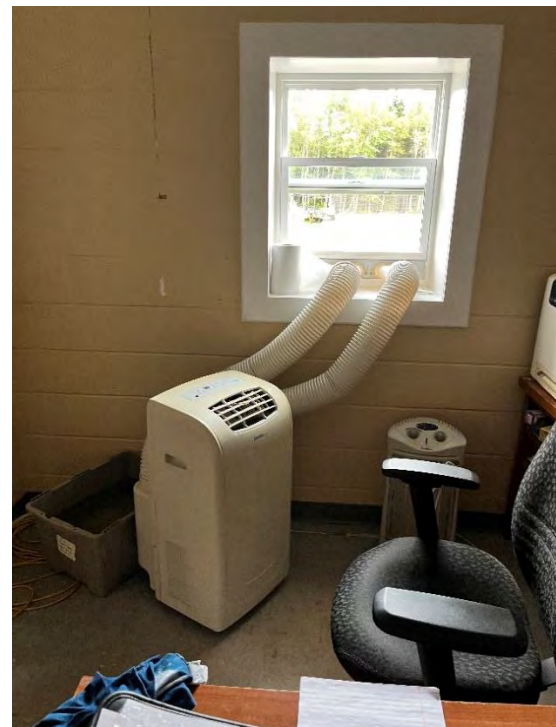
The maintenance area does not have any cooling aside from two window unit air conditioning units installed in the north and south offices, shown in Figures 18 and 19.

Figure 18 North office air conditioning unit

Figure 19 South office air conditioning unit

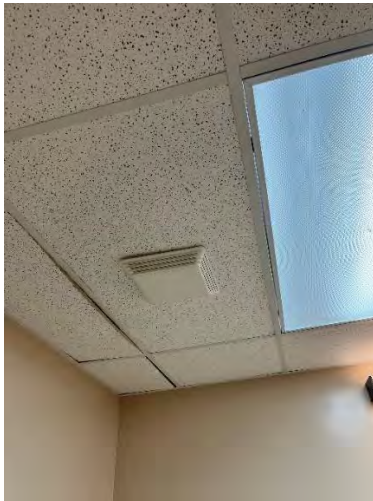
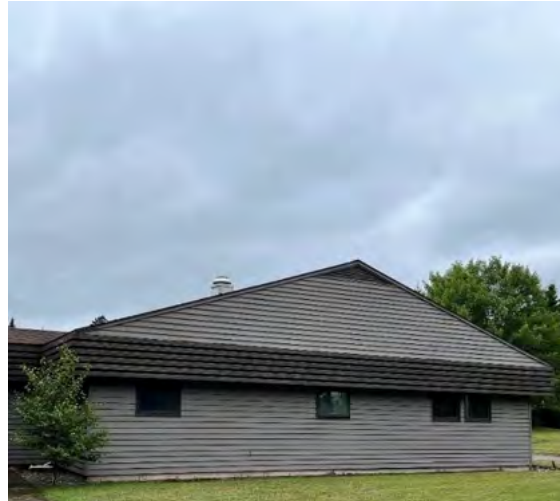
The only ventilation installed in the facility includes bathroom exhaust fans.

Figure 20 Bathroom exhaust inlet

Figure 21 Bathroom exhaust outlet

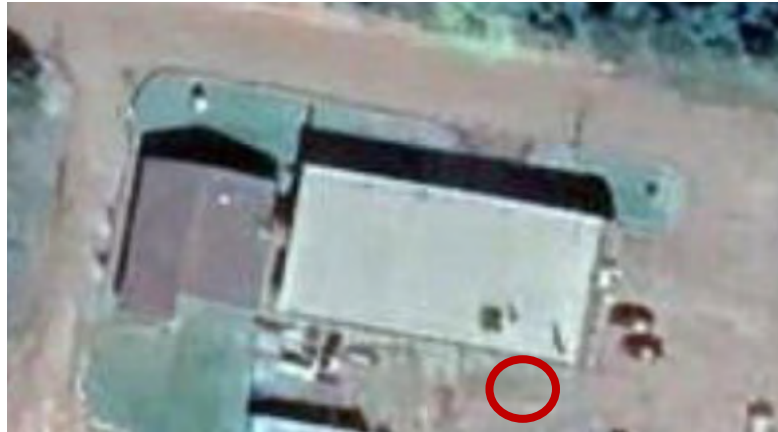
Figure 23 ASHP Outdoor Unit Location

The air source heat pump would be mounted outdoors on a stand outside of the mechanical room (shown in Figure 23 below). Ideally, the heat pumps would be installed on the south side of the building to maximize winter performance due to higher outdoor air temperatures.

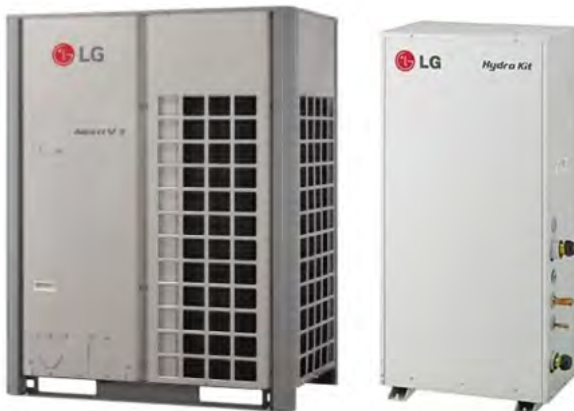
Figure 24 Split Air to Water Cold Climate Heat Pump

Heating will be generated by a cold climate air source heat pump (refer to Figure 24) in place of the oil-fired boiler. The heat pumps will have a circulation pump on the condenser side and speed will be controlled based on the compressor operation. Heating will be distributed by the existing hydronic baseboard heaters and thermal zones. A mini split heat pump will provide heating to the north office as the electric baseboards would be removed. Accessories to the hot water piping systems include make-up water source, expansion tank, air venting, circulation pumps, and isolation valves.

The air source heat pump has been sized according to so that it meets 60% of the peak heating load at a reduced outdoor air temperature of -4°F. The electric boiler is sized for the remaining 40% of the load. As peak demands rarely occur throughout the year, it is much more economical for the electric boiler to provide heating during peak demand periods. Reducing the heat pump capacity to 60% of peak load typically results in the electric boiler only providing 5 – 15% of annual heating.

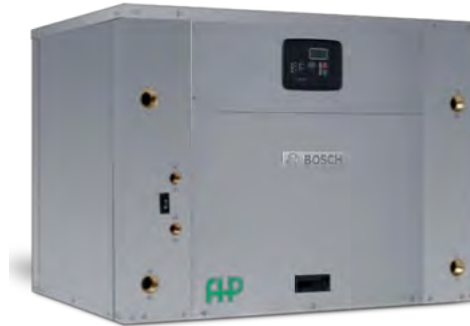
Figure 27 Ground Source Heat Pump

This option is the equivalent to the ASHP option except the heating will be generated by a water to water, or ground source, heat pump (as shown in Figure 27). A series of water to water heat pumps will be connected to closed-loop vertical borehole ground heat exchangers providing hot water to buffer tanks. The vertical loop heat exchanger system will consist of long lengths of 1-1/4" diameter HDPE or PEX tubing placed in boreholes drilled to a depth of approximately 150m below the surface level and filled with thermally enhanced grout. Length of pipe, diameter of pipe, and the spacing of wells will depend on the final building heating and cooling loads during detailed design. An

estimated three boreholes will be required to provide both space heating and domestic hot water for the building.¹ Similar to the ASHP, the GSHP system has also been sized for 60% capacity.

Accessories to the GSHP piping system would include glycol fill tank, expansion tank, air venting, circulation pumps and isolation valves. Each heat pump will have a circulation pump on the evaporator and condenser side and be controlled by the heat pump when the compressor is engaged.

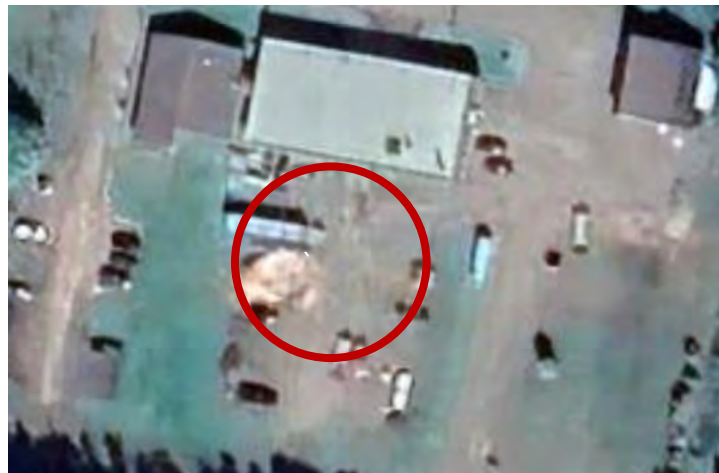
Figure 28 Proposed Borehole Location

The boreholes would most likely be located on the south side of the property on the site of the old greenhouse (refer to Figure 28); however, further geotechnical analysis must be conducted to confirm. Boreholes are typically spaced 4.8 – 6 meters apart. The GSHPs would be located in the mechanical room in Building B.

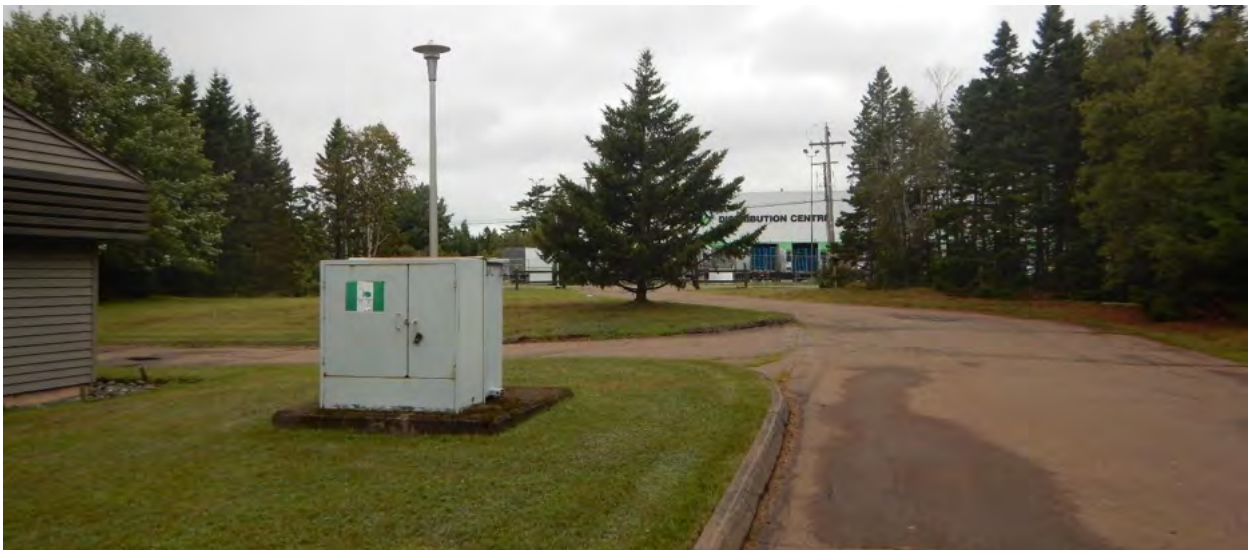
Figure 1

Existing incoming power service consists of two, 4" conduits on the primary side servicing the existing pad mount transformer on site. The pad mount transformer is 150kVA. The existing main incoming secondary service is sized at 800A and consists of two, 3-1/2" conduits containing 4#500MCM RW90 cables each. By today's code standards these cables would no longer be suitable for 800A service. The secondary service entrance enters the building in the main electrical room and terminates onto the main switchboard. The building's main disconnect is an 80% rated main breaker in the main switchboard.

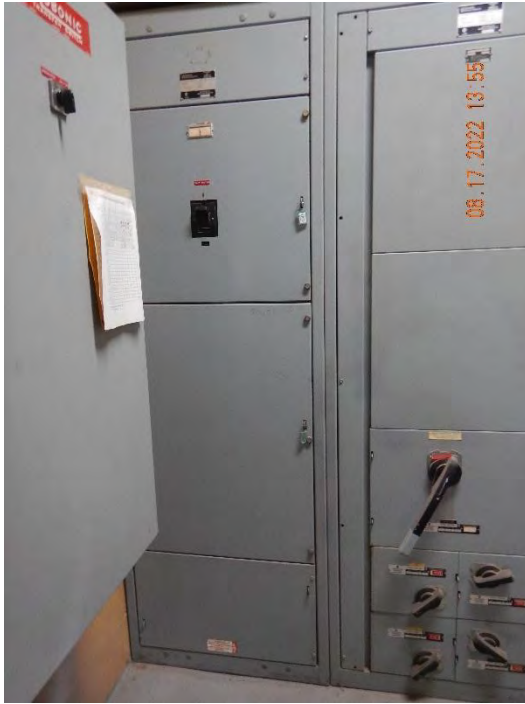
Figure 3

The existing main switchboard is original to the building. It appears to be well maintained but has reached its end of life. No maintenance logs are available to determine work done throughout the years.

The main building disconnect is an 80% rated 800A main breaker. All other disconnects for panels, motors etc. are fusible disconnects. Visually the disconnects appear to be in good condition. Although cubicles 1 and 3 are full, there is spare room in cubicle 2 for the addition of future buckets to expand the existing distribution. Several spare fusible disconnects exist in cubicle 3 that are currently not in use. There is a 400A emergency distribution panel installed inside the main switchboards second cubicle. The condition of the main switchboard is okay.

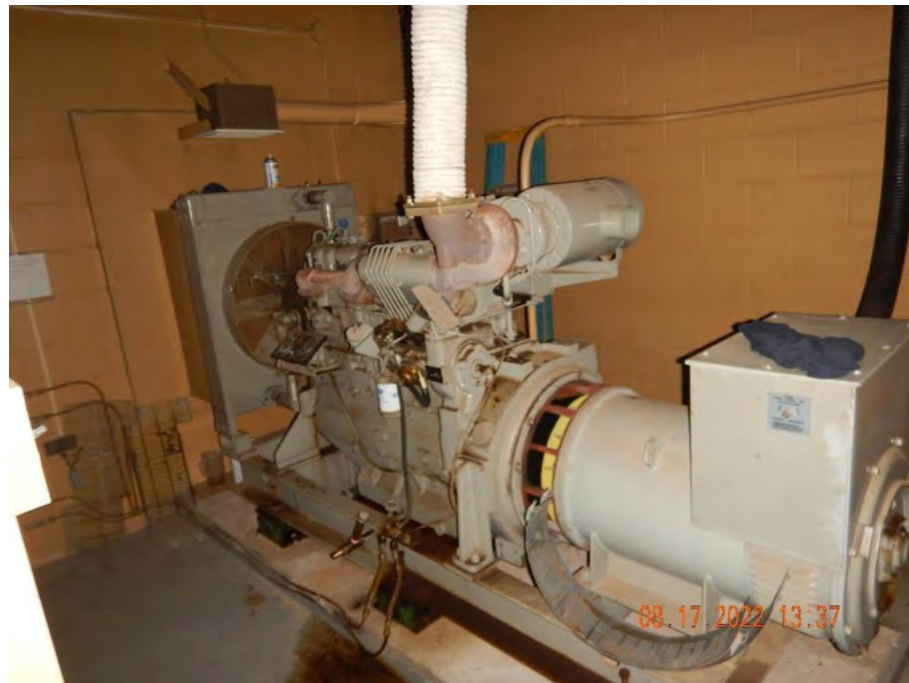
Figure 7

A 150kW 208V, 3P emergency generator and distribution exists on site but is reportedly no longer in use. The existing emergency distribution is always powered by the “normal” side and is essentially just used as normal power. It was discussed on-site that on-site emergency power generation is no longer needed.

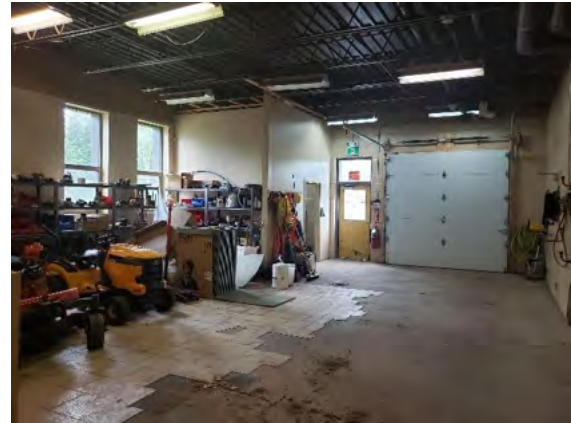
The side of the building occupied by Colchester County is primarily original lighting, consisting of mostly T12 fluorescent lamps. The warehouse areas of the building consist mainly of high output fixtures. The estimated lighting power density for this section of the building is 25W/m².

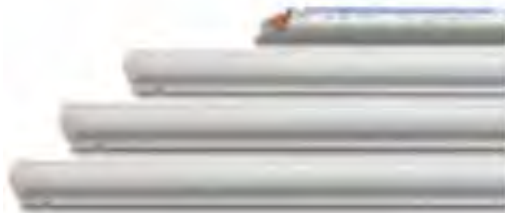
Figure 12

In the minimum acceptable scenario, all lighting throughout the building should be upgraded to LED using LED lighting retrofit kits. These kits come complete with LED replacement lamps and ballasts so the existing fixtures throughout the building can be internally re-wired to work with LED lamps. This will allow the existing building lighting to remain in the same areas and will fix the issue of frequent burnt out fixtures throughout the building. High bay retrofit kits will be provided for all the existing T8HO lamps and regular retrofit kits will be provided for the remaining fixtures. In this scenario, the lighting power density will reduce to an estimated 10W/m².

LED Retrofit Kit

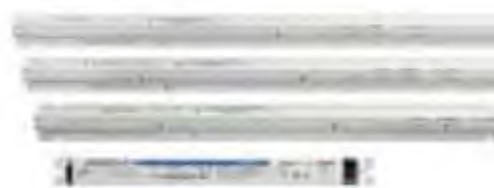
Figure 13

LED Retrofit Kit High Bay

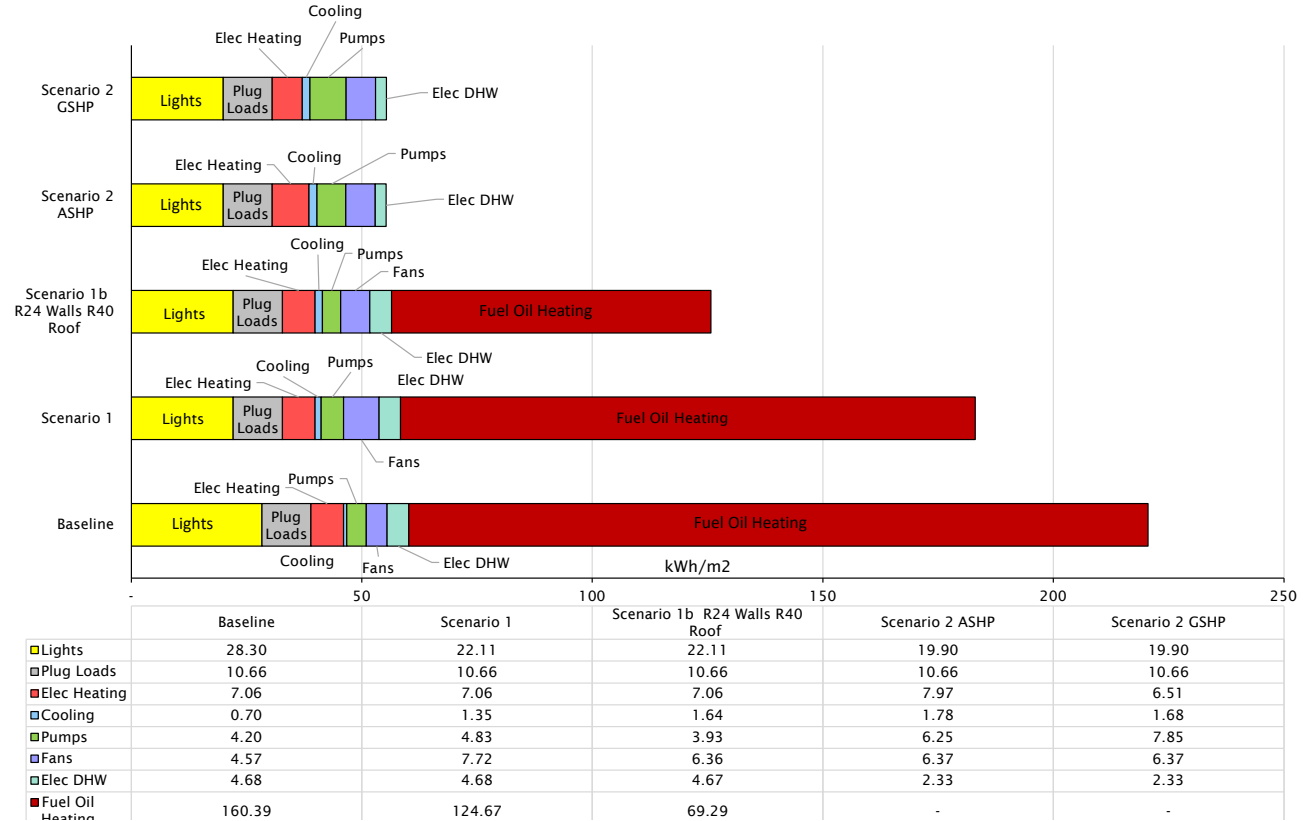
Total Energy Use Intensity TEUI (kWh/m²/yr):

Note: The values presented above represent the relative proportion of each component of total energy use.

TEUI:	Total:
Baseline:	220.6 kWh/m ²	158,423 kWh
Scenario 1:	183.1 kWh/m ²	131,492 kWh
Scenario 1b:	125.7 kWh/m ²	90,293 kWh
Scenario 2 ASHP:	55.3 kWh/m ²	39,691 kWh
Scenario 2 GSHP:	55.3 kWh/m ²	39,722 kWh

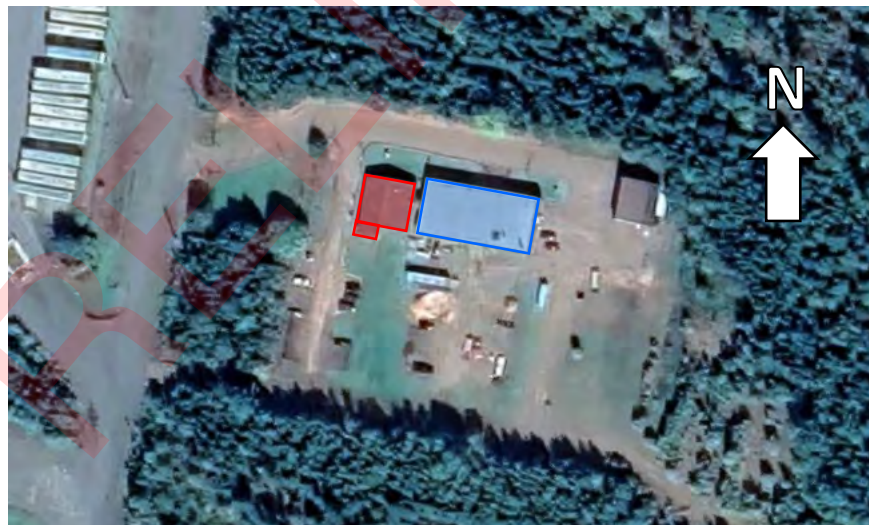
It is understood that the Colchester Water Utility Administration facility, built in 1979, is located in a small clearing east of Lancaster Crescent and the Sobeys Debert Distribution Centre. The buildings in question, namely Building A and Building B, are oriented a few degrees east of due North. The buildings are partially sheltered from the treeline located approximately 20-m to the North. The eastern side of Building A faces the western side of Building B, and the two buildings are linked by a 3.5-m long stretch of enclosed corridor (see **Figure 1**).

Figure 1 – Plan view location and orientation of Building A (shaded red) and Building B (shaded blue) of the Colchester Water Utility Administration facility, Debert (Google, 2022)

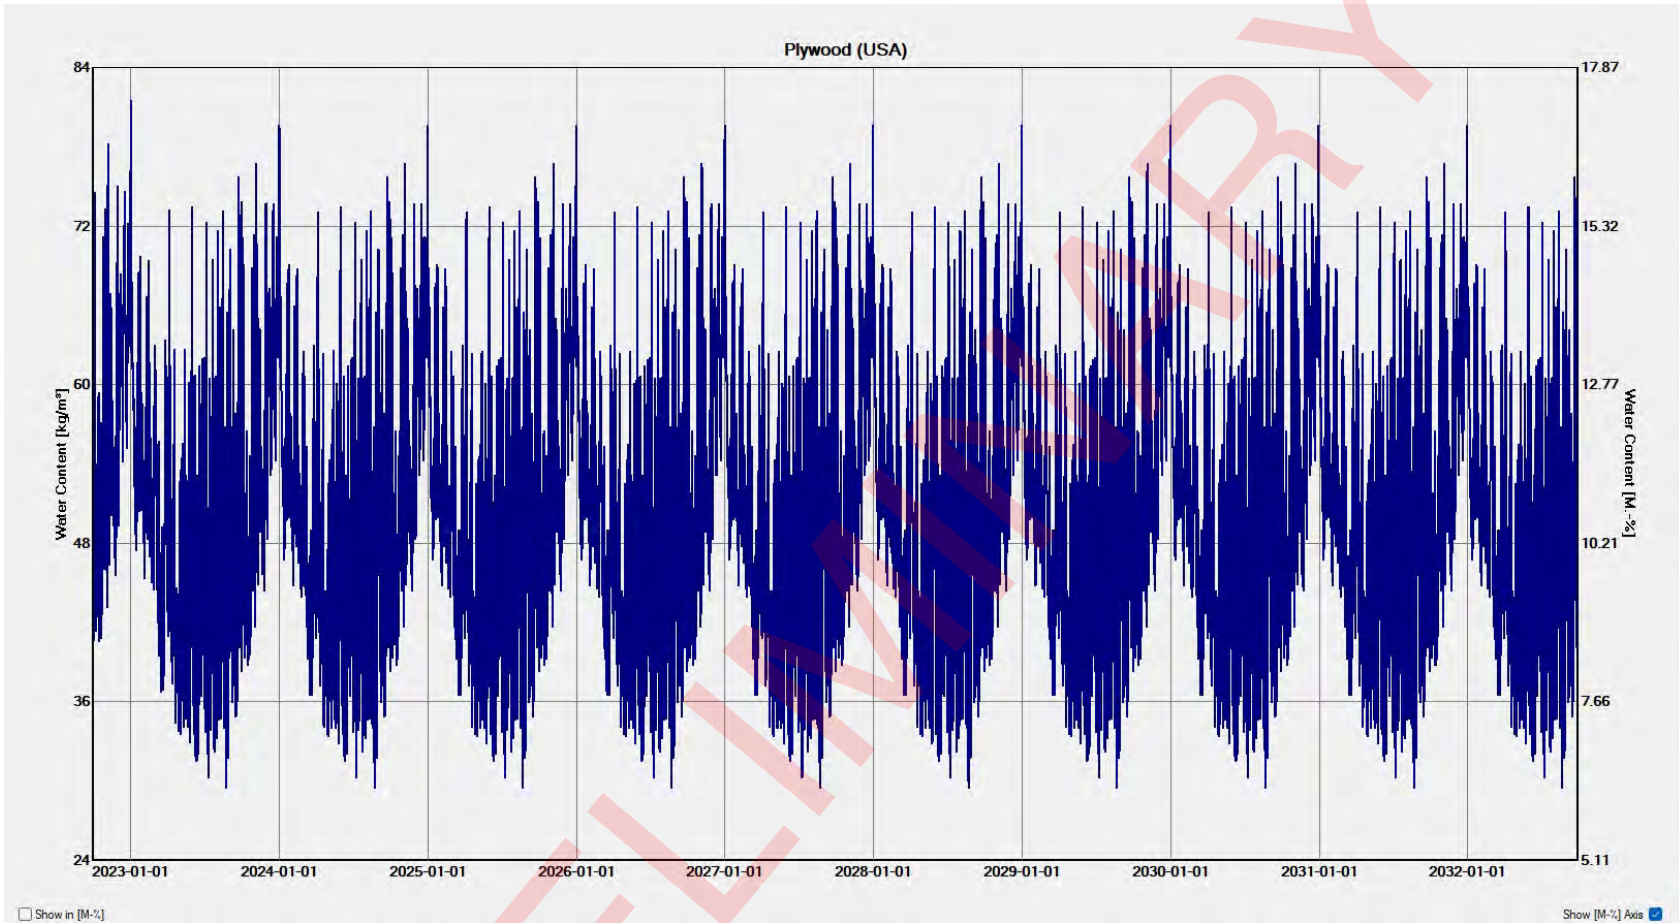
Figure 11 - WUFI® output for Building B Roof assembly: water content (kg/m^3 , %) over 10-year period studied for post-retrofit Building B South Roof assembly's inner 1/8-inch plywood layer (unshaded scenario)
