# Wood Fibre Prefabricated Exterior Energy Retrofits

# HSS DESIGN BUILD

## 1 Detailed background of existing building

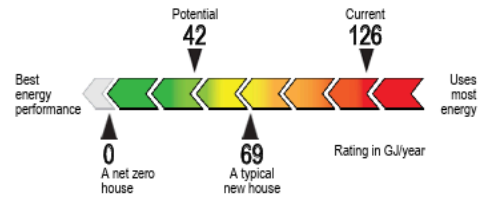
Figure 4. As part of the EnerGuide evaluation a renovation upgrade report is produced which recommends energy saving upgrades as well as this graphic displaying the current and potential energy performance of the building.

Unsurprisingly, the EnerGuide Evaluation determined that space heating is the predominant energy use in the building. The evaluation identified Windows, air leakage, the main walls, and the attic as the largest sources accounting for 34 percent, 25 percent, 20 percent, and 9 percent of heat loss respectively.

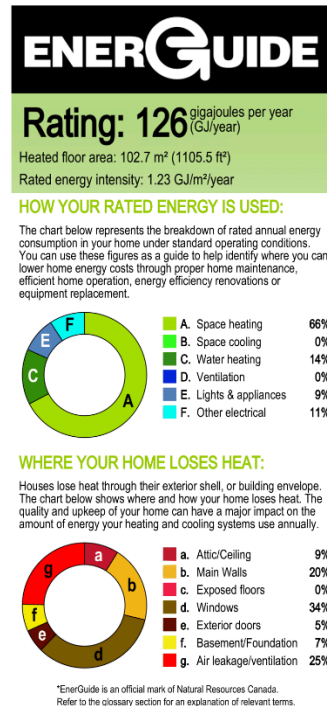
Figure 5. As part of the EnerGuide evaluation the homeowner information sheet contains details of the buildings construction as well as this graphic which shows how much energy the building uses annually, what most of that energy is used for and where heat is lost.

The most significant deficiency was the poorly performing windows. This was most clearly demonstrated by the extent of heat loss attributed to them in the EnerGuide evaluation. This was due in part to the low insulating properties of the aluminum frames and glazing, as well as significant air leakage observed during the blower door test. This issue was resolved when the windows were replaced as part of the PEER retrofit.

Air leakage was also a significant deficiency and the second largest source of heat loss. This was due to leaky windows, doors, walls, and significant leakage into the semi conditioned crawl space. Some of this was addressed as part of the PEER through window and door replacement, taping seams on existing sheathing, and the installation of blown in wood fibre. However much of the air leakage was through the interior floor into the semi conditioned and ventilated crawl space. While the homeowner addressed many of these problems, there were enough remaining at the end of the project to result in a higher than desirable blower door score. However, if air leakage in the crawlspace is addressed in the future, the building would achieve a good

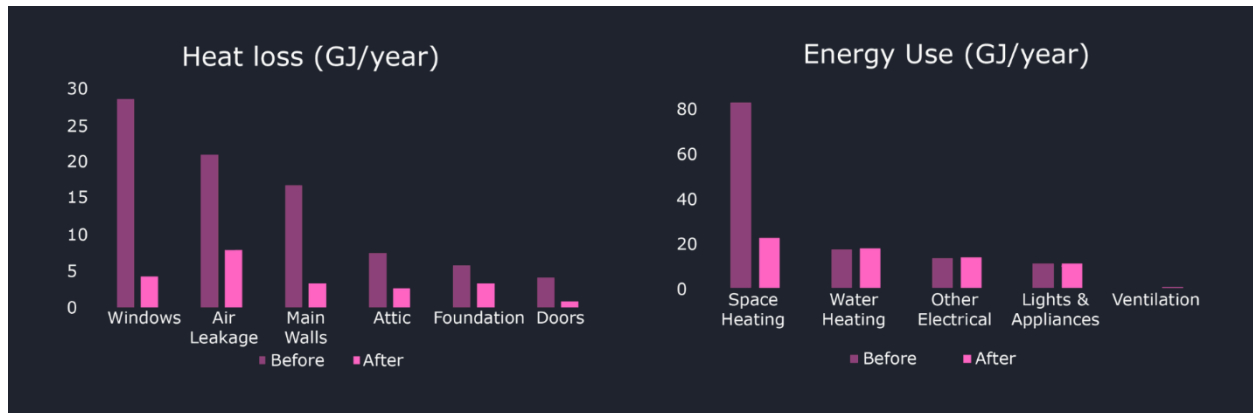
3.3 GJ/year, attic from 7.3 GJ/year 2.6 GJ/year, foundation from 5.7 GJ/year to 3.3 GJ/year, and doors from 4 GJ/year to 1 GJ/year.

Figure 14. A comparison of the heat loss and energy use data from the EnerGuide Evaluations completed before and after the retrofit.

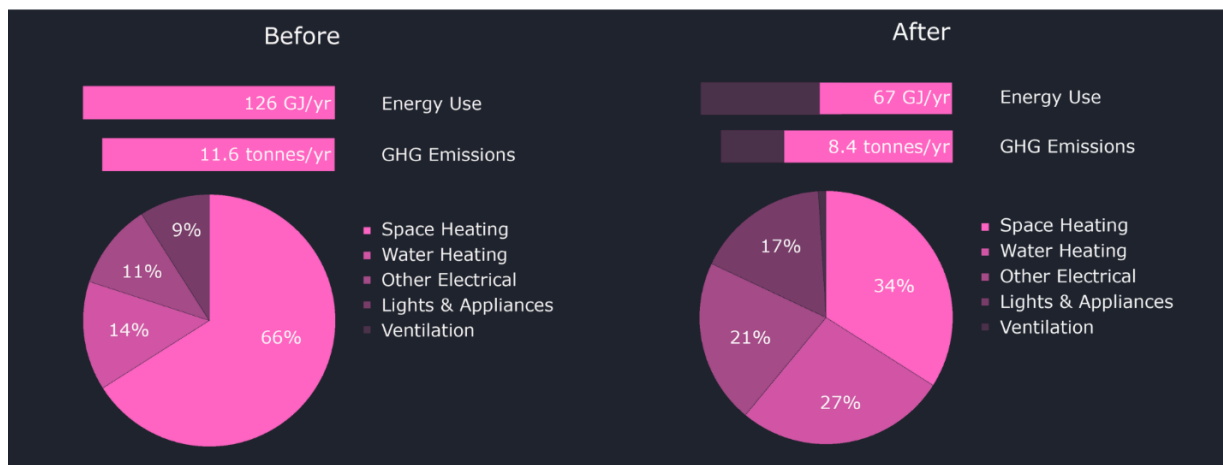
Total energy use was reduced from 126 GJ/year to 67 GJ/year. Green House Gas emissions were reduced from 11.6 tonnes/year to 8.4 tonnes per year. Space heating went from 66 percent to 34 percent of total energy use.

Figure 15. A more detailed comparison of the energy use data as well as greenhouse gas emissions from the EnerGuide Evaluations completed before and after the retrofit.
