PANELIZED DEEP RETROFITS OF MUNICIPAL BUILDINGS

Burlington Seniors Centre Case Study Report

Issue Date: September 30, 2023

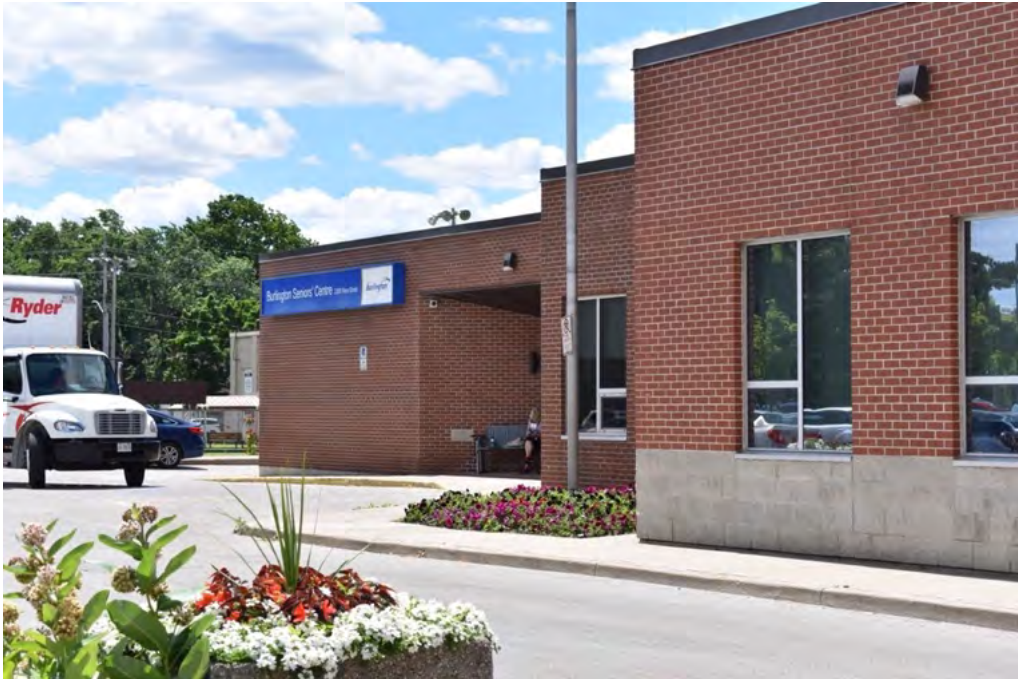
Figure 1 Burlington Seniors Centre

The Burlington Seniors Centre is a one storey structure with a gross floor area of 2,000m² (21,526 sq.ft.). Its footprint is irregularly shaped with many 135-degree angles. The original building was built in 1979 and it underwent a renovation and expansion in 2005.

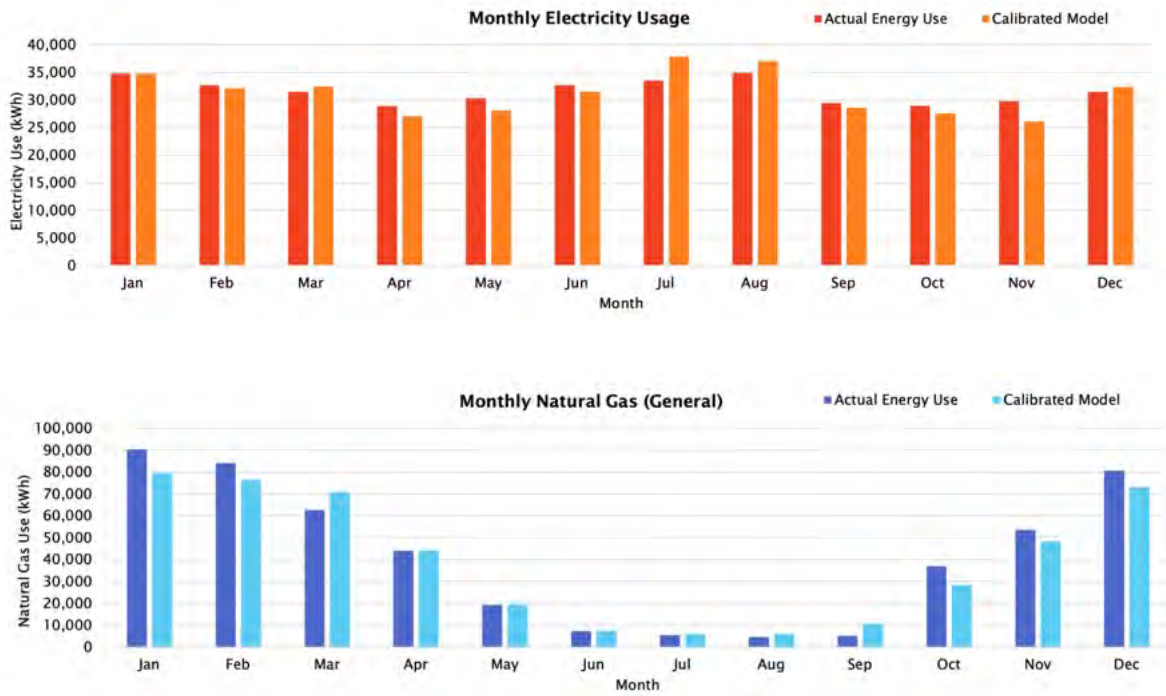
Figure 6 Calibrated Energy Use

Summertime electrical calibration did not align as closely to actual energy use as the rest of the year. This is assumed to be due to higher levels of programming in summer months. The annual calibrated electrical consumption is within 1% of actual use. Natural gas calibration deviates from actual use through the heating season. The gas heating system is supplemented with electricity in some spaces and the relative proportion of heating provided by the two systems is inconsistent. The calibrated natural gas consumption varies 5% from actual use.

The energy model was calibrated with the historical utility data to closely reflect the current building performance. As occupancy fluctuated during the pandemic, the calibration was based on consumption prior to March 2020 to best reflect energy use during standard operations.

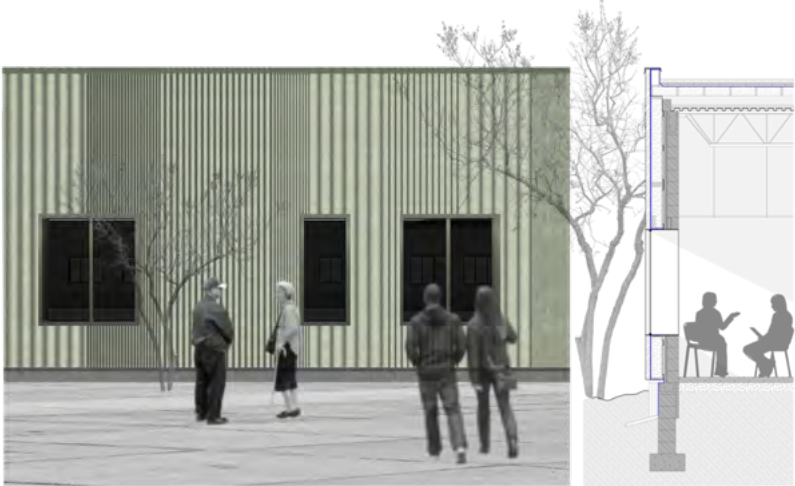
Figure 7 Burlington Seniors Centre partial elevation and section.

The strategy for building enclosure upgrades is to retrofit the walls with prefabricated ReCover panels and to complete a conventional retrofit to the roof by adding outboard rigid insulation as a panelized roof retrofit is not structurally viable.

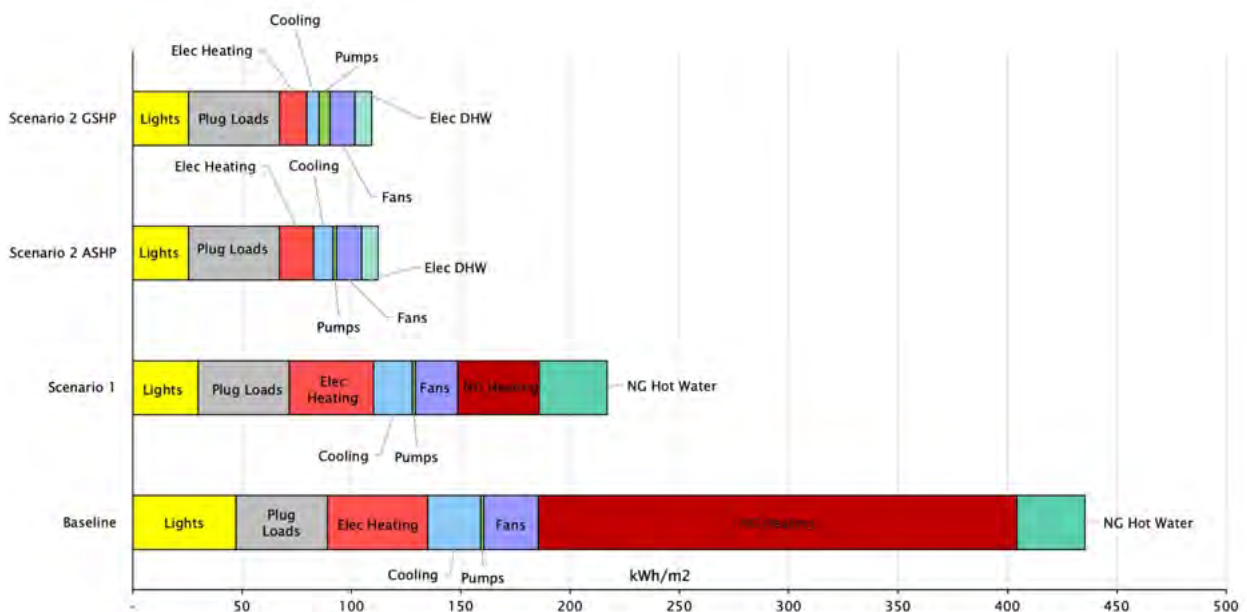
The existing **Total Energy Use Intensity (TEUI)** of the Burlington Seniors Centre is 435.4

Figure 9 Total Energy Use Intensity (TEUI) kWh/m²/yr

ekWh/m²/yr with 60% of energy use for space heating (Figure 9).

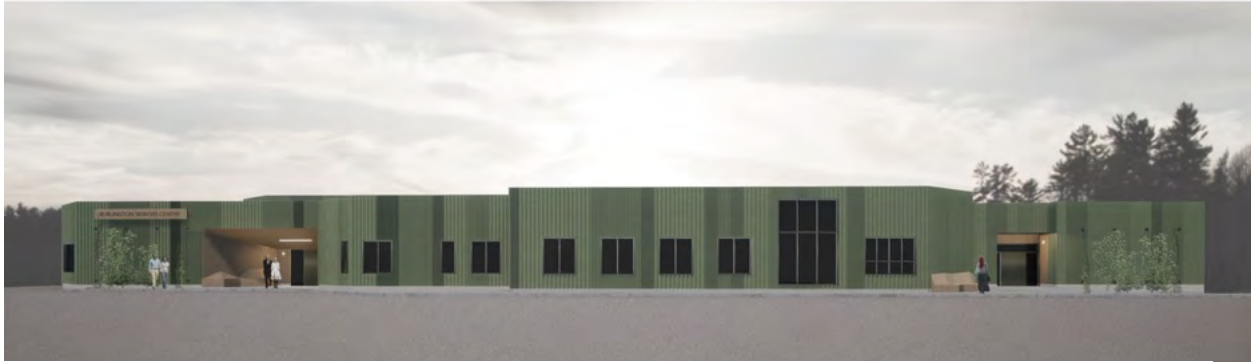
Figure 10 Design concept

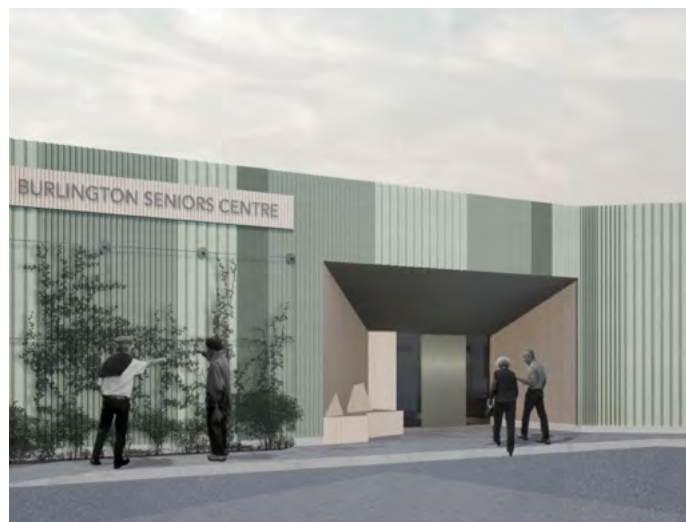
To improve wayfinding and to create a sense of warmth and welcome, the recessed entrances are wrapped with cedar siding. These will be illuminated with warm lighting to mark the doors with a golden glow.

Figure 11 Entry Concept

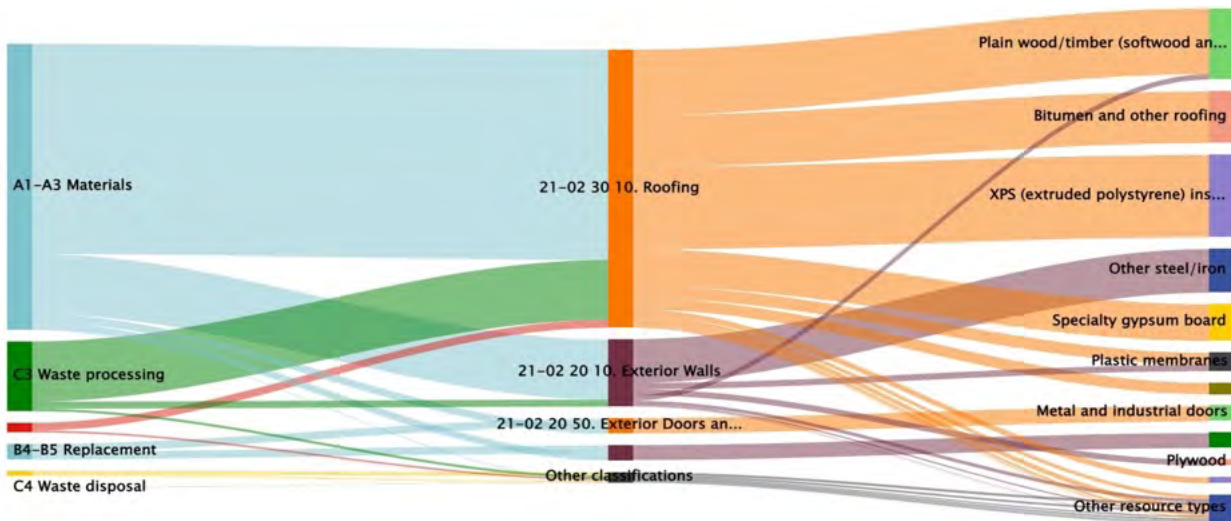
Figure 19 Life Cycle Impacts by Stage (%)

The major contributors to the GWP in this design are the metal roofing, EPS insulation, roofing membranes and windows. The A1-A3 Materials stage contributed 39% of the total carbon emissions associated with this building followed by C3 Waste processing at 34% as illustrated in Figure 19 & 20. The biogenic carbon of this building offsets 44.5% of the total A1-C4 carbon emissions. This storage is attributed to the wood products (68%) and cellulose insulation (32%) used in the assembly as shown in Figure 21.

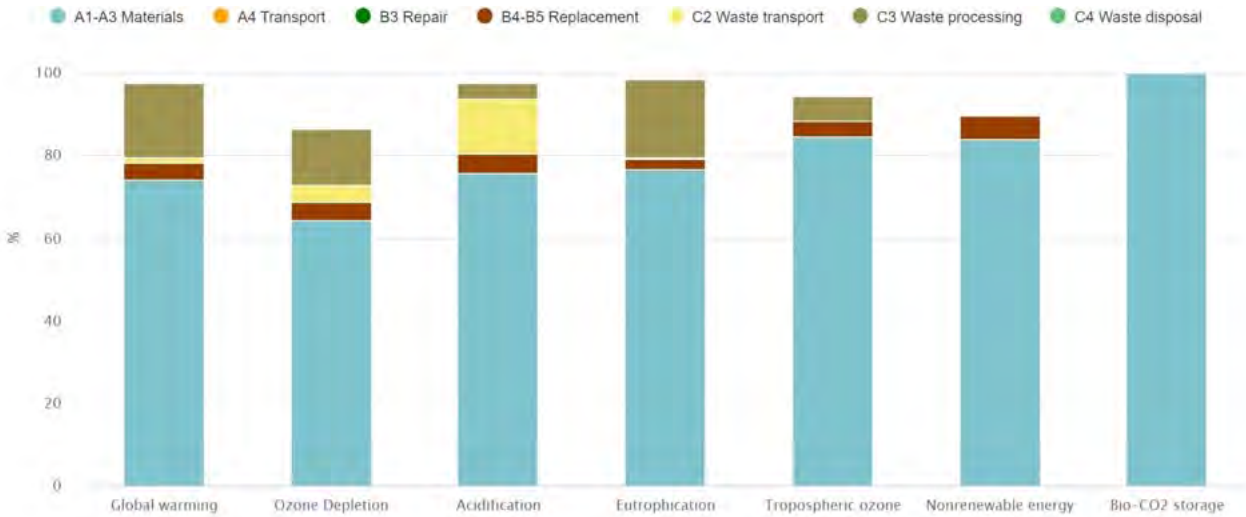
Figure 20 Global Warming by Stage and Material

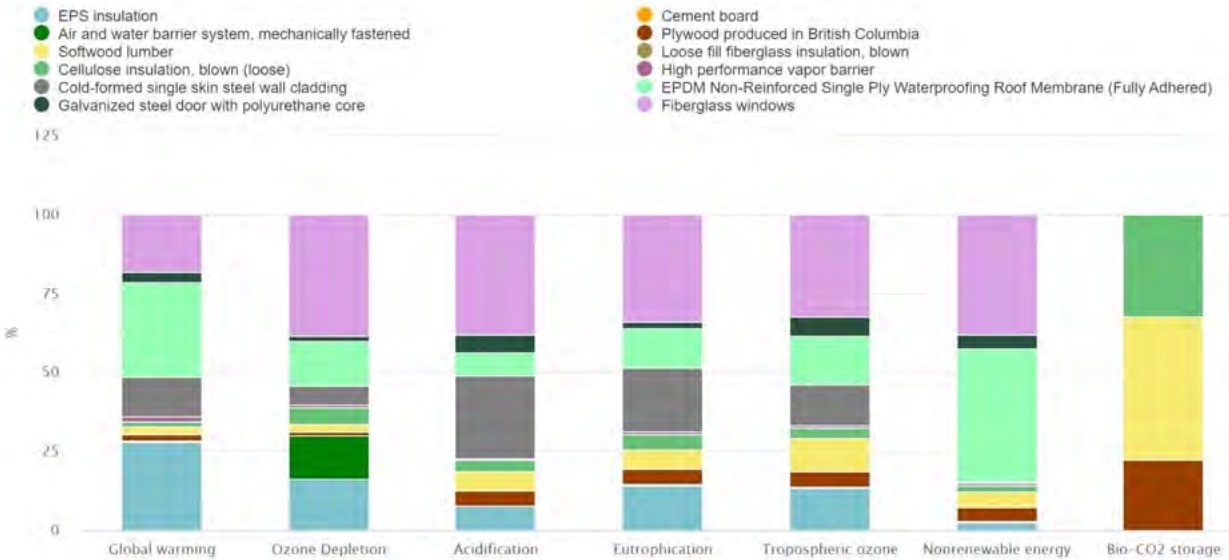
Figure 21 Life Cycle Cost by Material

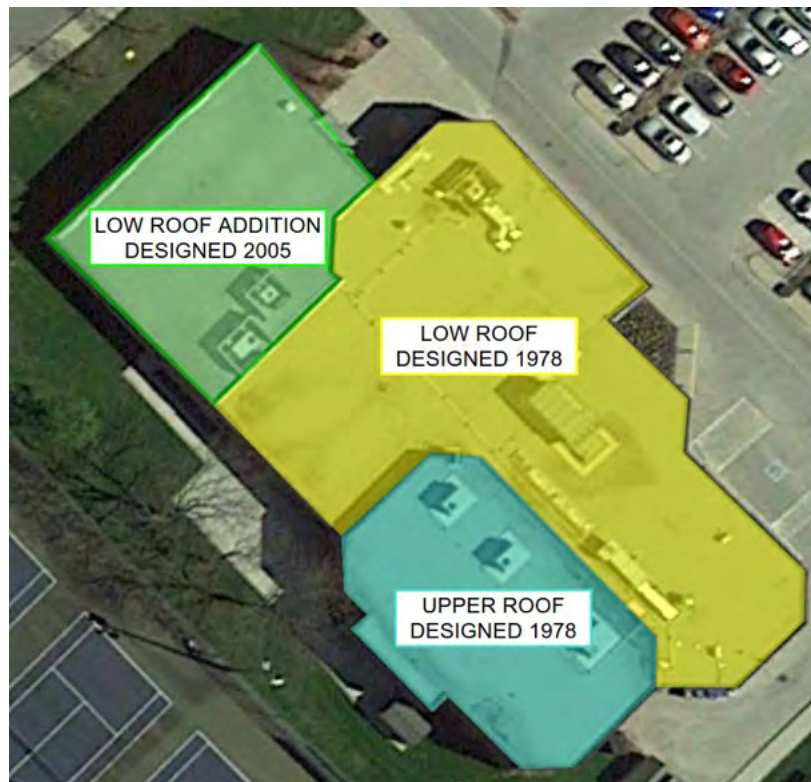
The Burlington Seniors Centre is a single-storey community recreation building located at 2285 New Street in Burlington, Ontario. The structure is owned and operated by the City of Burlington. It is our understanding that the existing building consists of an original structure, designed in 1978, and a single-storey addition at the northwest side of the building, designed in 2005. An aerial view of the building noting the different building sections is shown in Figure 1.

Figure 1: Burlington Seniors Centre roof areas.

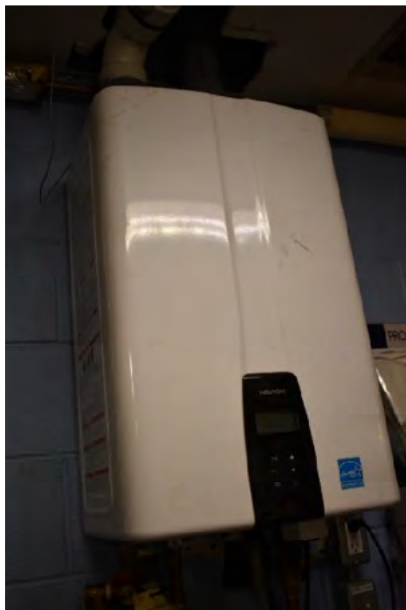
The existing hot water service includes a natural gas tankless water heater with a separate 80-gallon storage tank. The system includes a two-inch main line with rough ins included. Piping, controls, and shut off valves are primarily copper.

Figure 1 Natural Gas Tankless Water Heater

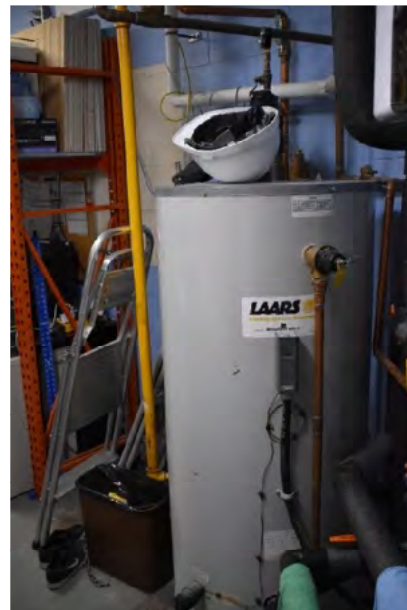
Figure 2 Storage Tankr

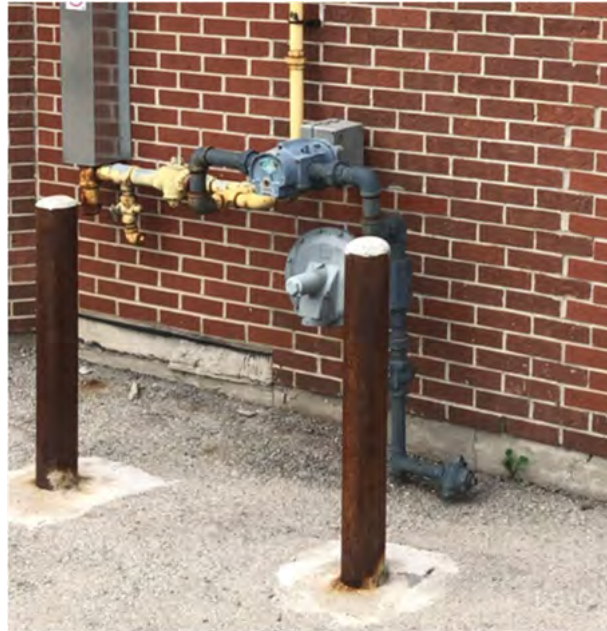
The gas main is distributed through steel piping, the building has a natural gas meter, as shown in the figure below.

Figure 3 Natural Gas Meter

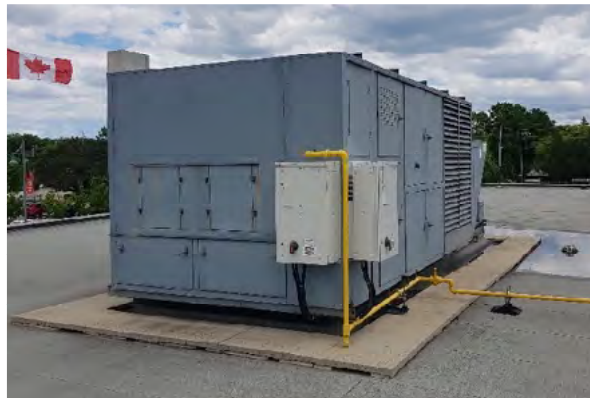
Unit ID: Multizone Packaged RTU
Manufacturer: Engineered Air
Model Number: FWE52/HE20/O
Distribution: VAV boxes are installed for each zone. The system serves seven zones: dining room, boutique room, billiard room, arts and crafts room, games room, admin offices, and reception areas.

Figure 5 Multizone Packaged RTU

Figure 6 Location of Multizone Packaged RTU

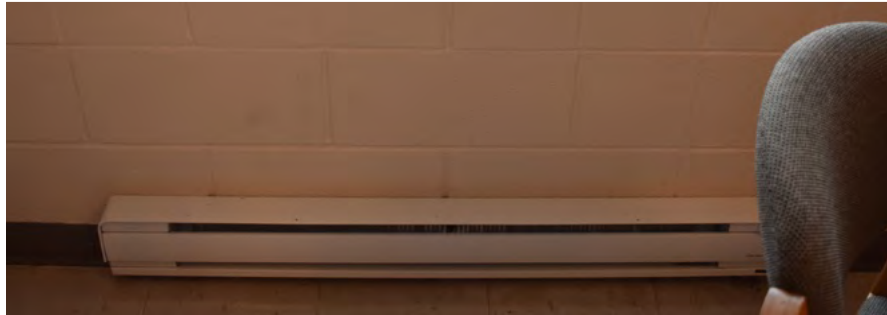
Due to occupant comfort complaints, electric heaters have also been added in the offices and games room. The boutique room has electric reheat for hot yoga programs.

Figure 7 Electric Heater in Games Room

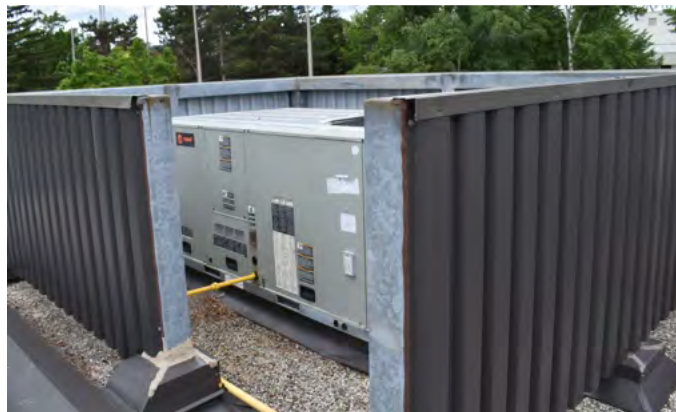
Unit ID: RTU-1
Manufacturer: Trane
Model Number: YSC072AWRAZJC100AIAOA600
Distribution: CAV system serves the Port Nelson and Wellington Multipurpose rooms

Figure 8 RTU-1

Figure 9 Location of RTU-1

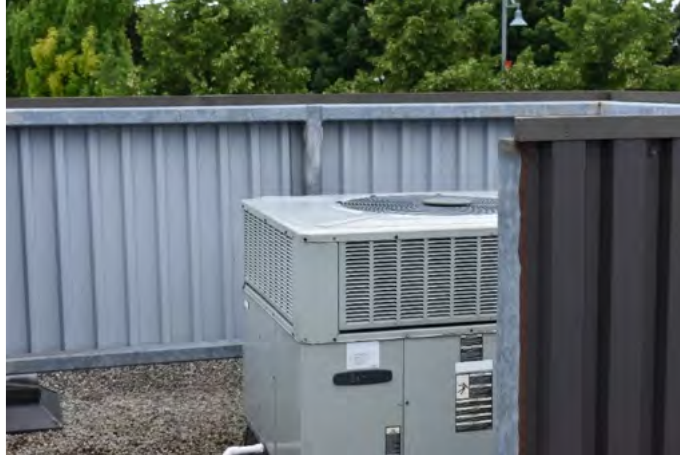
Unit ID: RTU-2
Manufacturer: Trane
Model Number: 2YCC3024A1064AA
Distribution: VVT system serves the Freeman Indian Point Room

Figure 10 RTU-2

Figure 11 Location of RTU-2

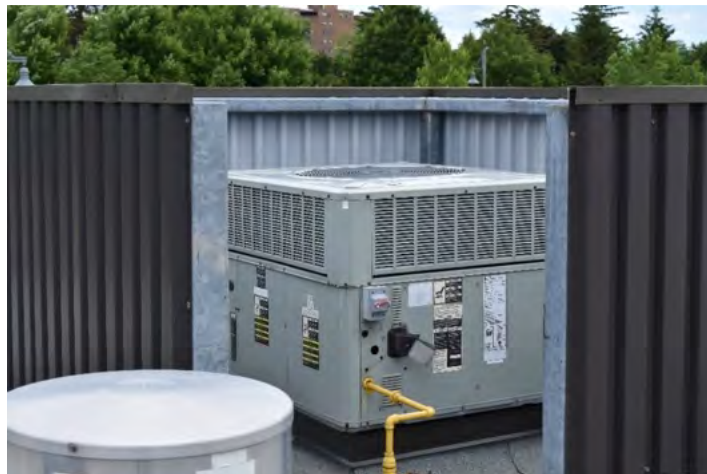
Unit ID: RTU-3
Manufacturer: Trane
Model Number: 2YCC3024A1064AA
Distribution: CAV system serves the entrance hallway, boardroom, and restrooms

Figure 12 RTU-3

Figure 13 Location of RTU-3

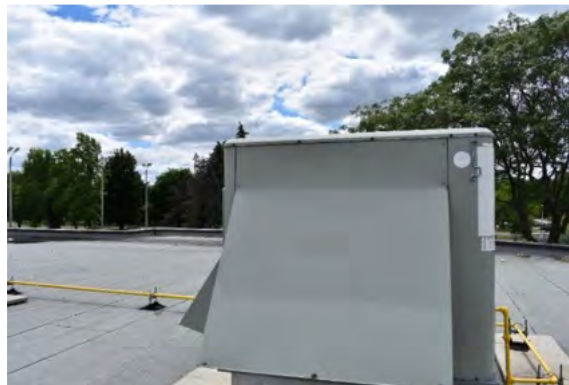
Unit ID: RTU-4
Manufacturer: Trane
Model Number: YCD180BWL AHB
Distribution: CAV system serves auditorium A

Figure 14 RTU-4

Figure 15 Location of RTU-4

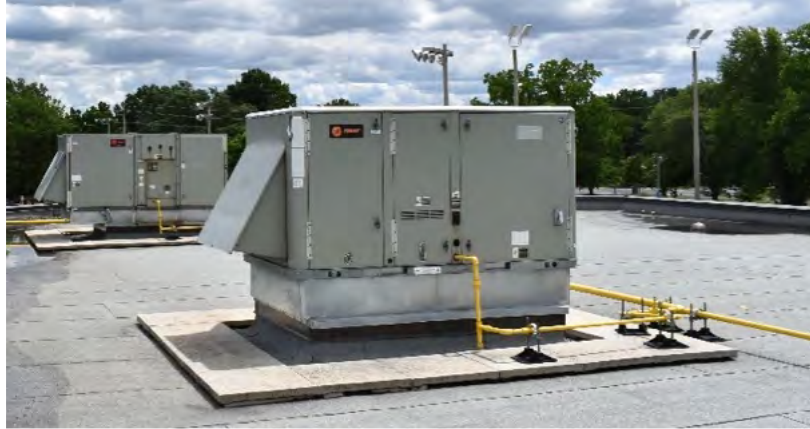
Unit ID: RTU-5
Manufacturer: Trane
Model Number: YSC120AWRHAOBVR
Distribution: CAV system serves auditorium B

Figure 16 RTU-5 (foreground)

Figure 17 Location of RTU-5

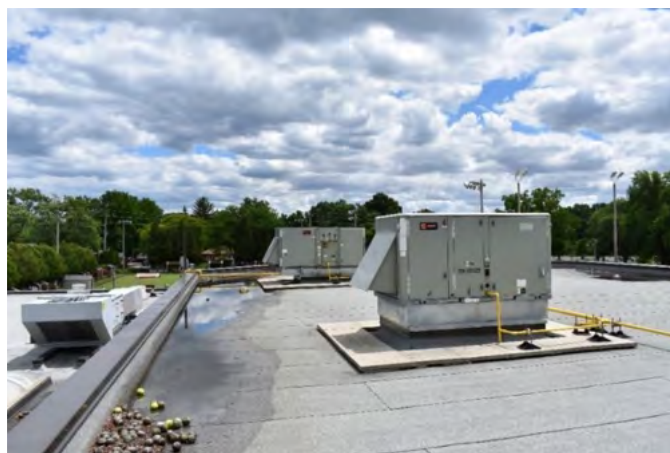
Unit ID: RTU-6
Manufacturer: Trane
Model Number: Y32120AWPHOBVR
Distribution: CAV system serves auditorium stage

Figure 18 RTU-6 (background)

Figure 19 Location of RTU-6

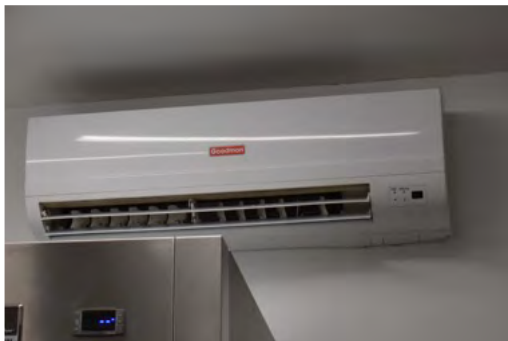
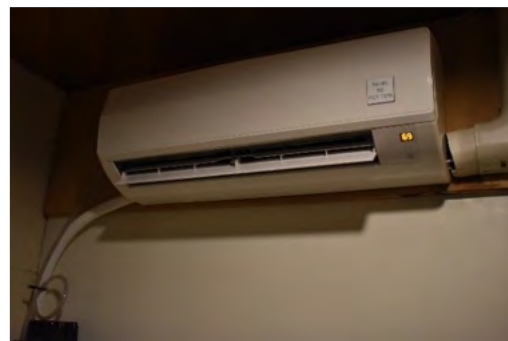
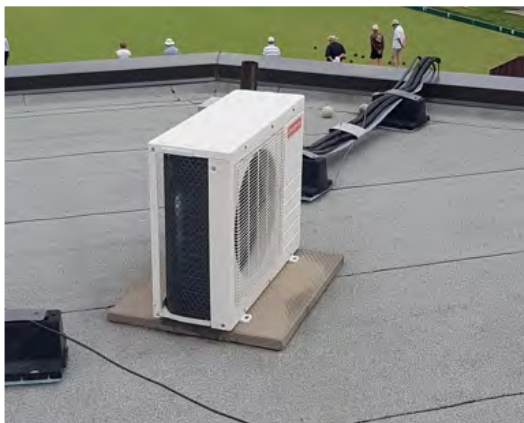
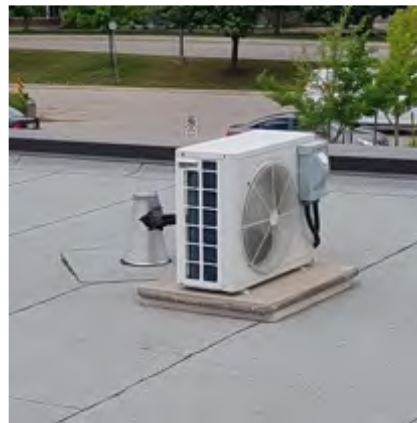
Two small storage rooms have supplemental cooling provided by mini split heat pumps. These units were recently installed due to the heat gain of commercial fridges and freezers in the storage rooms. Location and model have been included in the figures below.

Figure 20 Mini split indoor unit

Figure 21 Mini split indoor unit

Figure 22 Mini split outdoor unit

Figure 23 Mini split outdoor unit

Figure 24 Mini split indoor unit location

Figure 25 Minisplit outdoor unit location

Currently, two mini-split units have been installed in storage areas containing commercial fridge/freezers. The need for these units is due to the central system not designed to accommodate the added heating load of the equipment. For future designs, it is recommended that the design professional discuss current and future building use with the building owner to optimize equipment installation.

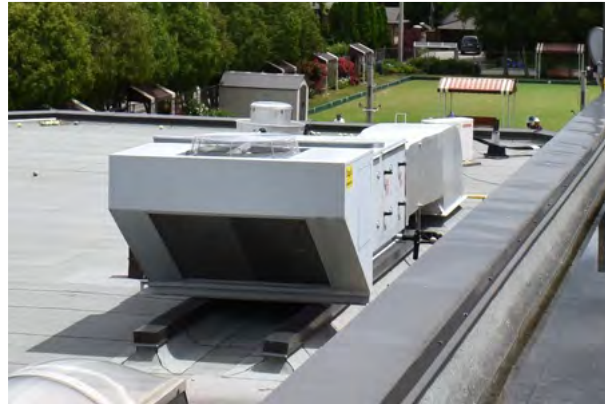
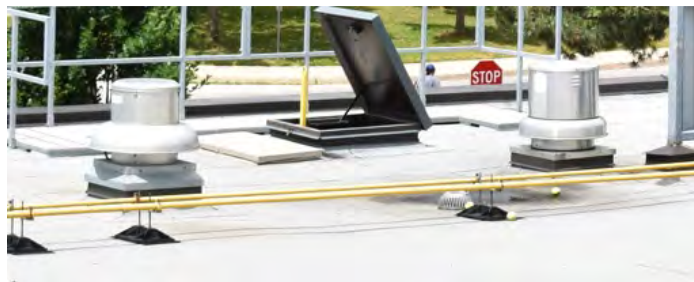
Outdoor air is provided by the rooftop units. There are four exhaust fans that serve the kitchen, two-bathroom facilities, and kiln room. A make-up air unit has also been installed in the kitchen.

Figure 26 Kitchen Make-Up Air Unit and Exhaust Fan

Figure 27 Kiln and Washroom Exhaust

The kitchen MUA unit and exhaust fan system is currently constant volume, these can be converted to variable air volume to enable fan and heating savings along with a new high performance (lower airflow) kitchen hood.

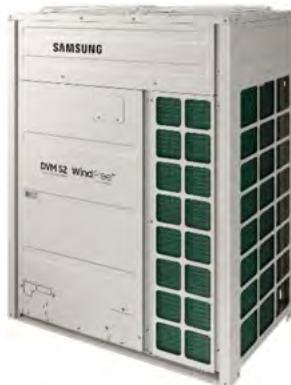
The VRF system would include refrigerant piping from the condensing units to a branch controller which will then distribute the piping to fan coils units. The fan coils would then tie into the existing ductwork and air would be distributed to each zone. Each fan coil would be hooked up to a thermostat, thus having one fan coil per zone.

Figure 28 Air Source Cold Climate VRF Heat Pump

The natural gas rooftop units, mini split units, and baseboard heaters will be replaced with a VRF system to heat and cool the entire building.

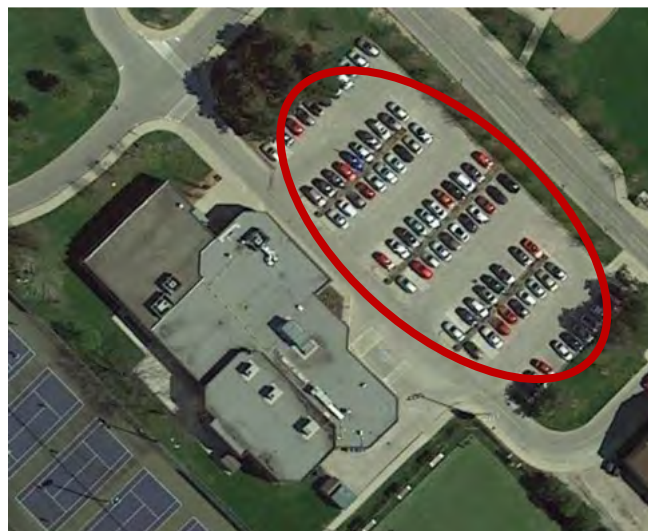
The boreholes would most likely be located under the parking lot on the northeast side of the property, refer to Figure 32. However, further analysis must be conducted to confirm the system design.

Figure 32 Proposed Borehole Location

¹ Assumes 150m boreholes with capacity of 160 m per kW (150 ft per ton)

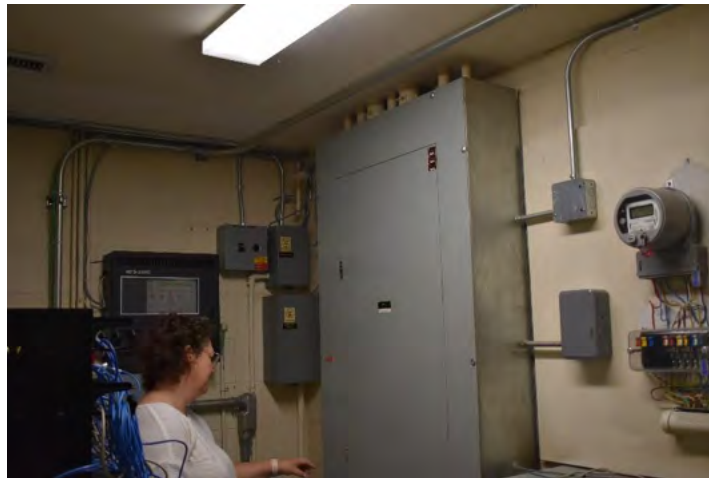
The existing main distribution is original to the building and consists of a main disconnect, a main 600V panelboard and multiple branch circuit panelboards throughout the building. Based on the photos provided, the main distribution equipment appears to be in okay condition. No maintenance logs are available to determine if any work has been completed done throughout the years.

The main building disconnect is a 80% rated 400A fused disconnect switch. All other disconnects for panels, motors etc. are also fusible disconnects. Visually the disconnects appear to be in okay condition. No complete photos of the main electrical room are available so we are unsure of how much room remains for future additions and expansion of the electrical distribution system. Based on the original as-built drawings, the electrical room was constructed without room for future expansion in mind.

Figure 2: Panel PP#1

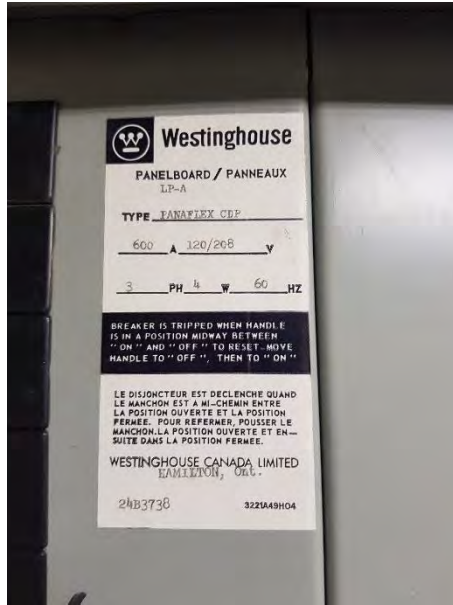
Several 120-208V branch circuit panelboards exist throughout the building servicing various areas. All panelboards appear to be original to the building and range from okay to good condition. No mini breakers are present in the existing panelboards. There is limited breaker space available for additional equipment. Depending on the scope of electrical changes, additional distribution may need to be added. Some panels appear to have breakers installed that are no longer in use, which could be removed to allow room for new distribution and branch circuits.

Figure 3: Panel LP-A

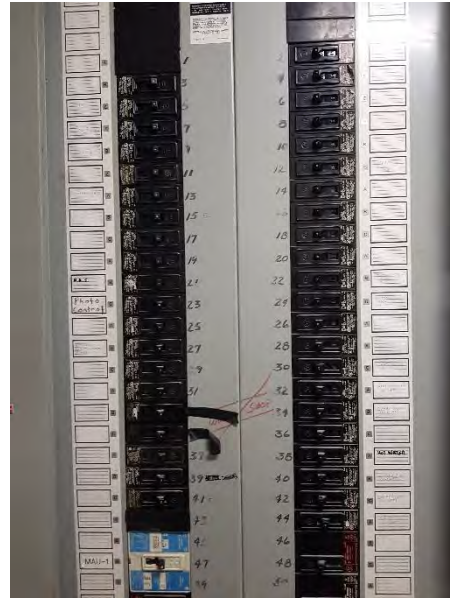
Figure 4: LP-A Circuits

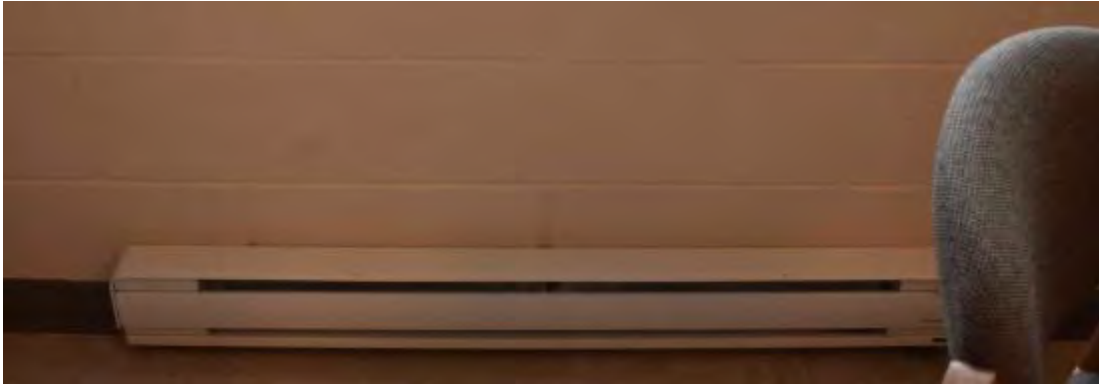
Electric baseboard heaters are located throughout the building to support the main heating system which consists of several rooftop units and mini-split units. The baseboard heaters do not appear to be original to the building. The heaters are in good condition and well within their life expectancy.

Figure 5: Electric Heater in Games Room

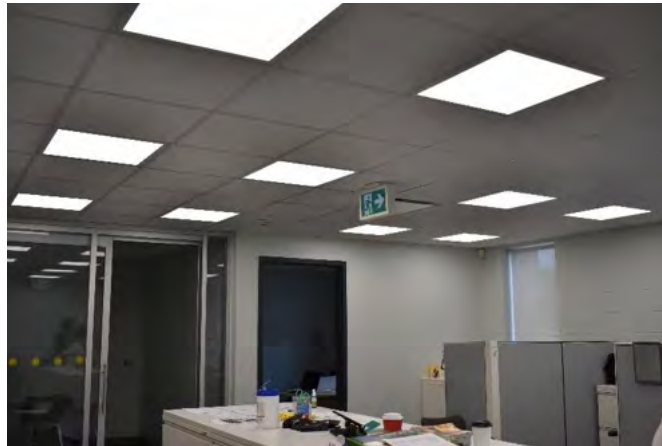
The office area of the building appears to have been retrofit recently with new LED flat panel fixtures. The fixtures are new and in extremely good condition. The estimated LPD for the office area is 7W/m².

Figure 8: Office Lighting

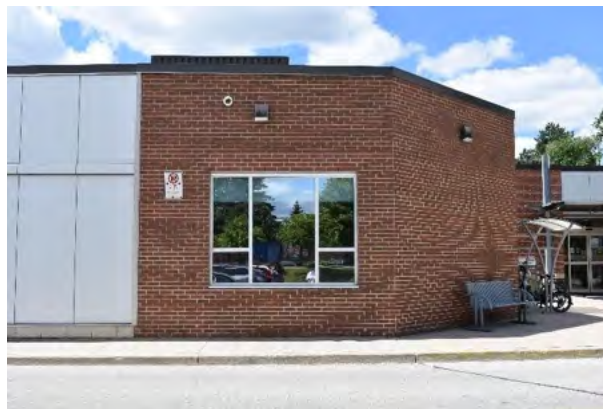
The existing exterior lighting has been retrofit to LED. Several LED wall-packs exist around the perimeter of the building which are controlled by a timeclock. The wall-packs appear to be in good condition.

Figure 9: Office Lighting

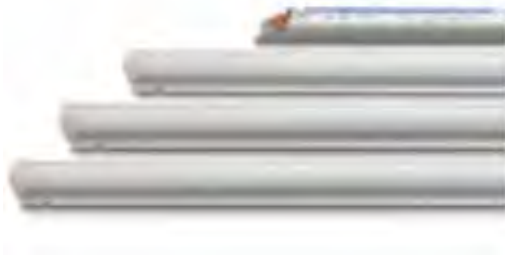
Figure 10

In the minimum acceptable scenario, all existing fluorescent lighting throughout the building should be upgraded to LED using LED lighting retrofit kits. These kits come complete with LED replacement lamps and ballasts so the existing fixtures throughout the building can be internally re-wired to work with LED lamps. This will allow the existing building lighting to remain in the same areas and will reduce maintenance. New LED retrofit kits and bulbs will be provided on an as needed basis depending on the type of fixture.

LED Retrofit Kit

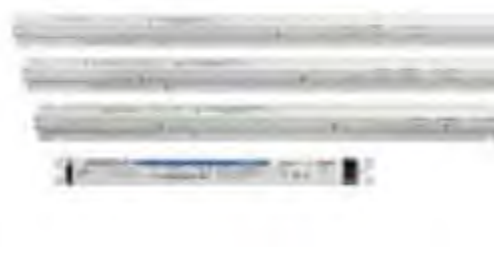
Figure 11

LED Retrofit Kit High Bay

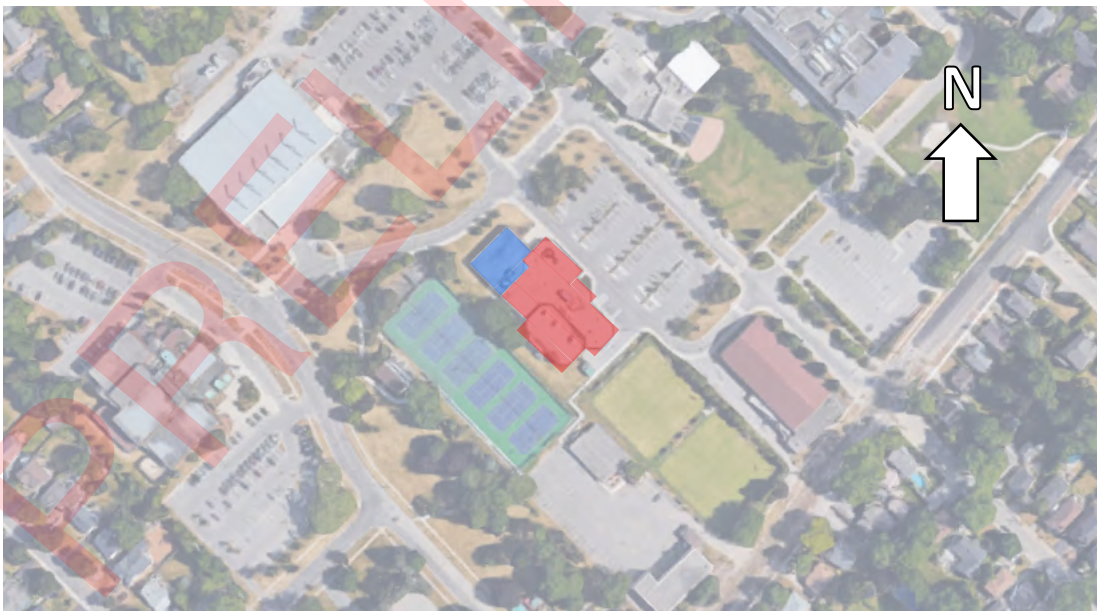
Figure 1 – Plan view location and orientation of the Existing Seniors’ Centre (shaded red) and the (existing) Building Expansion (shaded blue) of the Burlington Seniors’ Centre, Burlington (Google, 2022)

It is understood that the Burlington Seniors’ Centre, built in 1979, resides in the suburbs of Burlington north of the intersection between New St. and Drury Ln. The building in question is composed of two parts, namely the original centre (henceforth named the Existing Seniors’ Centre) and the addition constructed in 2005 (henceforth the Building Expansion), both of which are fully attached to create one building. The centre’s length runs South-East to North-West. The north-eastern side of the building faces the centre’s parking lot, while the south-western side faces the community tennis courts (**Figure 1**).

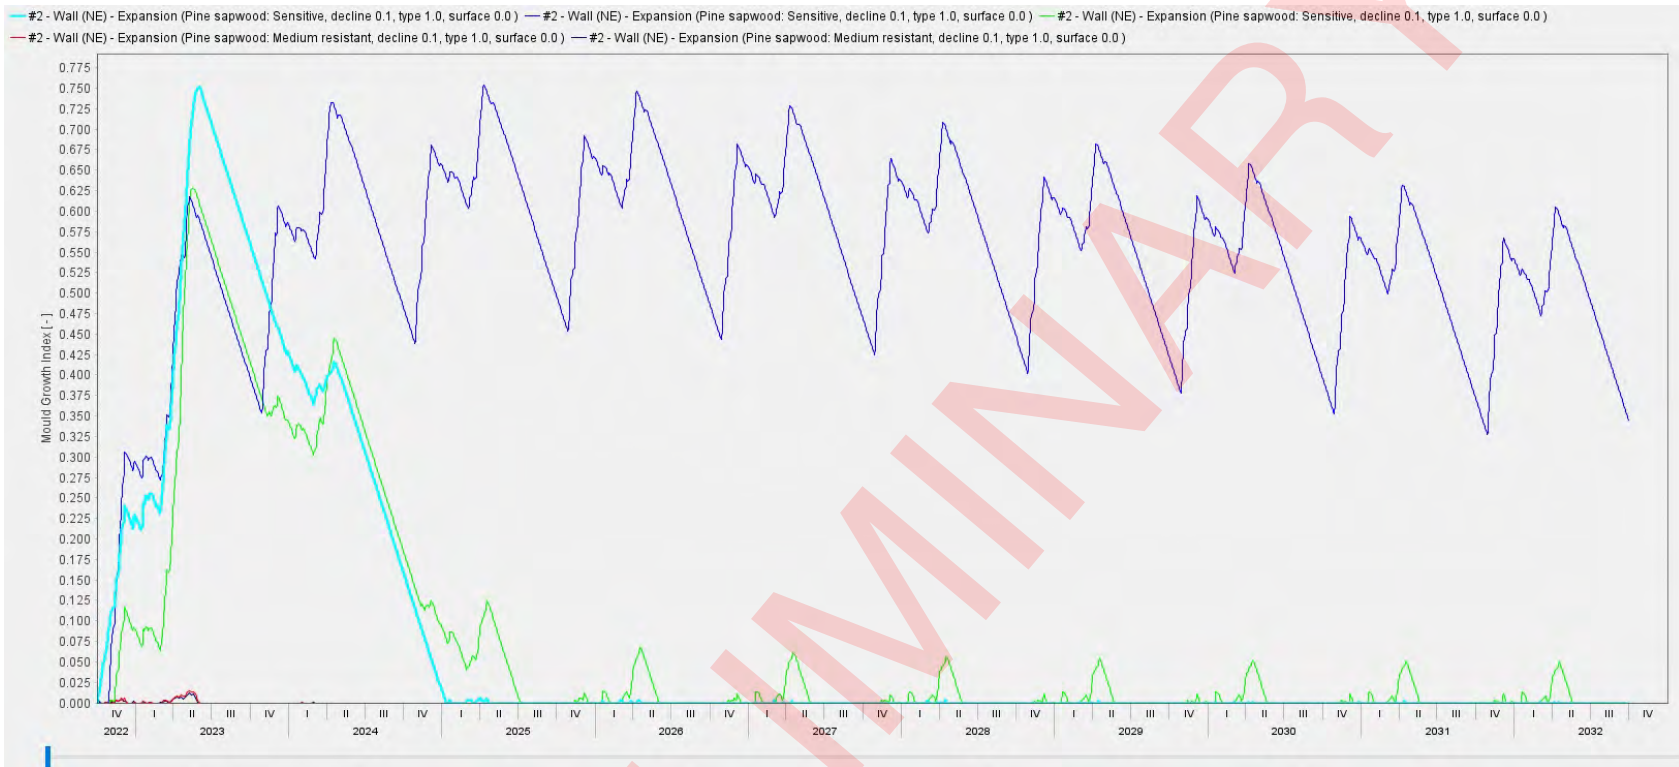
Figure 13 – WUFI® output for wall assembly: VTT mold growth index simulation over 10-year period simulated for post-retrofit Expansion Centre North-East wall assembly's plywood and cellulose layers
 (blue: outer plywood; green: center plywood; light blue: inner plywood;
 red: outermost cellulose element; black: second outermost cellulose element)

For mold-related durability, a VTT simulation was again conducted to simulate the mold growth index at the specified locations within the plywood layers and the outermost element of the cellulose layer. Using the same assumptions as per the Existing Senior's Centre wall assemblies' simulations, the results of the roof assembly VTT simulation indicate a green VTT traffic light in all locations simulated (see **Figure 13**). In the North-East orientation, the mold growth index increases annually in the outermost plywood layer (dark blue line, **Figure 13**) – however, the index begins decreasing after 2025.

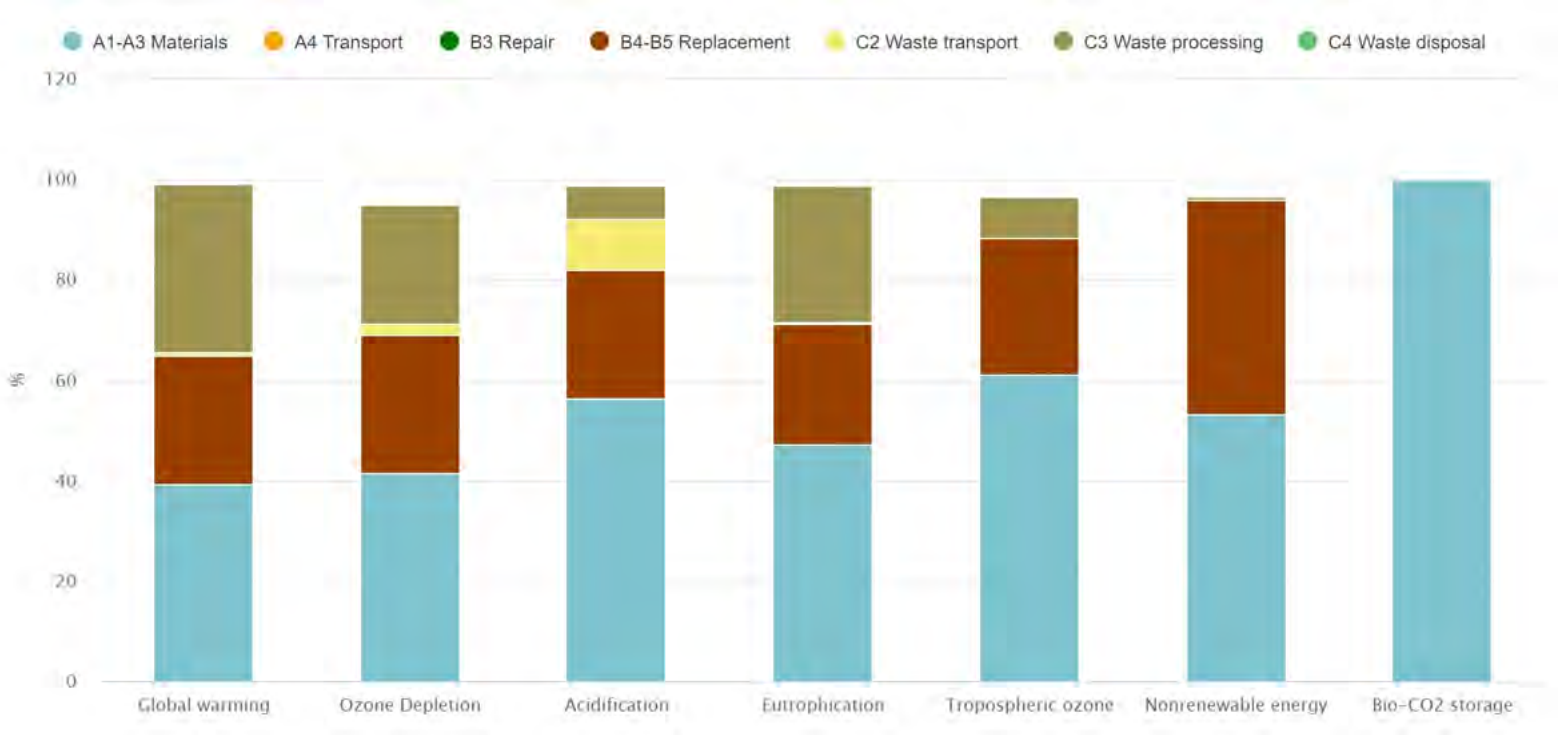
Burlington Retrofit Life-Cycle Impacts by Stage (%)

Figure 2: Burlington retrofit design breakdown of the life cycle impact categories and the associated life cycle stages

The major contributors to the GWP in this design are the metal roofing, EPS insulation, roofing membranes and windows. The A1-A3 Materials stage contributed 39% of the total carbon emissions associated with this building followed by C3 Waste processing at 34% as illustrated in Figure 1 & 2. The biogenic carbon of this building offsets 44.5% of the total A1-C4 carbon emissions. This storage is attributed to the wood products (68%) and cellulose insulation (32%) used in the assembly as shown in Figure 3. The results graphs below show the breakdowns of life cycle stages and impact categories associated with the building materials.

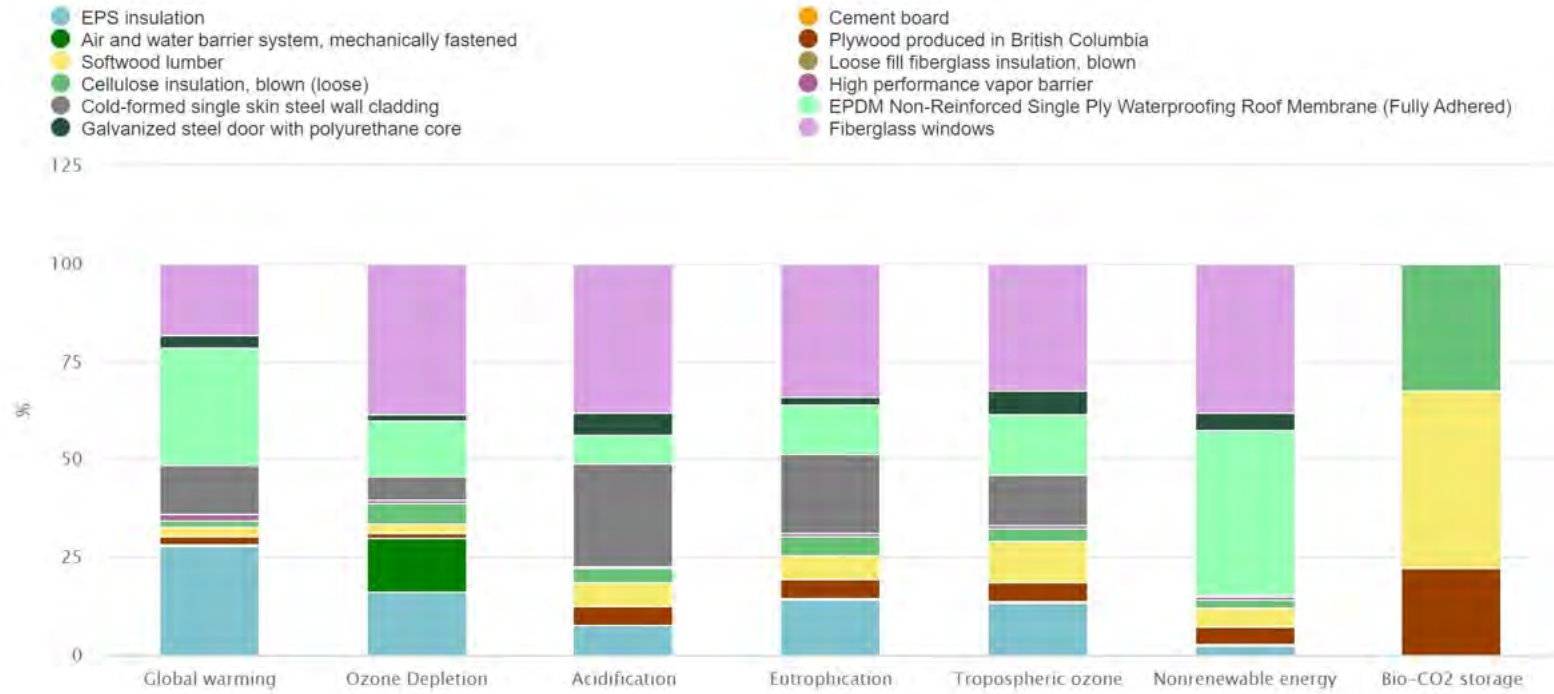
Burlington retrofit Life-Cycle Impacts by Material (%)

Figure 3: Burlington retrofit design breakdown of the life cycle impact categories and the associated materials
