PANELIZED DEEP RETROFITS OF MUNICIPAL BUILDINGS

Harrietsfield Williamswood Community Centre Case Study Report

Issue Date: September 30, 2023

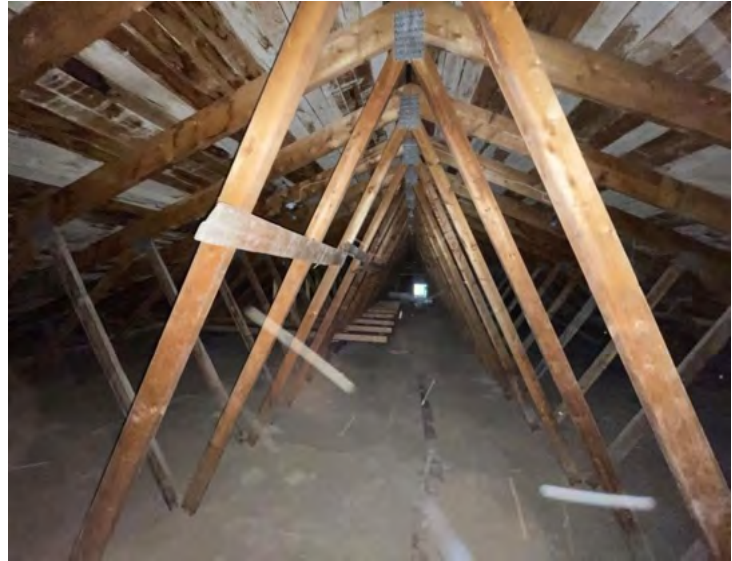
The roof trusses are leaning, with the truss ridge approximately 25mm (1”) east relative to the bottom chord of the truss. This issue wasn’t identified in the 2013 Building Condition Assessment (Appendix B). A roof leak was also identified, by an employee of the daycare. This has anecdotally been present since Hurricane Dorian in September 2019.

The existing roof structure was determined to be inadequate to support the existing roof loads. Alterations or additions to the structure must be independent of the existing roof trusses.

Figure 4 Roof structure

The roof is framed with wood trusses and insulated with approximately 200mm (8”) of loose cellulose at the ceiling plane. There appears to be a polyethylene vapour barrier installed in the walls and roof. Given the building’s age, this is unlikely to be continuous.

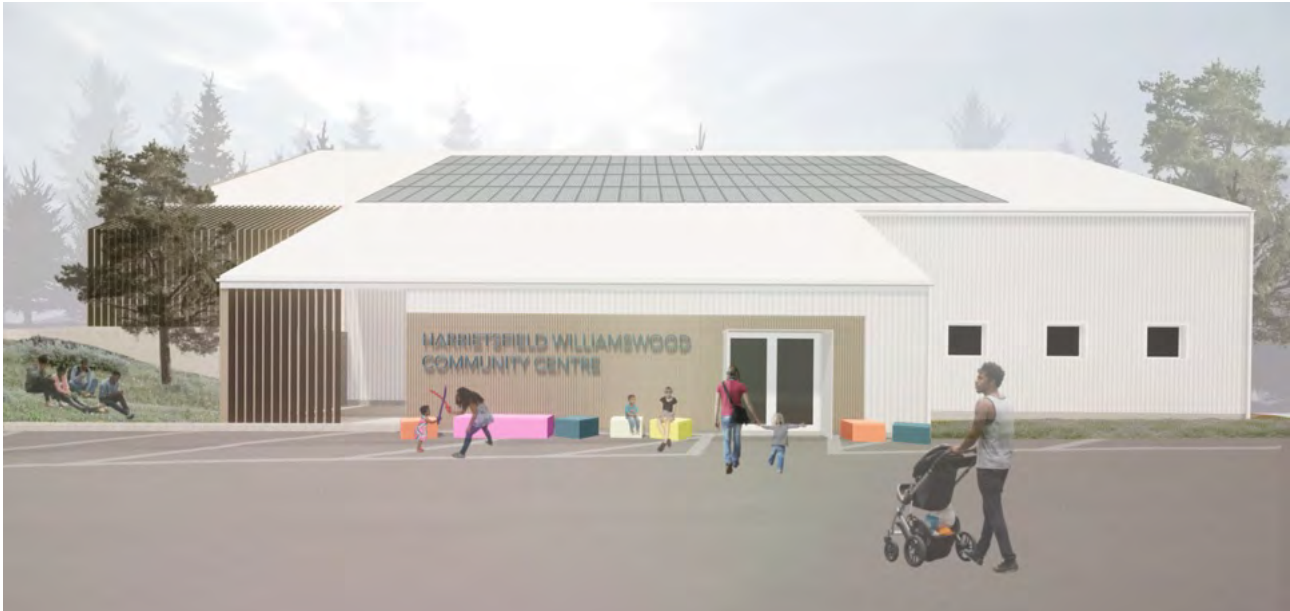
Figure 9 Design South View

Aesthetic alterations may benefit the energy performance of the Harrietsfield Williamswood Community Centre. As noted earlier in this report, the building has a low window to wall ratio and its windows are obscured with security grilles. While glazing is thermally inferior to insulated walls, natural light and passive ventilation could meaningfully reduce energy use as lighting loads make up 25% of total energy used in the NZER scenarios.

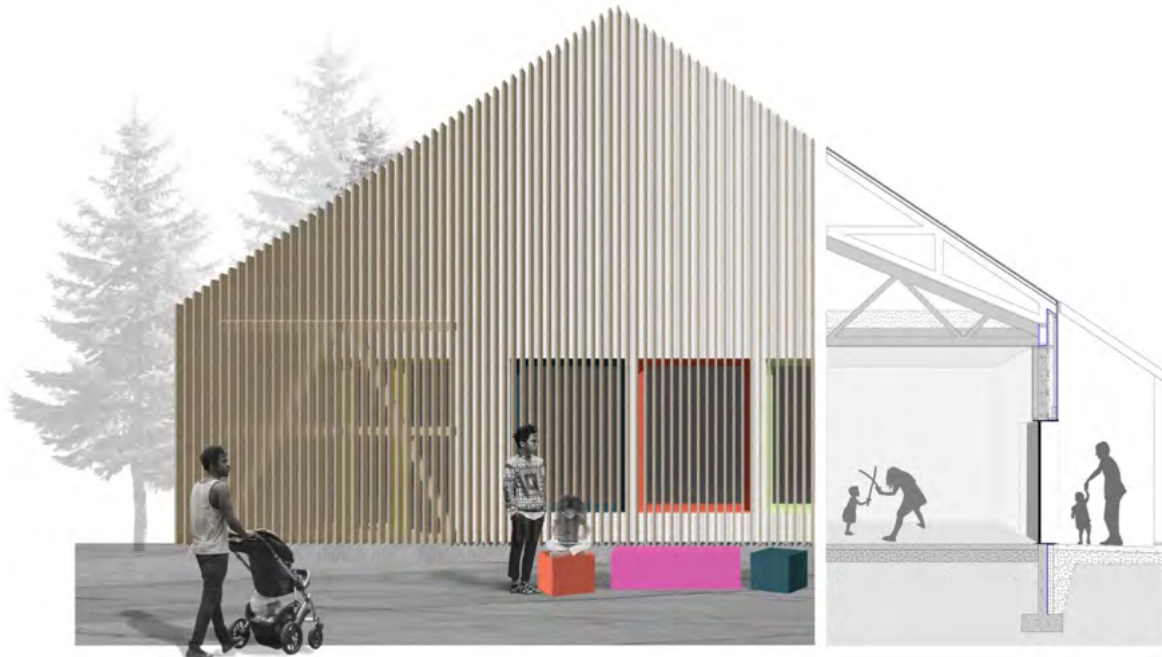
Figure 10 Concept Design Partial West Elevation-Section

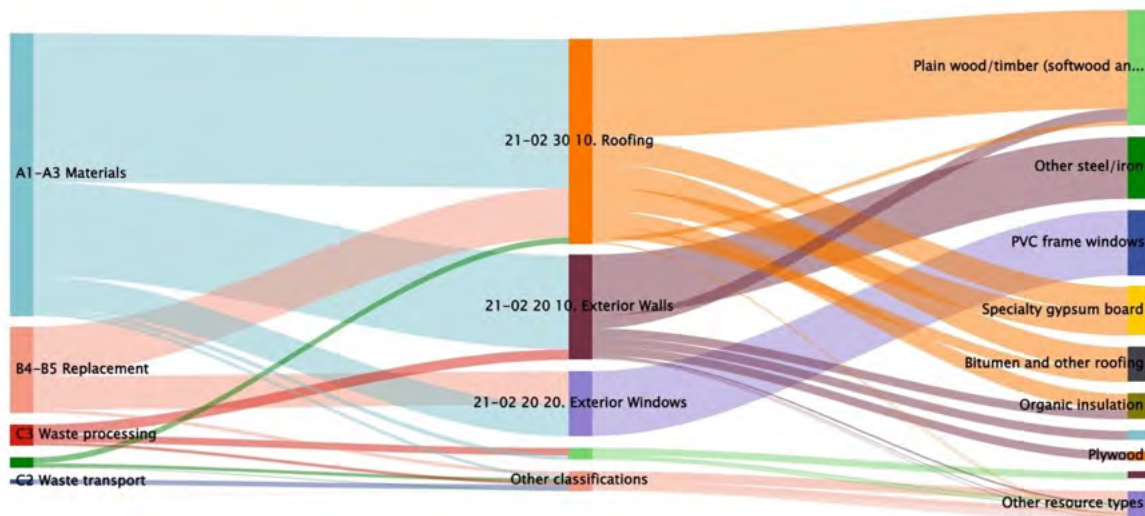
Figure 18 Life Cycle Impacts by Stage (%)

The major contributors to the GWP in this design are the wood trusses and steel cladding. The A1-A3 Materials stage contributed 70% of the total carbon emissions associated with this building as illustrated in Figure 18 & 19.

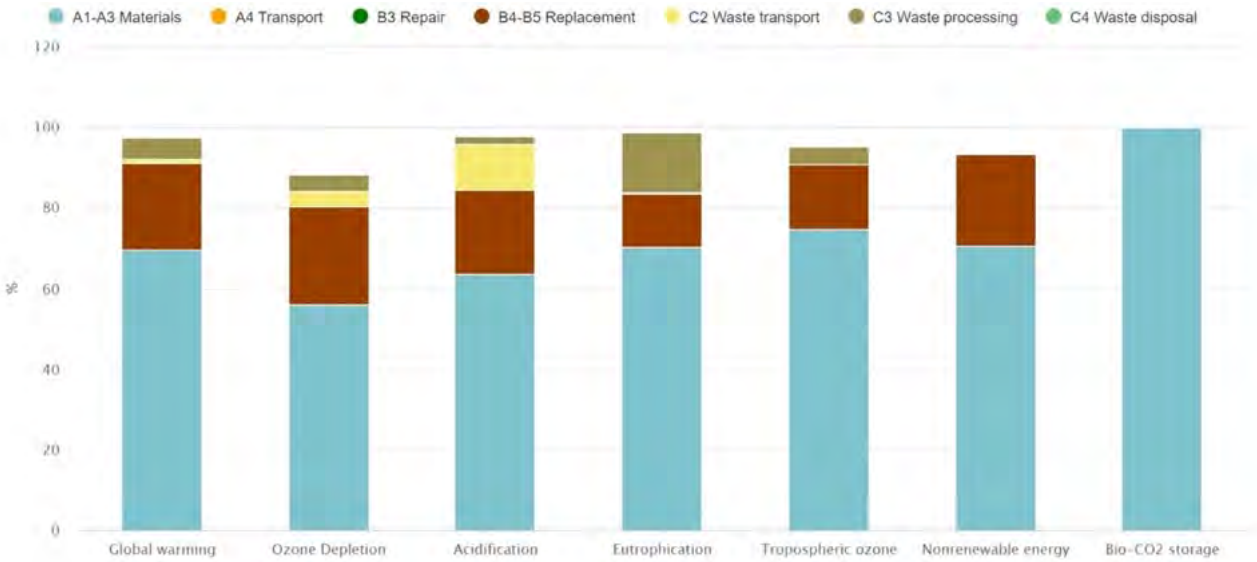
Figure 19 Global Warming by Stage and Material

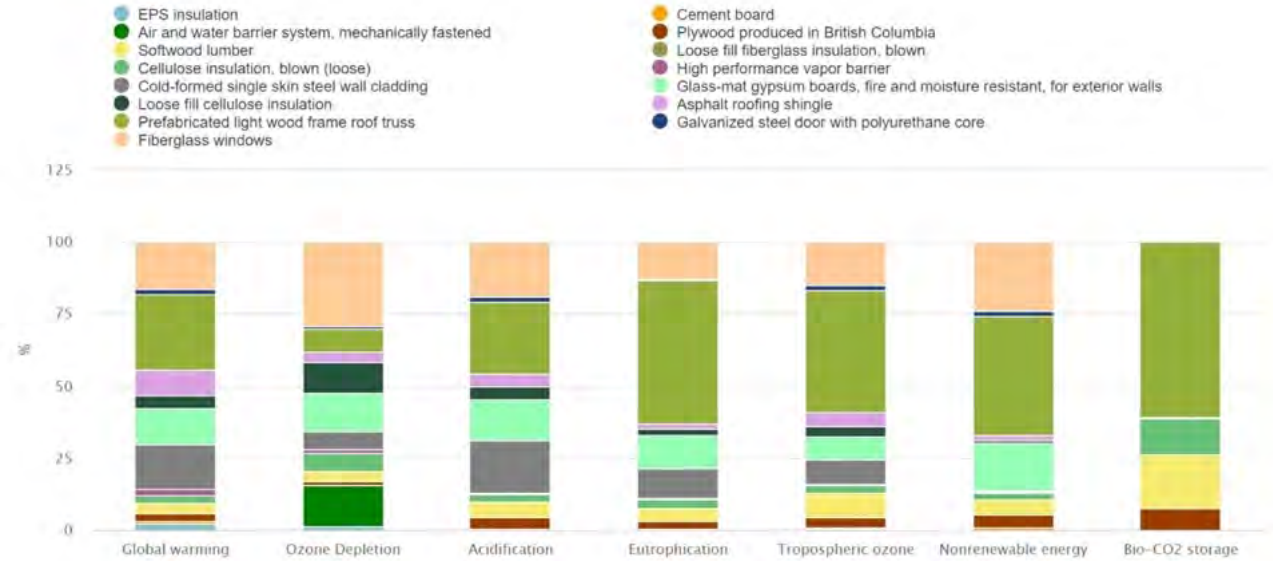
The biogenic carbon storage surpasses that of the A1-C4 emissions by 43%, making a surplus in carbon storage capacity (Table 4). This storage is attributed to the wood products (87%) and cellulose insulation (13%) used in the assemblies (Figure 20).

Figure 20 Life Cycle Impacts by Material (%)

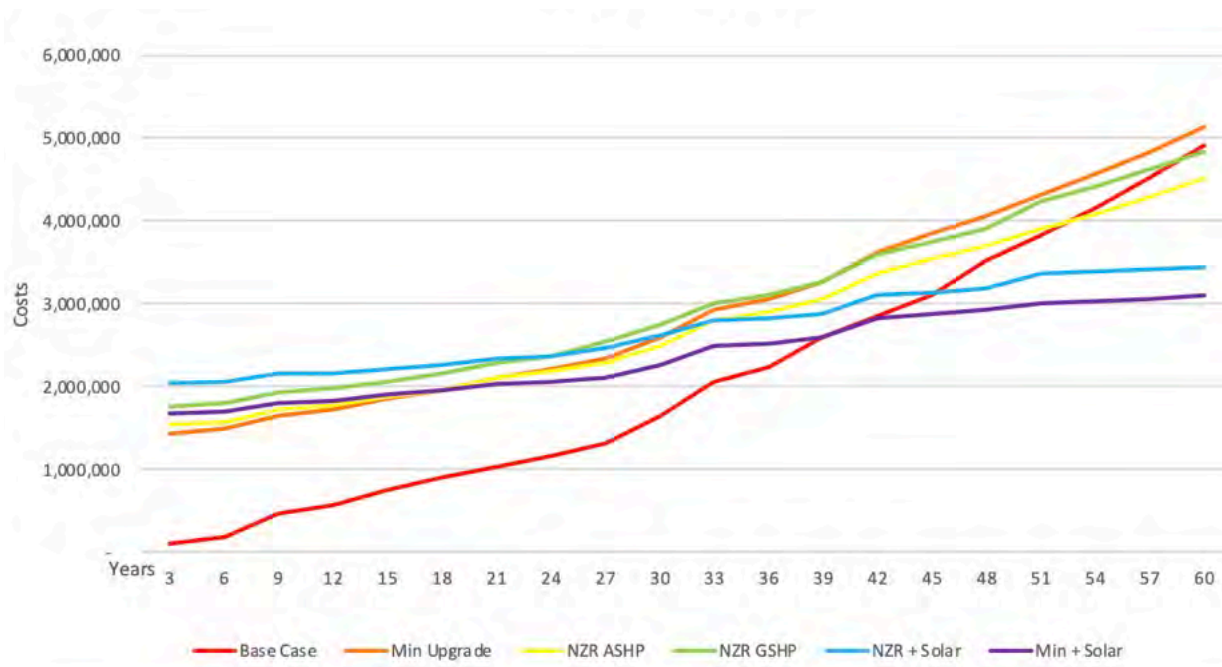
Figure 22 Cumulative TCBO

The existing building has the lowest TCBO for the first 39 years, but the Minimum Upgrade + Solar scenario has lower costs for the remaining life of the building.

The Minimum Upgrade retrofit scenario with the addition of Solar PV is the best investment for this building, resulting in 100% GHG reductions and 37% operational savings compared with the base case.

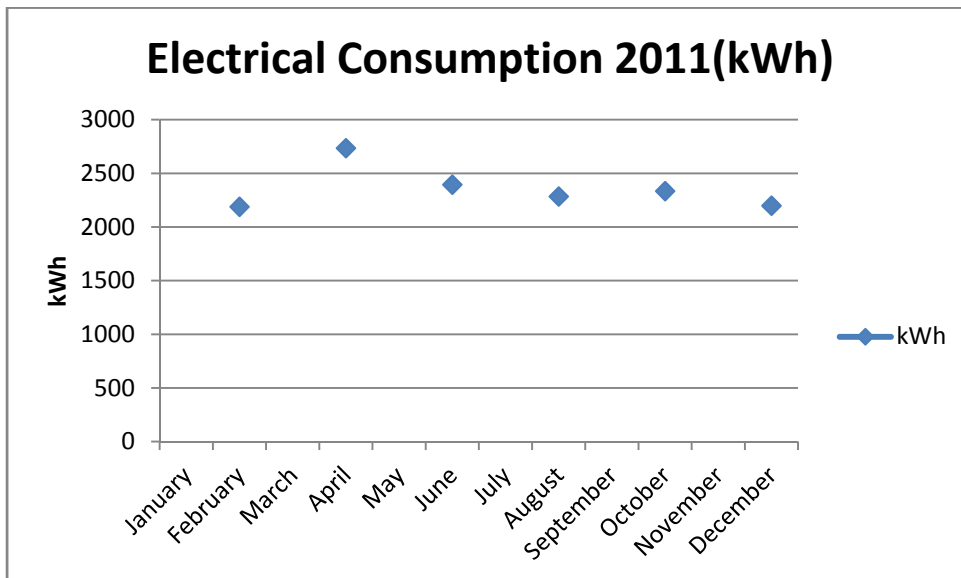
Electrical Consumption				
Year	2009	2010	2011	2012
Month	Electricity kWh	Electricity kWh	Electricity kWh	Electricity kWh
January				
February			2189	2116
March				
April			2735	1695
May				
June			2395	1803
July				
August			2285	1750
September				
October			2335	1658
November				
December		2651	2199	
Total	0	2651	14138	9022

From the data provided this facility consumed 14,138 kWh (50.90 GJ) of electricity in 2011. Electricity costs were \$1,896.50 inclusive of taxes and miscellaneous service charges or an average of \$0.1341 per kilowatt hour.

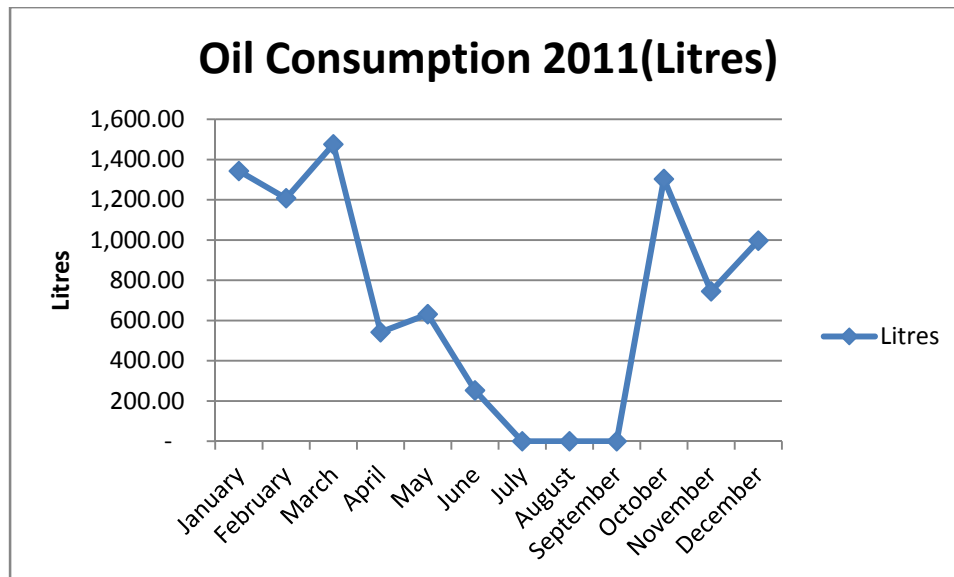
Fuel Oil Consumption				
Year	2009	2010	2011	2012
Month	Oil Litres	Oil Litres	Oil Litres	Oil Litres
January		2,732.90	1,343.00	1,177.00
February		2,438.30	1,207.70	971.10
March		1,153.70	1,475.50	814.20
April		1,024.40	541.90	700.90
May		490.00	631.60	521.30
June		-	252.60	
July		-	-	
August		200.70	-	
September		91.00	-	
October		-	1,303.50	
November		2,336.50	745.10	
December		1,637.40	996.80	
Total	-	12,104.90	8,497.70	4,184.50

The facility consumed 8,497.7L (329.71 GJ) of oil in 2011. Fuel oil costs were \$6,934.52 inclusive of taxes and delivery fees or an average of \$0.8160/liter.

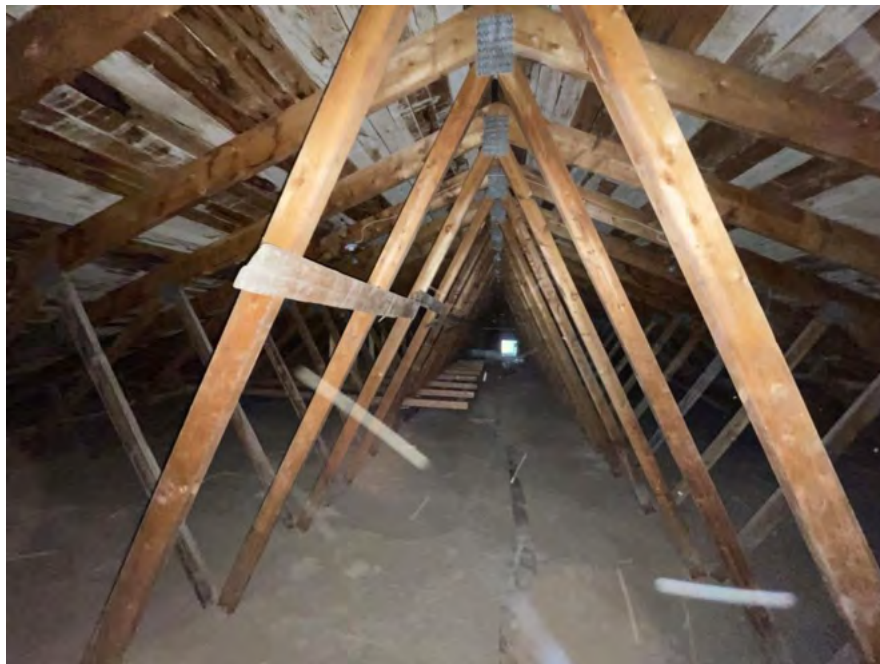
Figure 2: Typical roof truss.

The roof structure above the East and West sections of the building consists of pre-engineered timber trusses with 3/4" tongue and groove plank decking. The trusses have an overall span of approximately 45', with a roof pitch of approximately 5/12. Notably, the spacing of the varies slightly, and was measured to be between 27"-29" during the structural measure-up of the roof structure.

The trusses consist of 2x8 top chords, 2x6 bottom chords, and 2x4 web members. Although lumber grade stamps were not identified during the inspection, the timber members have been assumed to be No. 2 Spruce-Pine-Fir (SPF) lumber based on conservative visual grading. Truss members are connected via galvanized steel truss plates, which did not contain a manufacturer's identification stamp. A photo of the typical roof structure is shown in Figure 2.

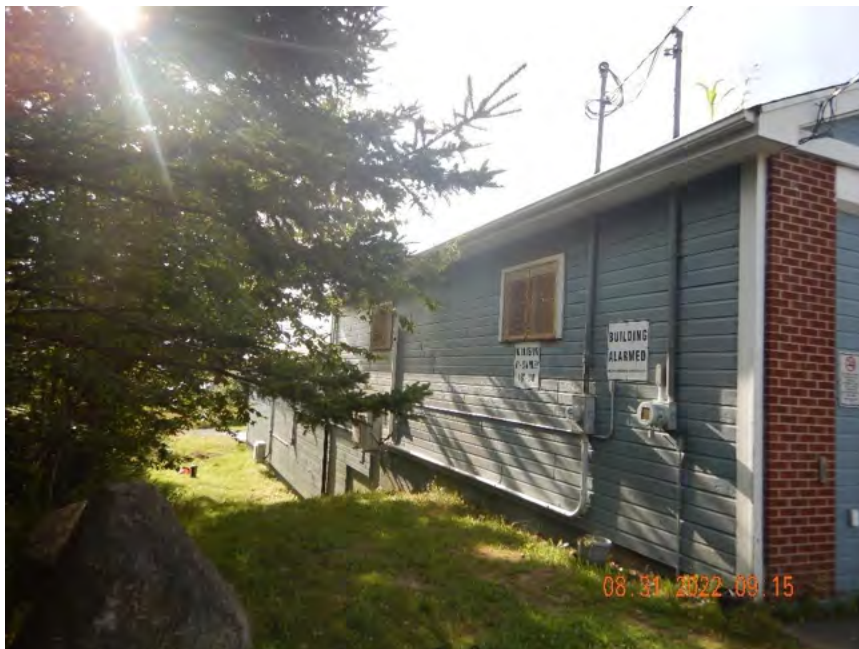
Figure 1: Service Entrances

The building currently has two existing service entrances, one for the upper level and one for the lower level. Both service entrances share the same set of overhead secondary wires which run back to a nearby poletop transformer. There are two separate meters, one for each service entrance located on the exterior of the building. The size of the overhead shared secondary conductors is unknown due to the lack of a single line diagram. The upper-level service is sized at 100A and terminates onto a panel c/w a built in 100A, 80% rated main breaker. The lower-level service is sized at 200A and terminates onto a panel c/w a built in 200A, 80% rated main breaker.

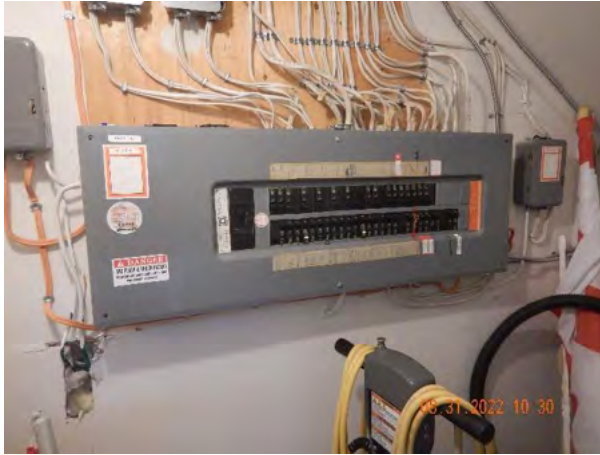
Figure 4: Lower Level Panelboard

The lower level has a 1P, 240V, 200A panelboard with an 80% rated 200A main breaker. The lower-level panelboard appears to be in good condition. No formal panel schedule is available, however similar to the upper-level panelboard, each circuit on the panel itself is labeled with tape and marker. Most existing wiring is NMD90 with a few runs of BX cable.

The majority of the breakers in both panelboards are 15A, with a few 20A breakers throughout. There is also a 2P, 40A breaker in the upper-level panelboard for the range in the kitchen. There are a few spare breaker spaces in the lower level 200A panelboard.

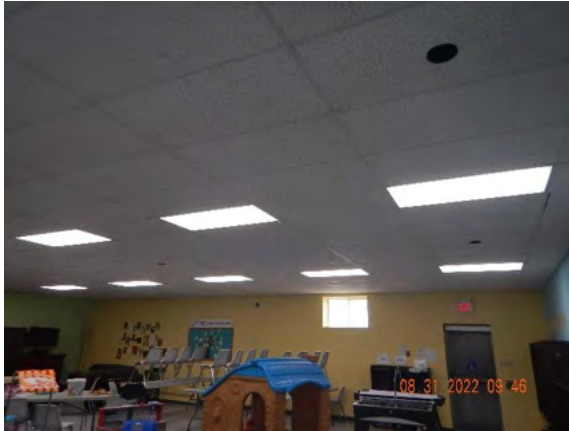
Figure 6: Daycare Lighting

The upstairs daycare in the building appears to have had an LED retrofit done a few years back. The existing lighting throughout the upper level is primarily 2'x4' retrofitted fluorescent fixtures with LED lamps and ballasts. The fixtures appear to be in good condition and no replacement or modification is needed. The LPD for the building is estimated to be 7W/m².

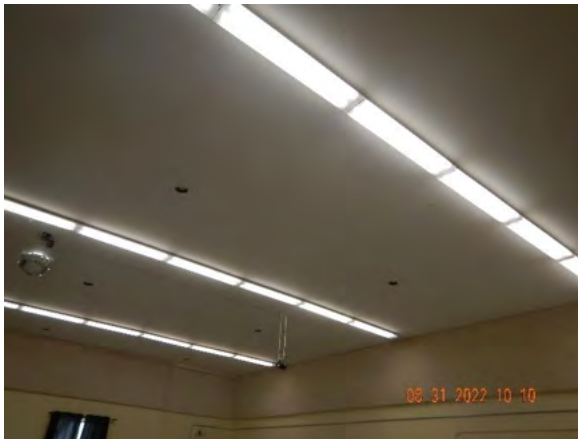
Figure 7: Multipurpose Room Lighting

The downstairs multipurpose area of the building has also been retrofitted to LED recently. The existing lighting throughout is primarily surface mounted 2 lamp linear retrofitted fluorescent fixtures with new LED lamps and ballasts. These fixtures are in good condition and no replacement or modification is needed.

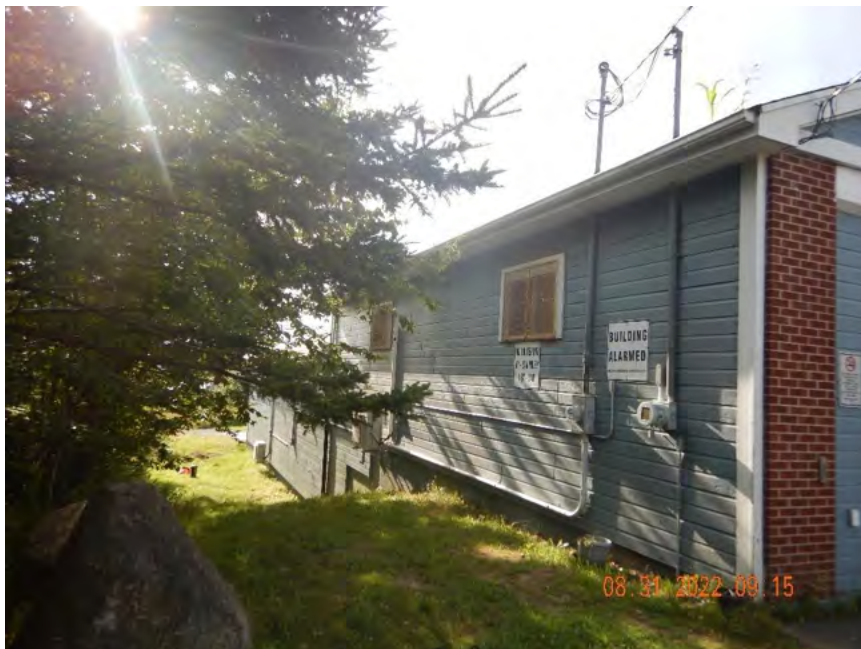
Figure 1: Service Entrances

The building currently has two existing service entrances, one for the upper level and one for the lower level. Both service entrances share the same set of overhead secondary wires which run back to a nearby poletop transformer. There are two separate meters, one for each service entrance located on the exterior of the building. The size of the overhead shared secondary conductors is unknown due to the lack of a single line diagram. The upper-level service is sized at 100A and terminates onto a panel c/w a built in 100A, 80% rated main breaker. The lower-level service is sized at 200A and terminates onto a panel c/w a built in 200A, 80% rated main breaker.

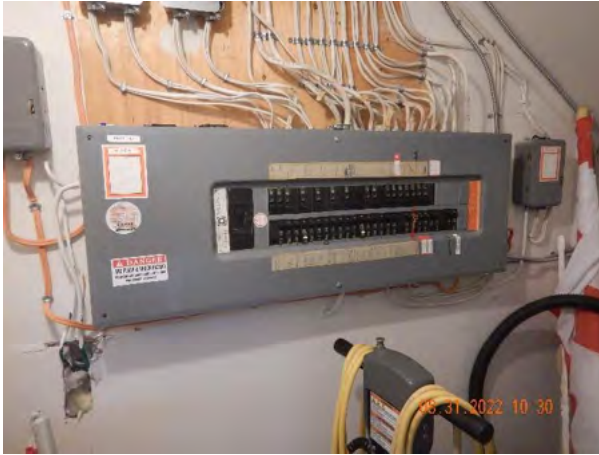
Figure 4: Lower Level Panelboard

The lower level has a 1P, 240V, 200A panelboard with an 80% rated 200A main breaker. The lower-level panelboard appears to be in good condition. No formal panel schedule is available, however similar to the upper-level panelboard, each circuit on the panel itself is labeled with tape and marker. Most existing wiring is NMD90 with a few runs of BX cable.

The majority of the breakers in both panelboards are 15A, with a few 20A breakers throughout. There is also a 2P, 40A breaker in the upper-level panelboard for the range in the kitchen. There are a few spare breaker spaces in the lower level 200A panelboard.

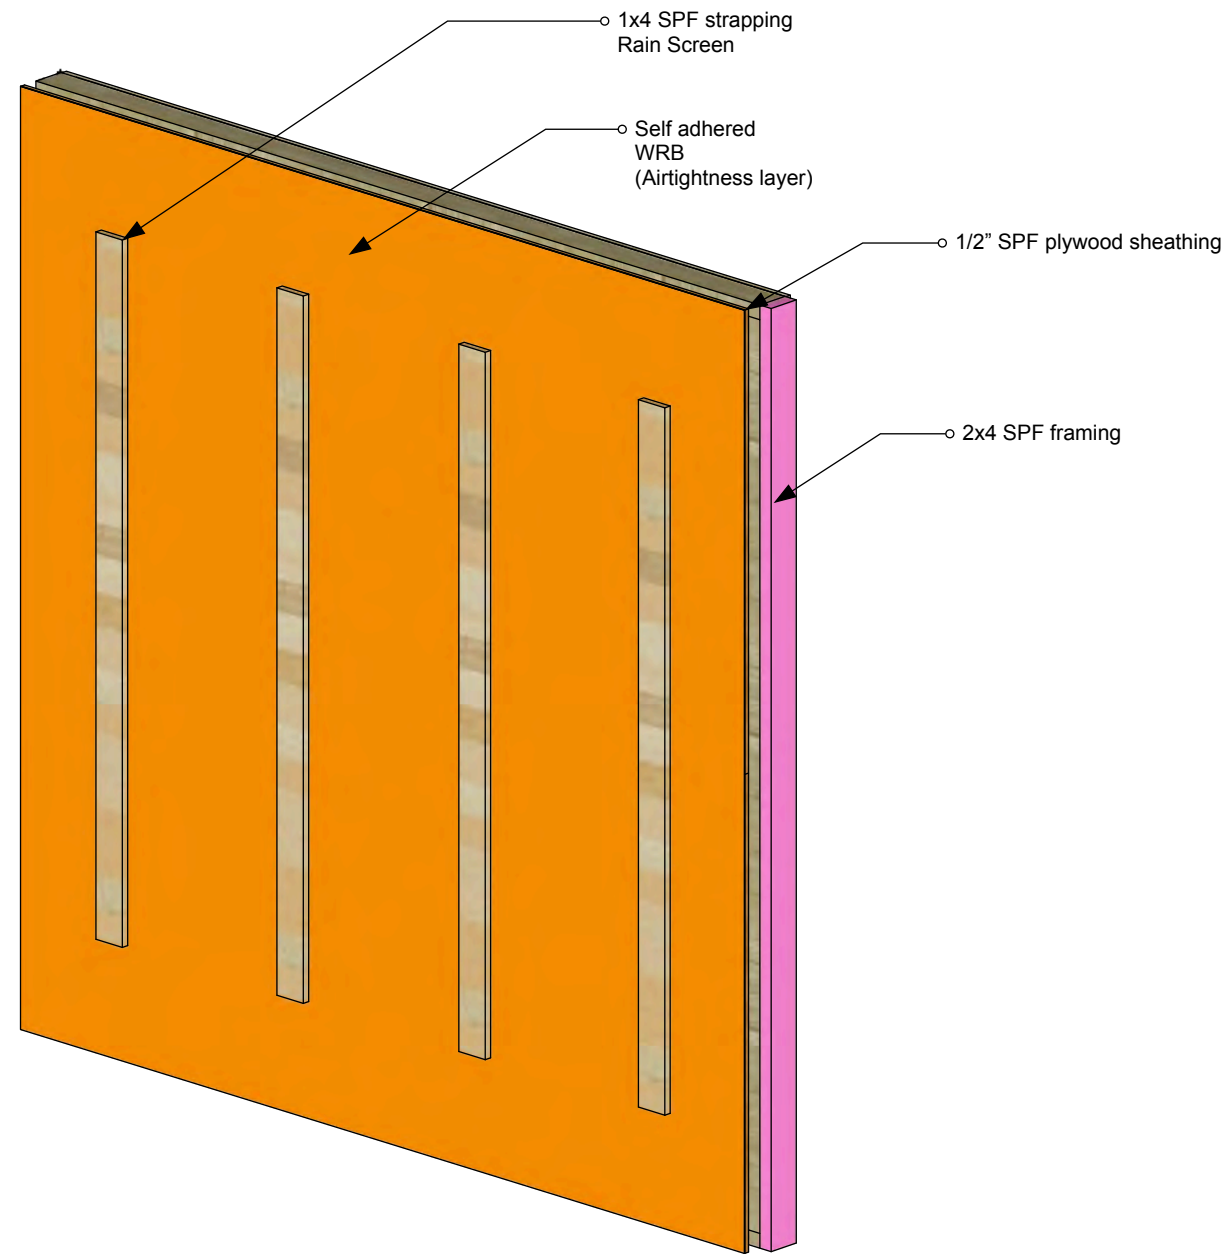
Panel - Overview

Panel schematic with all membranes in place

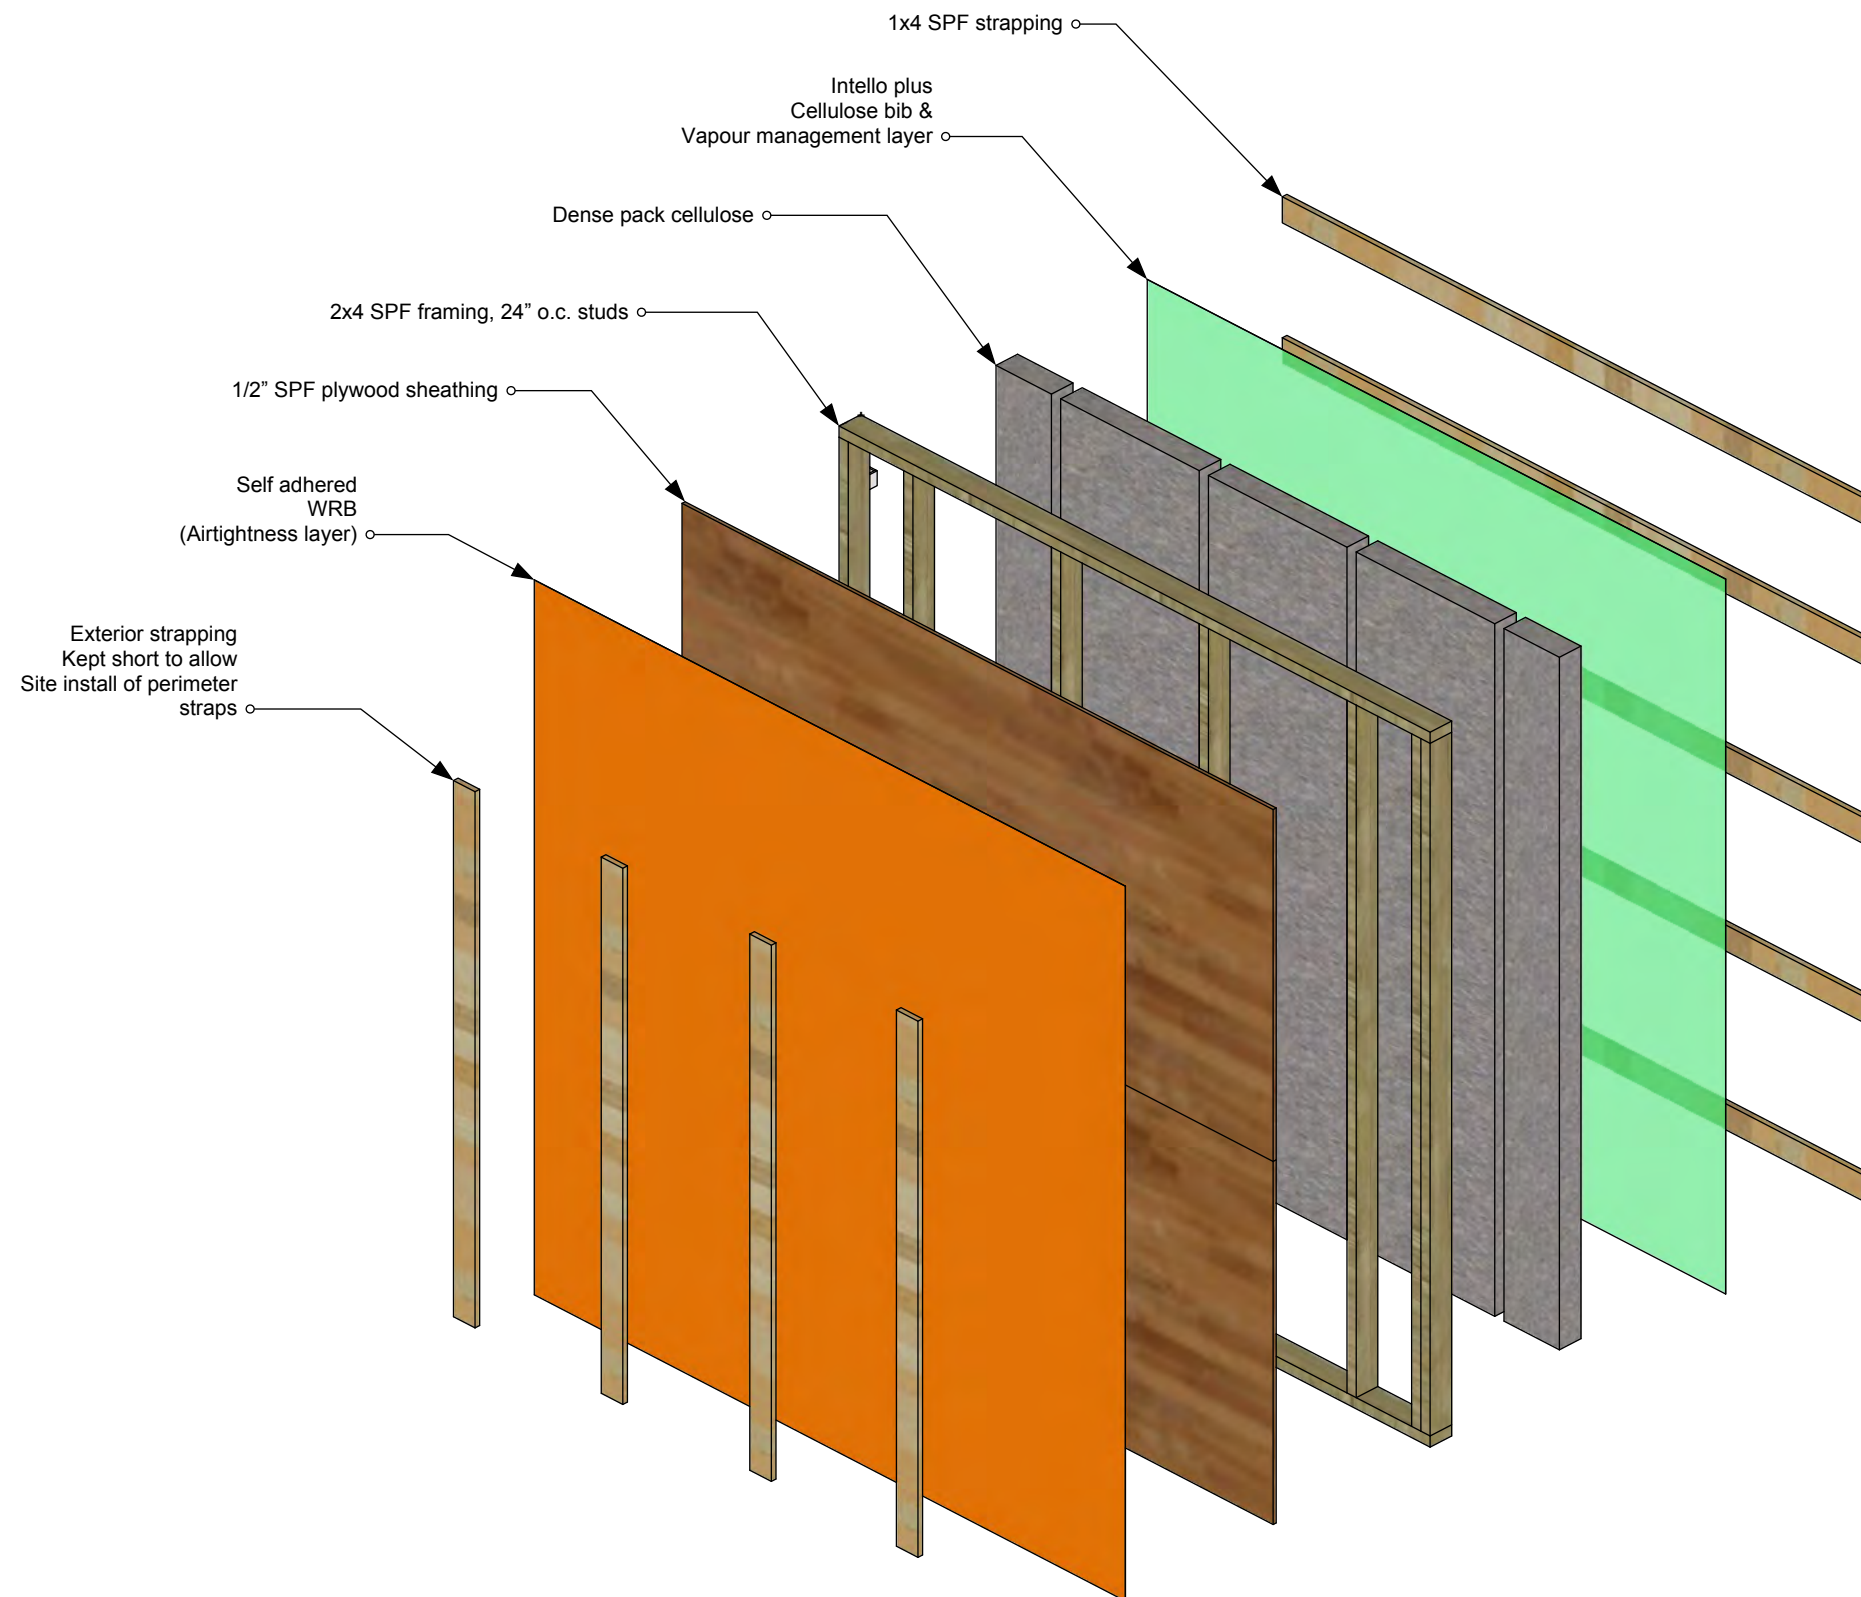
Panel - Exploded View

Panel schematic with all membranes in place

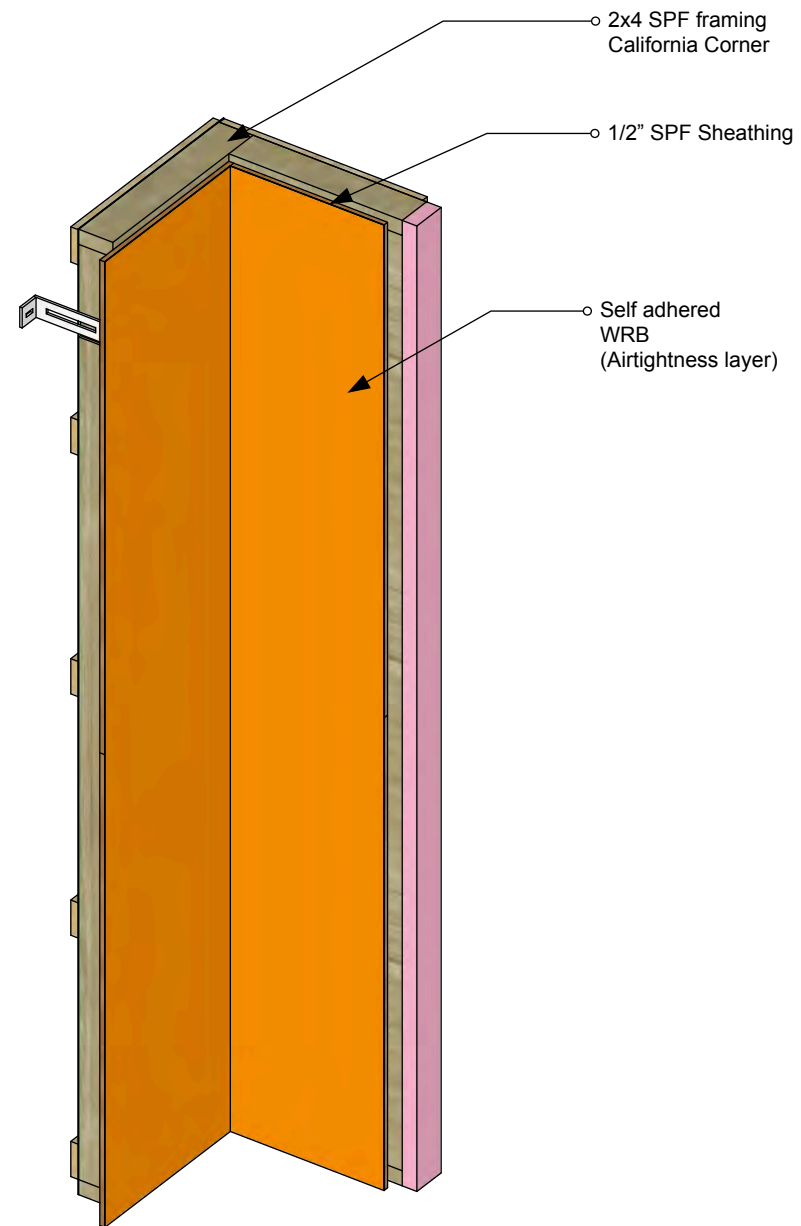
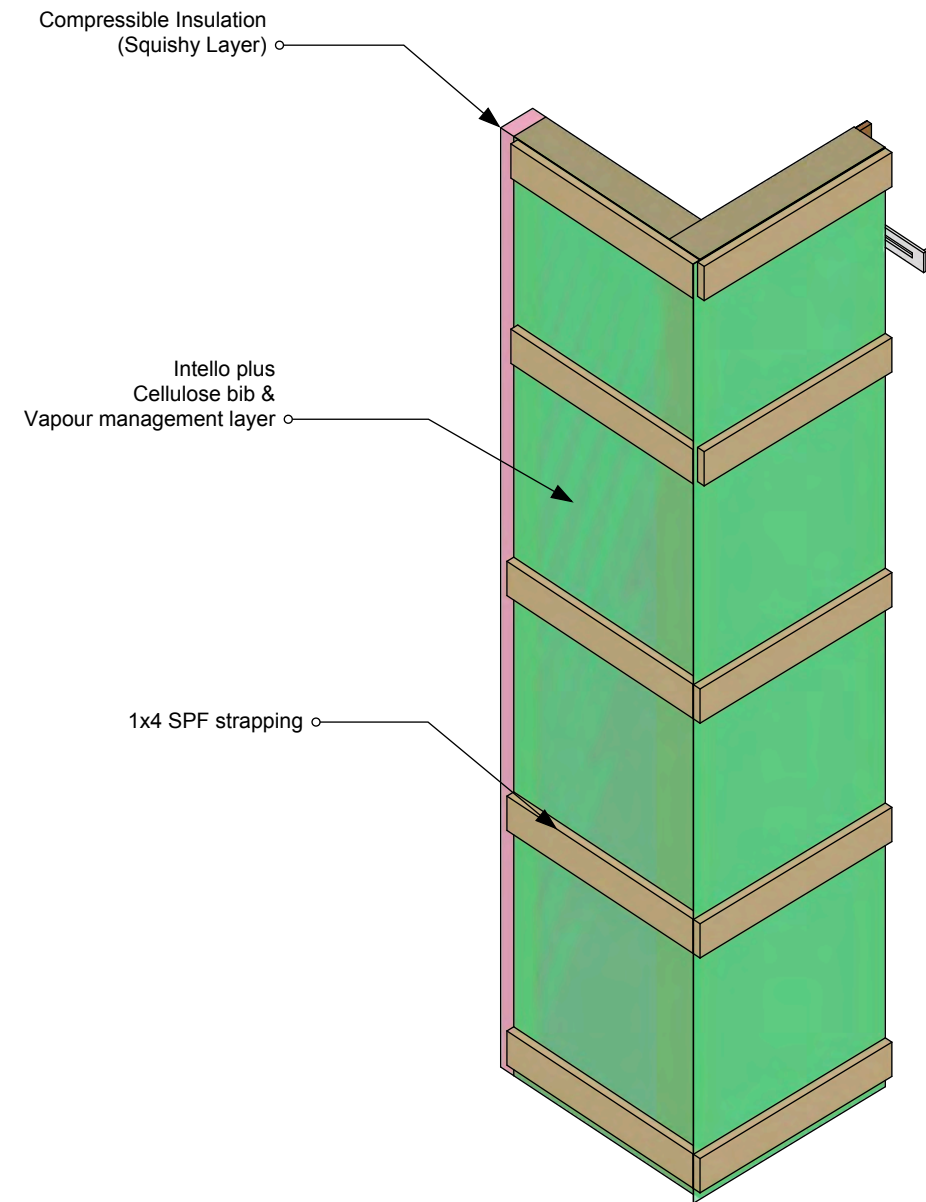
Panel - Inside Corner

Panel schematic with all membranes in place

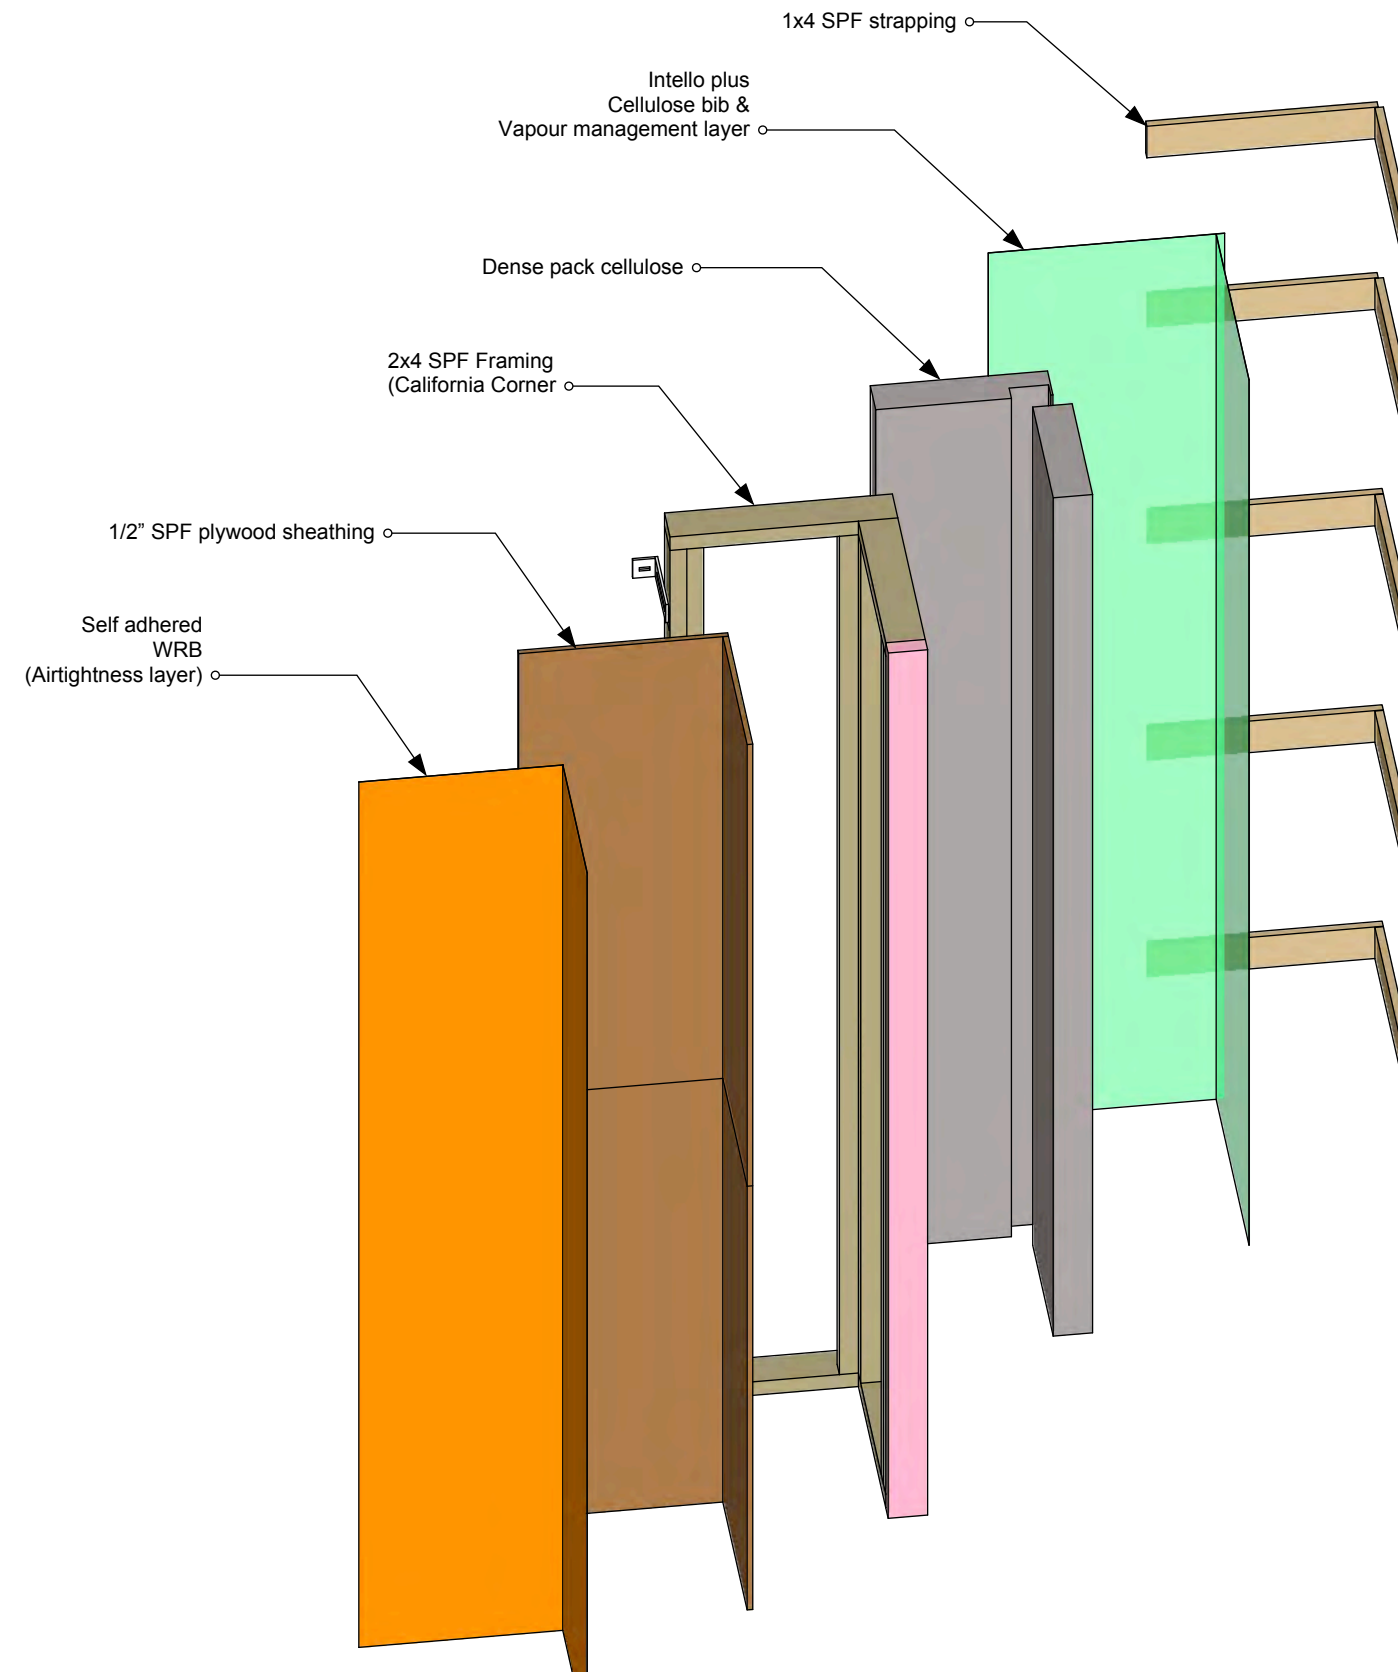
Panel - Inside Corner - Exploded

Panel schematic with all membranes in place

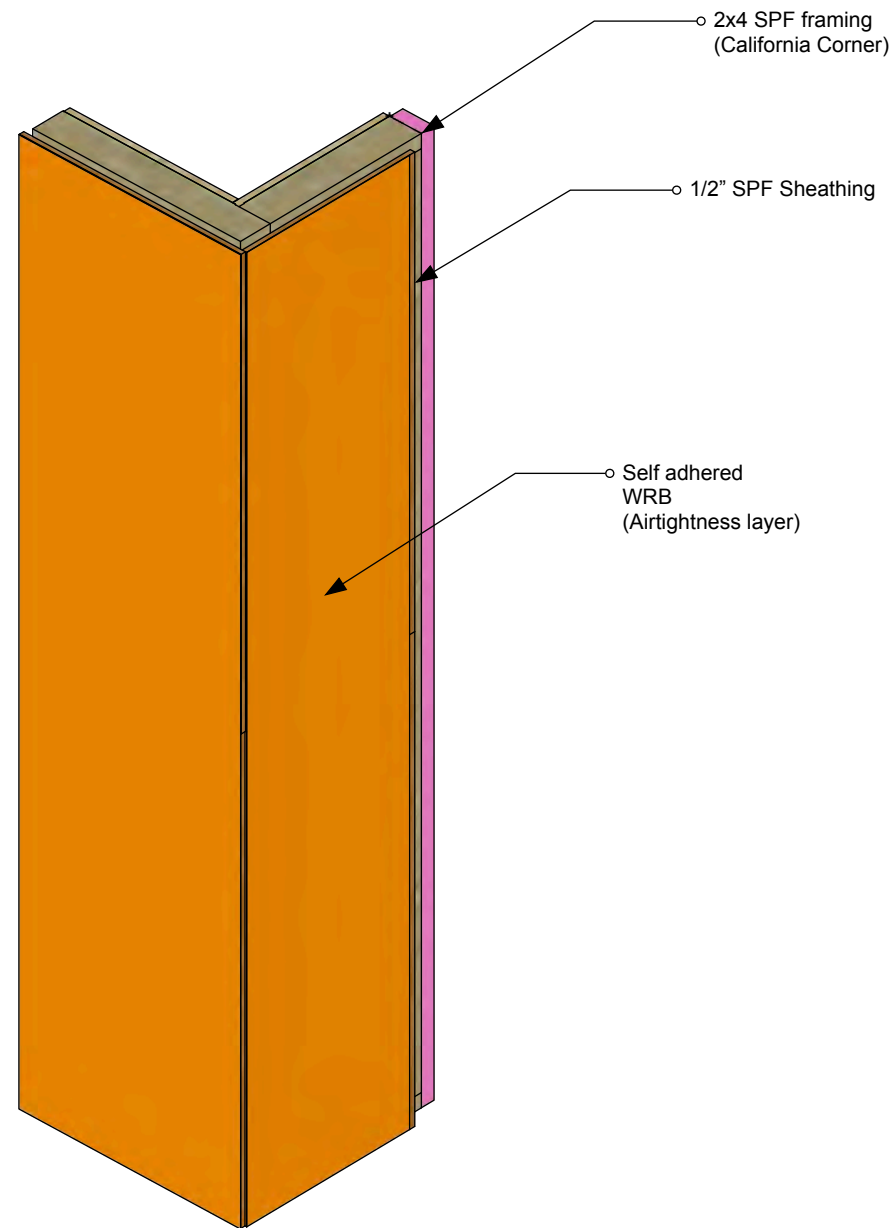
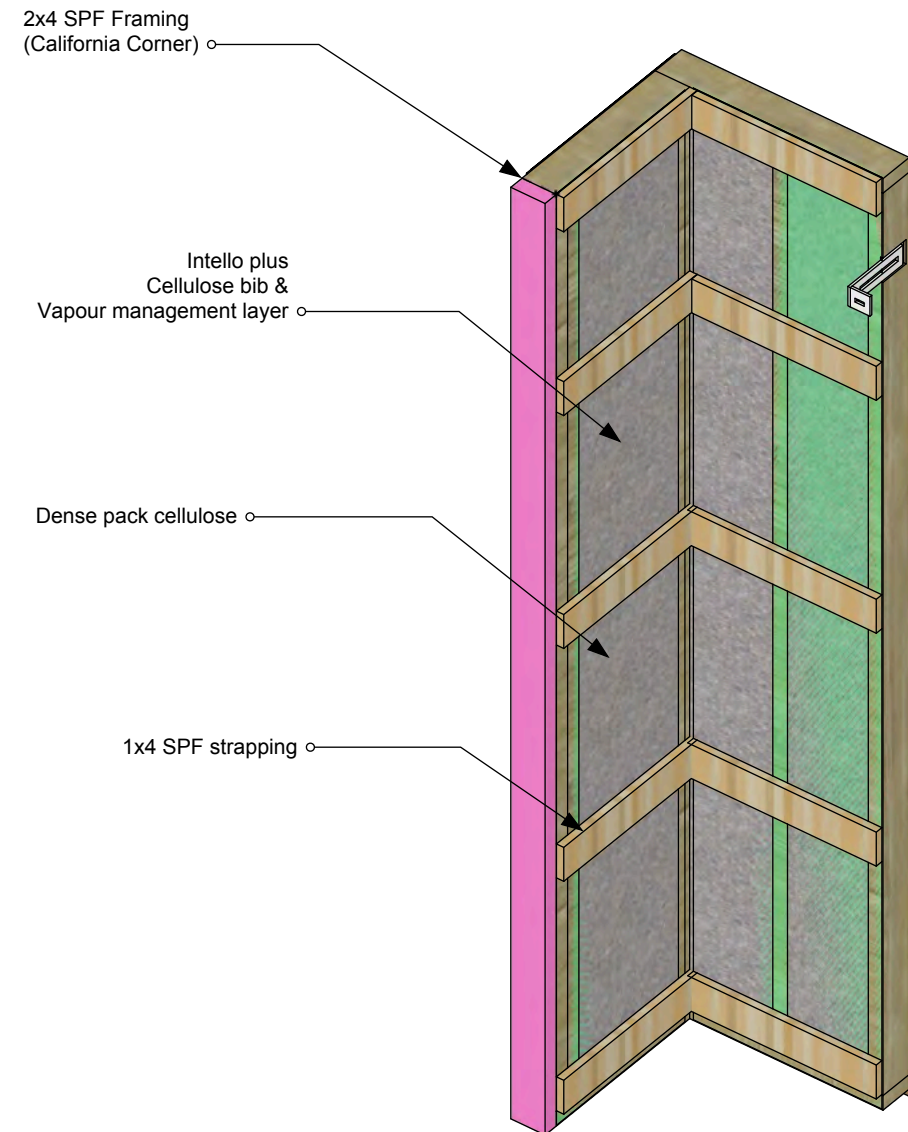
Panel - Outside Corner

Panel schematic with all membranes in place
