PANELIZED DEEP RETROFITS OF MUNICIPAL BUILDINGS

Harrietsfield Williamswood Community Centre Case Study Report

Issue Date: September 30, 2023

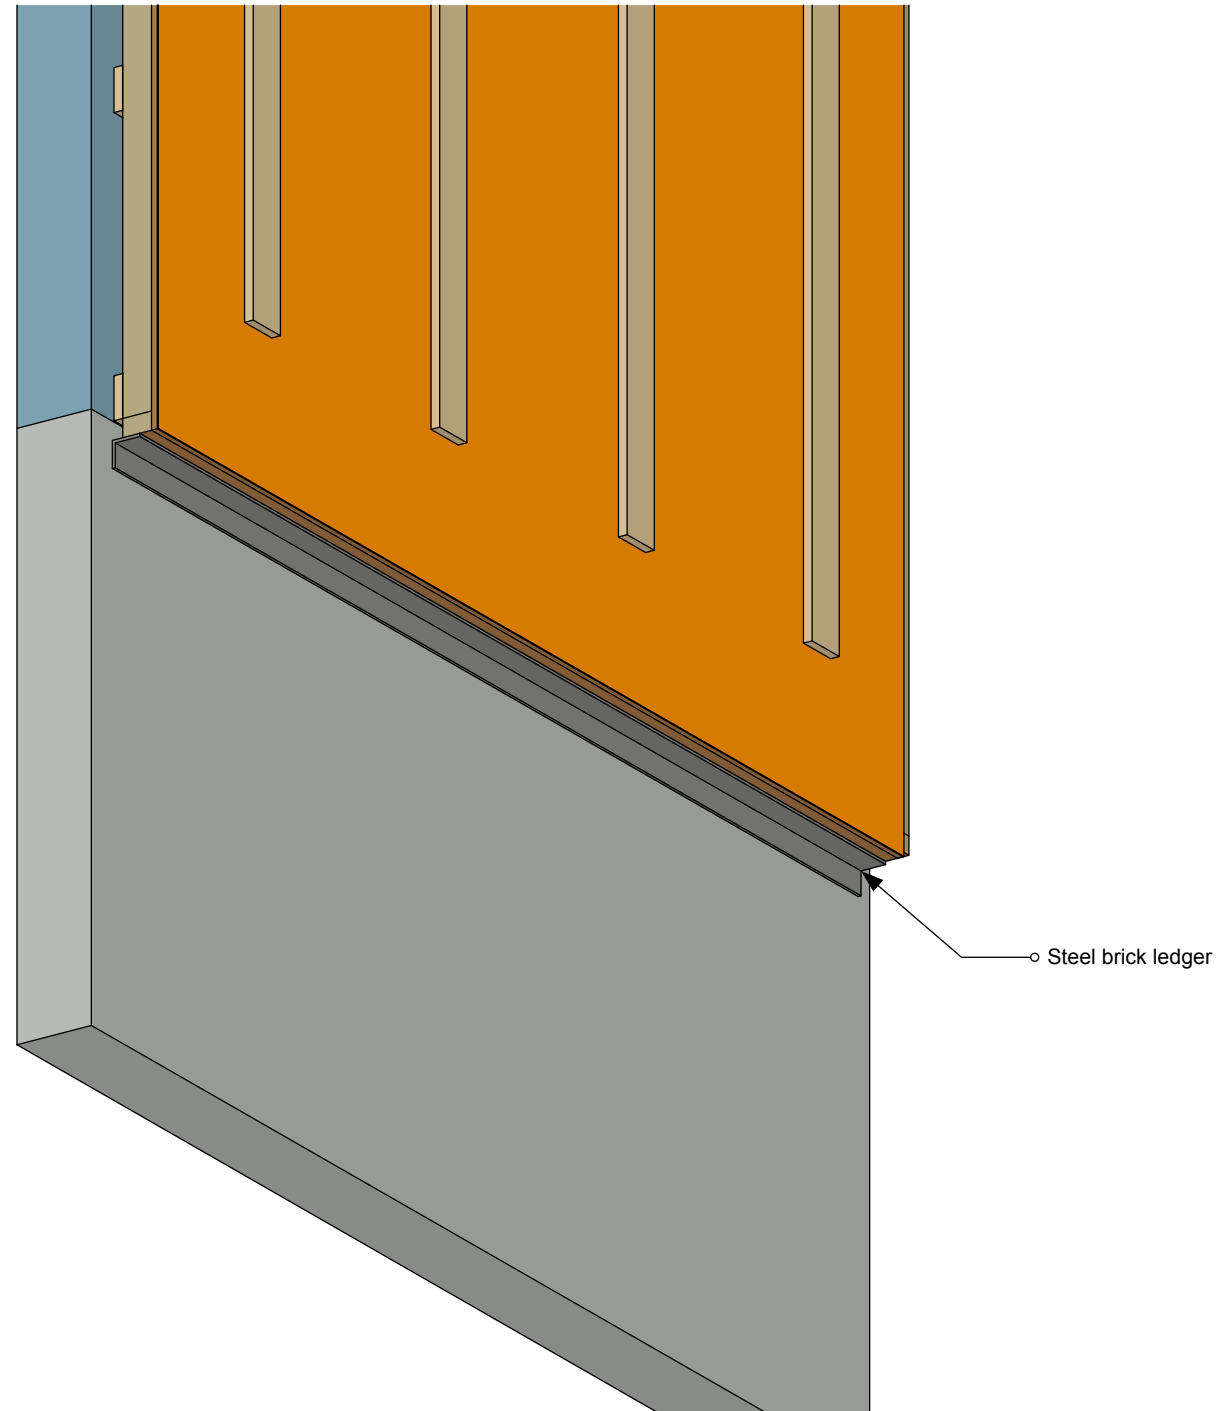
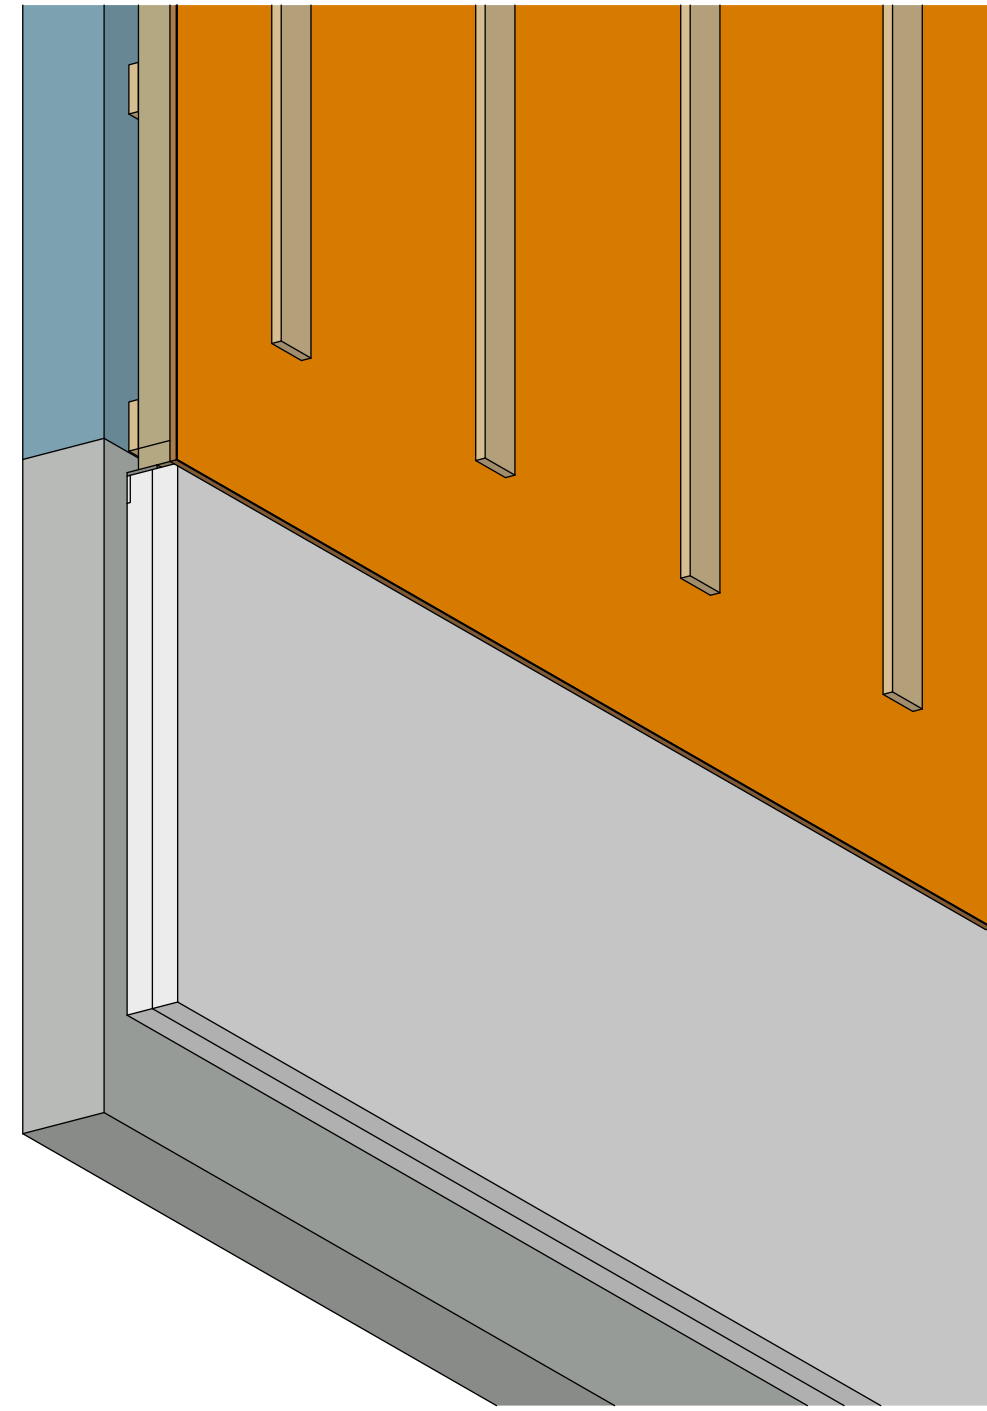
Foundation Attachment - Ledger

"Brick Ledger" style continuous ledger for panel support

Foundation Attachment - Brick Ledger

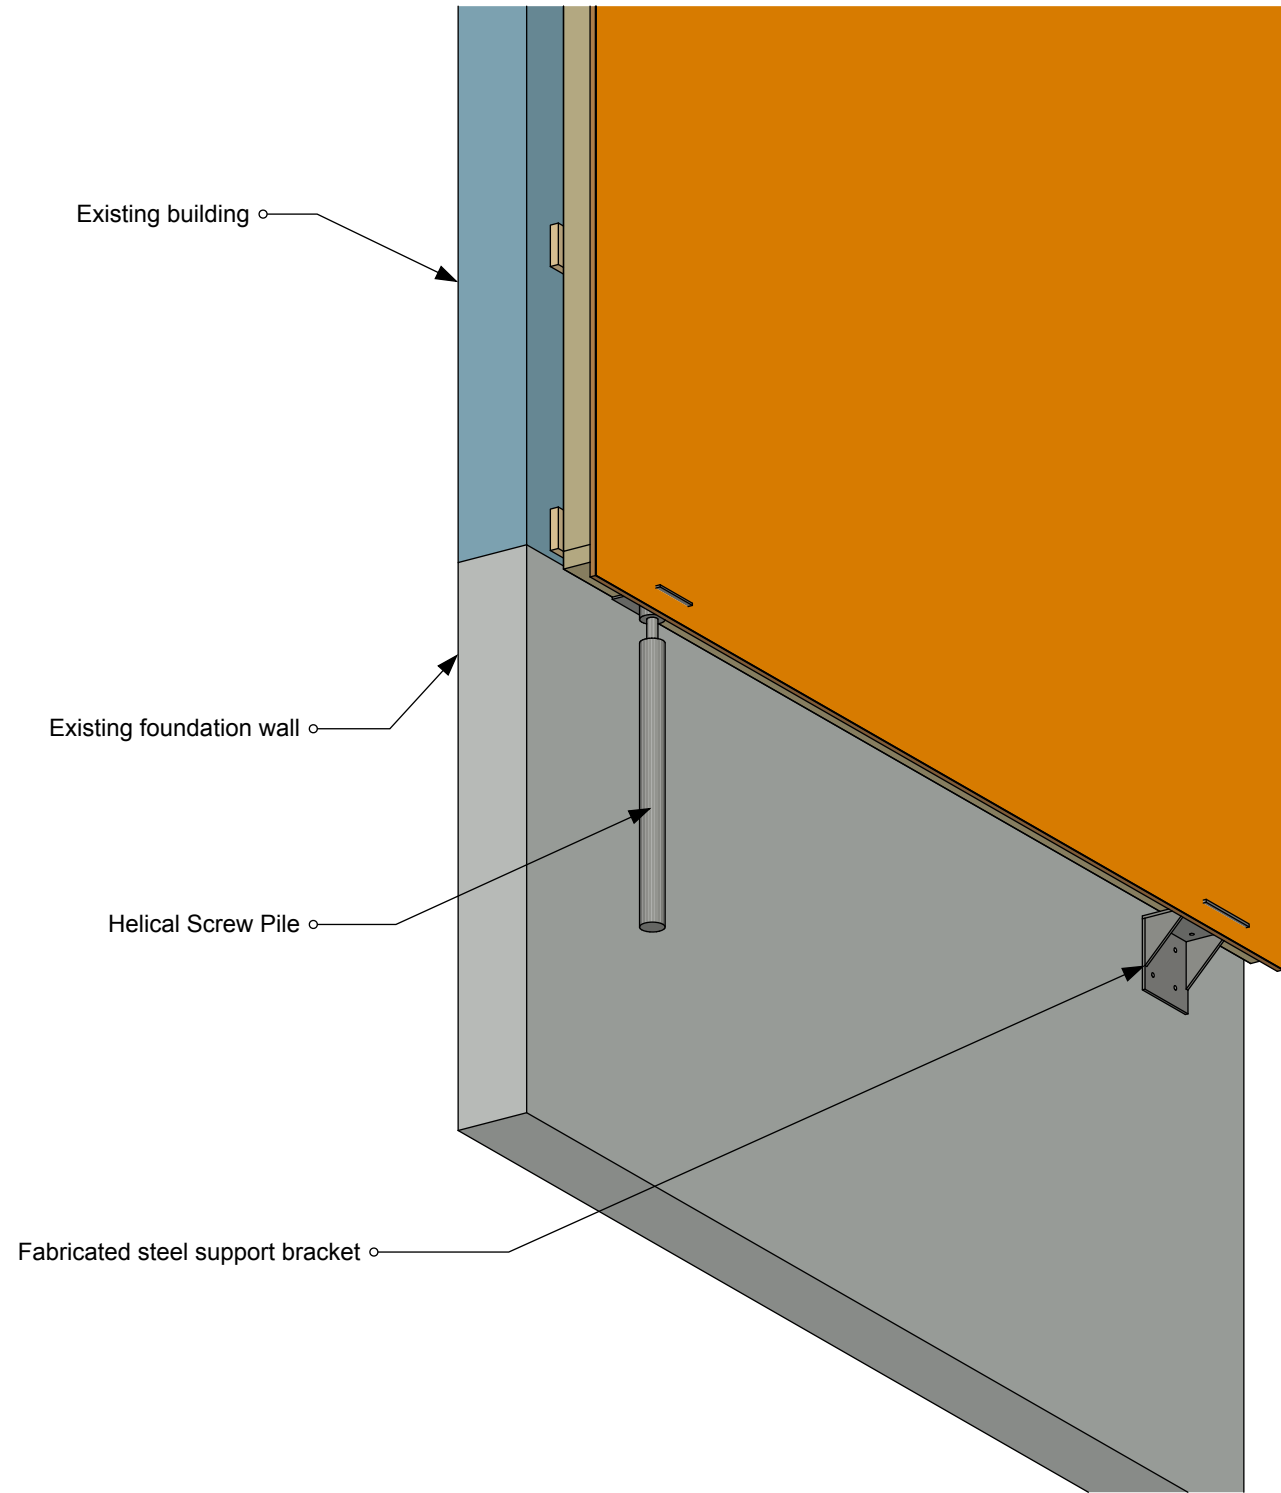
First options for attaching the panels to the foundation

Alternate Foundation Attachment - Pile or Bracket

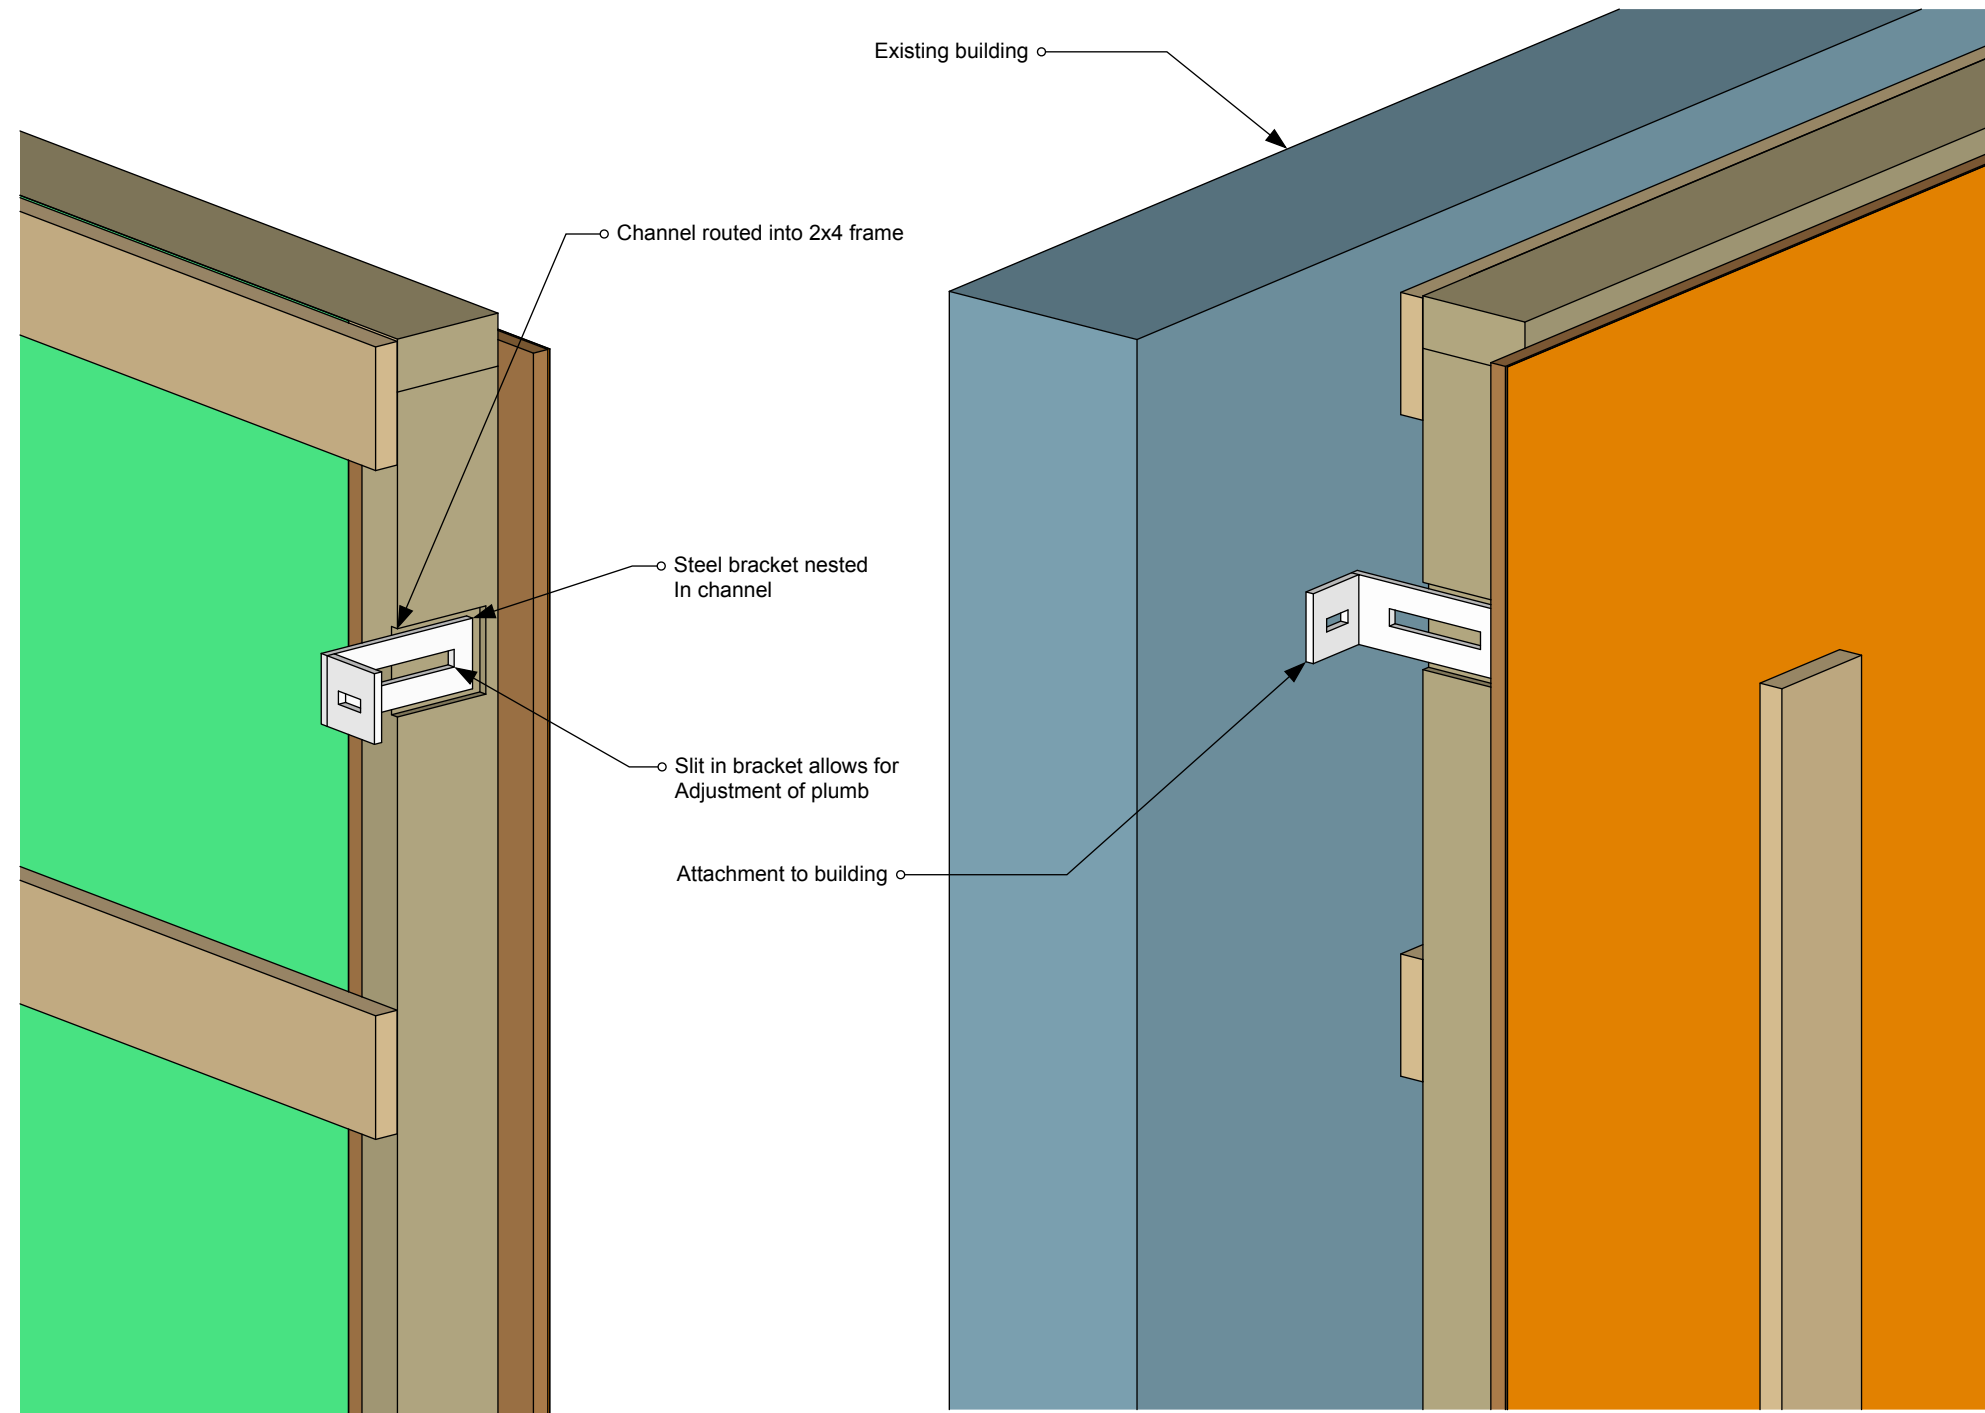
Attach to Existing

Bracket to attach individual panels to existing

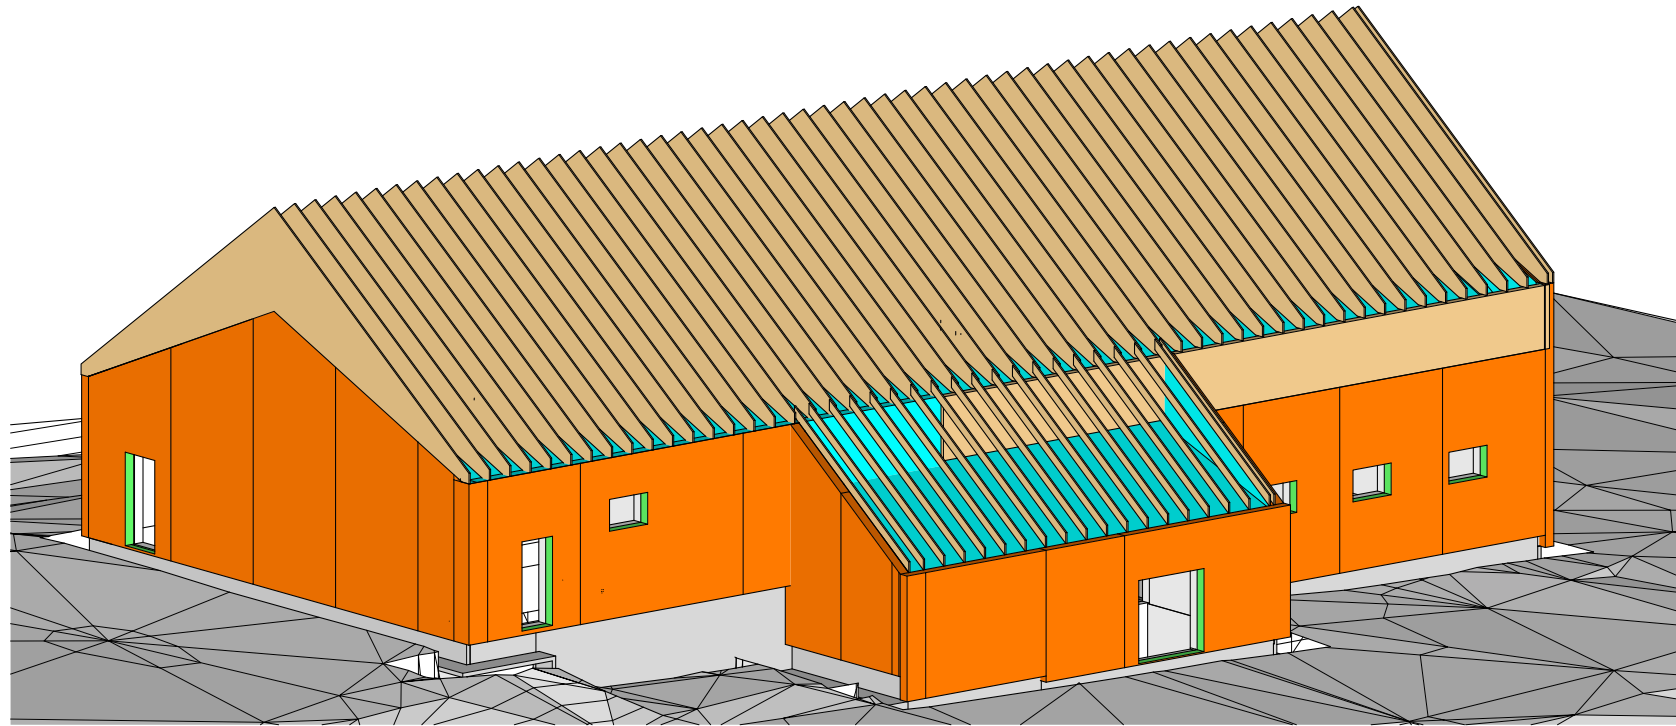
New Roof and Insulation

1. Install roof truss's to create new continuous roof.
2. Stick framed roof over bump out.
3. Install blown in cellulose in new attic space.
4. Install roof sheathing.
5. Install new roofing as per architect.

Raised heel truss's created needed depth to accommodate blown in cellulose

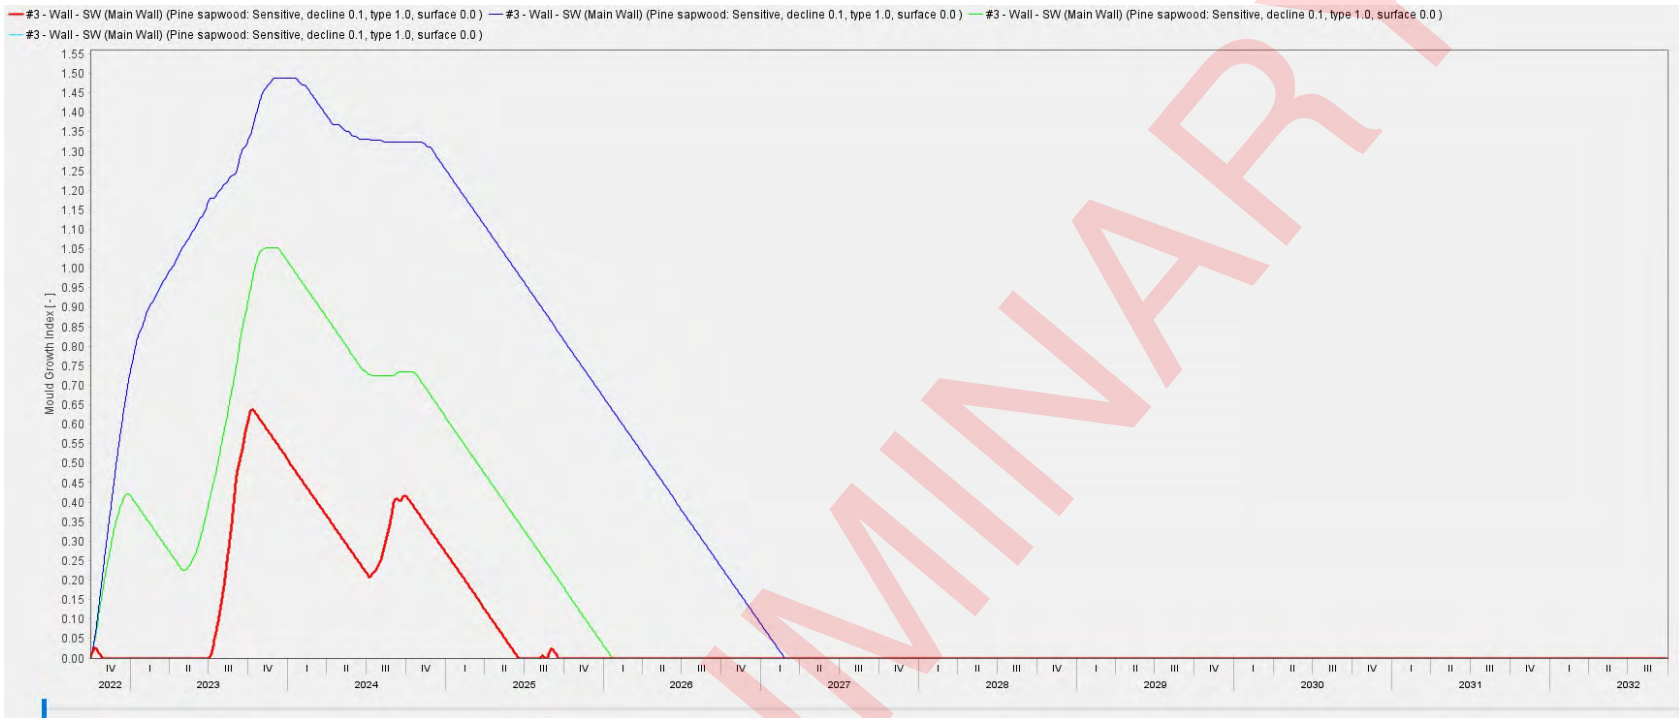
Figure 4 – WUFI® output for South-West Main Wall assembly: VTT mold growth index simulation over 10-year period studied for post-retrofit South-West Main Wall assembly’s fiberglass batt layer (proxy for assumed existing wood studs) (blue: outermost fiberglass element [Yellow VTT]; green: second-outermost fiberglass element [Yellow VTT]; red: two innermost fiberglass elements [Green VTT])

In all orientations simulated for the Main Wall assembly, the elements chosen for VTT simulation within the plywood and cellulose layers demonstrated a green VTT traffic light, indicating low mold growth indices. **However, within the existing fiberglass batt layer, the outer element(s) chosen for VTT simulation indicated a yellow VTT traffic light (mold growth index <1.6) in all orientations. For instance, in the South-West orientation, the mold growth index in the elements studied increases during the first year of simulation, peaks at the end of 2023/beginning of 2024, and decreases in subsequent years (Figure 4).**

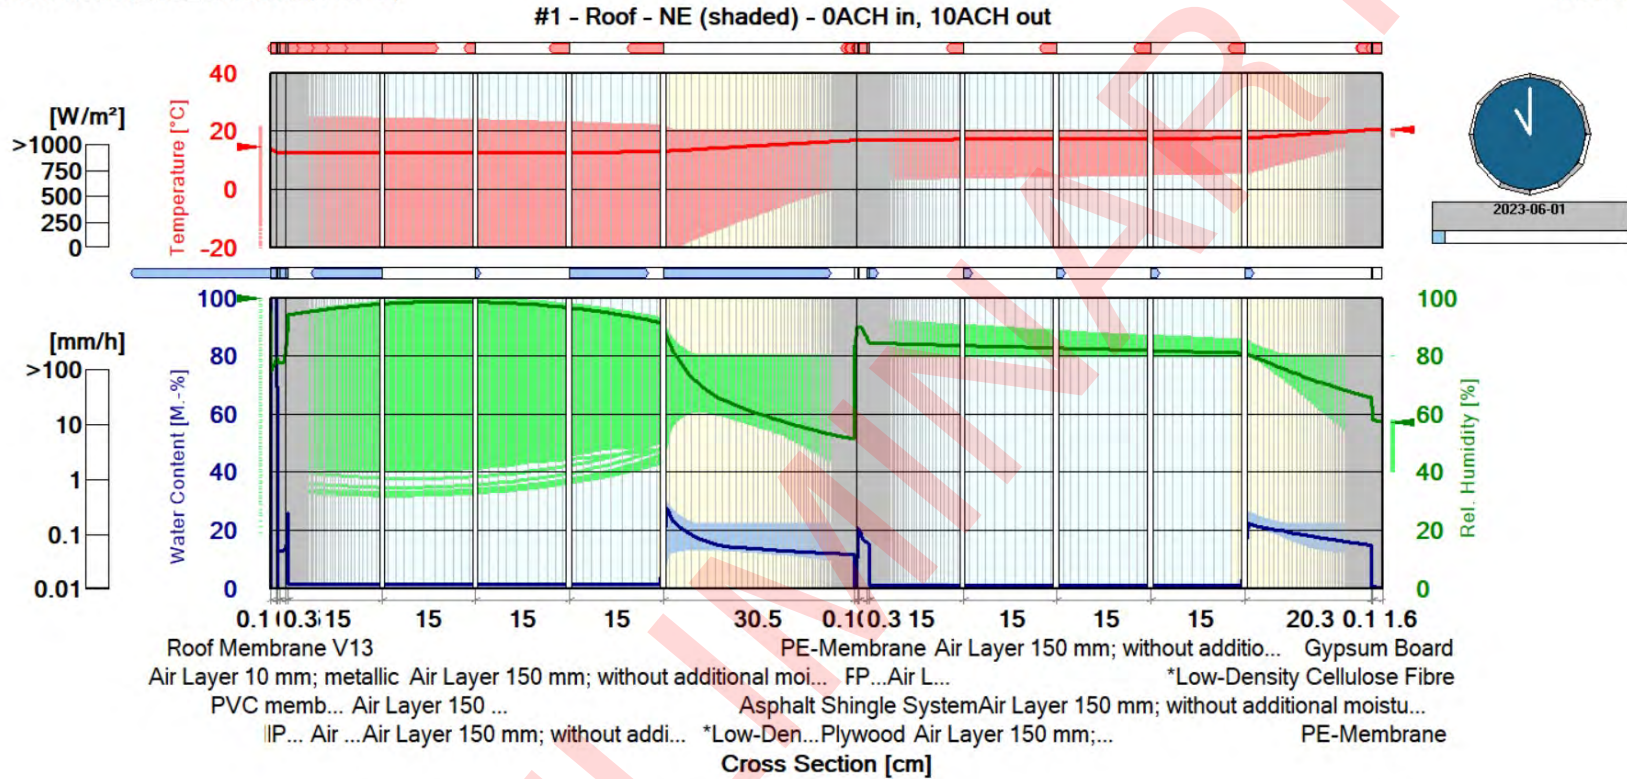
Figure 9 – WUFI® film output for North-East Roof assembly: temperature(°C) and water content (kg/m³, %) over 10-year period studied for post-retrofit North-East Roof assembly – high RH in new airspace/ attic space (scenario with 0-ACH existing attic, 10-ACH new attic space, shaded)

However, it should be noted that, per WUFI® film results, **the relative humidity (RH) in the new attic air space (behind the new plywood layer and above the new cellulose layer) reaches**

approximately 100% in all scenarios (Figure 9). Moreover, the scenarios with 0-ACH or 0.01-ACH existing attic exchange rates demonstrate elevated RH levels (approximately 90%) in the existing attic space (though the max RH seems to decrease annually), while the 0.1-ACH existing attic exchange rate scenario only seems to reach 90% RH in the existing attic in the first year of simulation.
