PANELIZED DEEP RETROFITS OF MUNICIPAL BUILDINGS

New Glasgow Municipal Operations Building Case Study Report

Issue Date: September 30, 2023

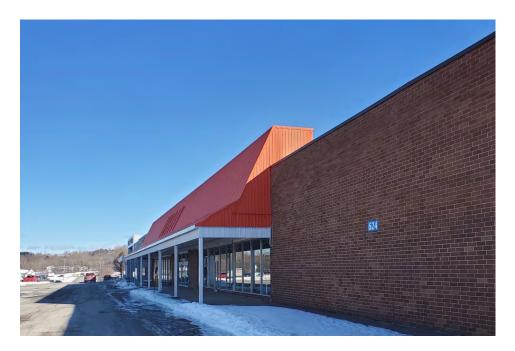
Figure 1 Municipal Operations Building

The New Glasgow Municipal Operations Building is a one-storey steel structure with a gross floor area of 7,430m² (80,000 sq. ft). The space is divided into two areas, a 5,670 m² retail space at the front of the building, which is presently unoccupied, and a 1,760m² space at the back used by the New Glasgow Public Works and Engineering Department. The facility is used as a maintenance shop for storage and servicing of New Glasgow's fleet of trucks, snowplows, and other heavy machinery. It also contains office space, storage rooms, washrooms, and service spaces. The north wall of the building is partially shared with an adjacent movie theatre.

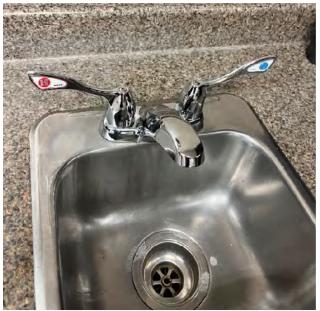
Figure 2 Typical Bathroom Fixture in Facility

The facility consists of a men's and women's washroom in the office area. The washroom facility contains seven toilets, three urinals, and seven wash sinks. No flow rate was available on the fixtures, but most appear to be original to the building. The sinks were noted to not have touchless faucets. The back breakroom contained an oven, fridge, sink, and microwave. The building originally had a commercial kitchen which has since been removed. Should water efficiency measures be installed, it is recommended that fixtures be upgraded to low flow units.

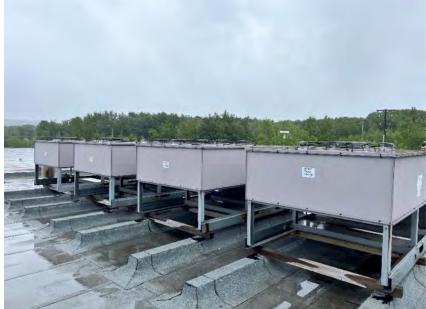
Figure 7 Condensing Units on Roof

Heat is distributed from the boiler by two main heating loops. The first loop is connected to a builtup air handling unit (see Figure 6) with a hydronic heating coil which supplies air to the retail space in the front of the building. The air handling unit also has a DX cooling coil served by four 34-ton rooftop condensing units, see Figure 7. The unit has not operated since the space was unoccupied last summer. The circulation pump for this loop is rated at 5 HP.

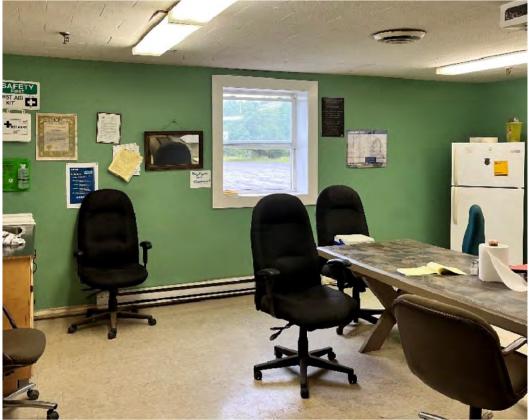
Figure 11 Electric Baseboard in Breakroom

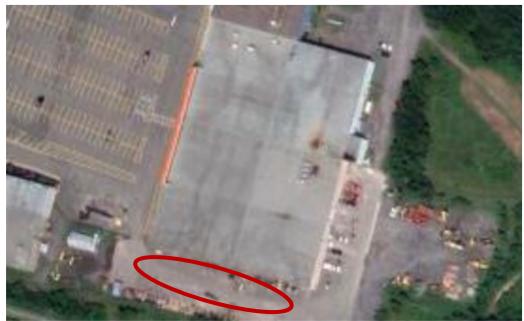
The air source heat pump would be mounted outdoors on a stand outside of the mechanical room (shown in the figure below). Ideally, the heat pumps would be installed on the south side of the building to maximize winter performance due to higher outdoor air temperatures.

Figure 24 Location of Air Source Heat Pump

The air source heat pump has been sized according to so that it meets 60% of the peak design heating load at a reduced outdoor air temperature of -4°F. The electric boiler is sized for the remaining 40% of the load. As peak demands rarely occur throughout the year, it is much more economical for the electric boiler to provide heating during peak demand periods. Reducing the heat pump capacity to 60% of peak load typically results in the electric boiler only providing 5 - 15% of annual heating.

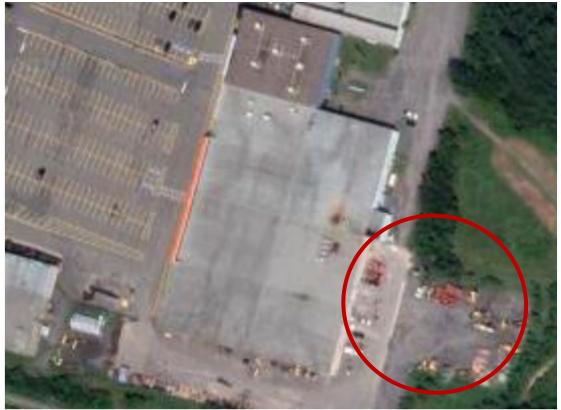
The boreholes would most likely be located on the southeast side of the property as to minimize disruption to site operations, refer to Figure 28. However, further analysis must be conducted to confirm the system design. The GSHPs would be located in the mechanical room.

Figure 28 Proposed Borehole Location

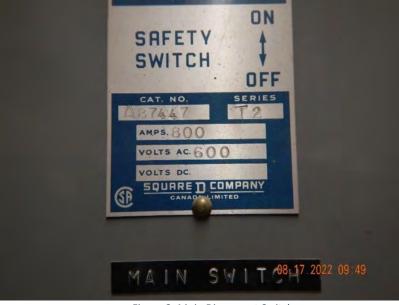
Figure 3: Main Disconnect Switch

The main building disconnect is a 80% rated 800A fusible disconnect switch. All other disconnects for panels, motors etc. are fusible disconnects. Visually the disconnects appear to be in okay condition. Where all existing main distribution equipment is loose disconnects and panels off a main splitter, there is not much room left in the main electrical room to add future distribution.

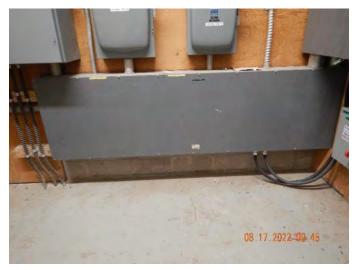
Figure 4: Main Building Splitter

The existing main distribution is original to the building and consists of a main disconnect, a main splitter and multiple branch circuit panelboards. All main distribution equipment has surpassed its reasonable life expectancy and some equipment is showing signs of rust. No maintenance logs are available to determine if any work has been completed done throughout the years.

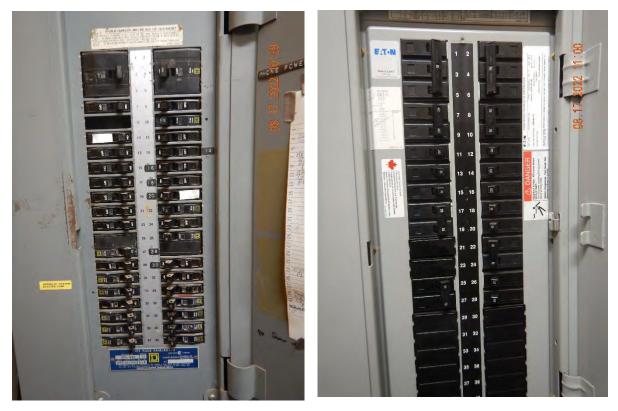
Figure 5: Existing Distribution

Several 120-208V and 347-600V branch circuit panelboards exist throughout the building servicing various areas. All panelboards appear to be original to the building and range from very poor to good condition. Some panelboards have been completely filled with breakers and as a result, minibreakers have been installed to expand capacity past what they were originally designed for. Some panels do appear to include breakers that are no longer in use, which could be removed to allow room for new distribution and branch circuits.

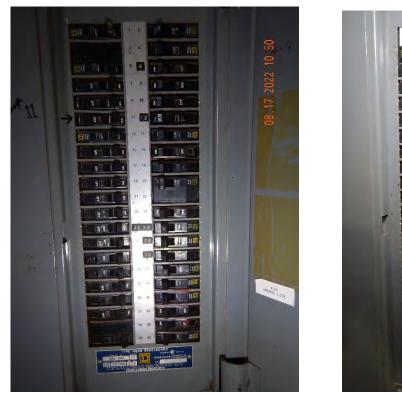
Figure 7: Existing Distribution

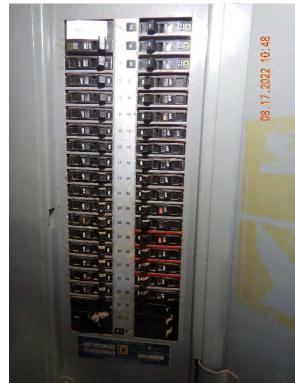
Figure 8: Existing Distribution

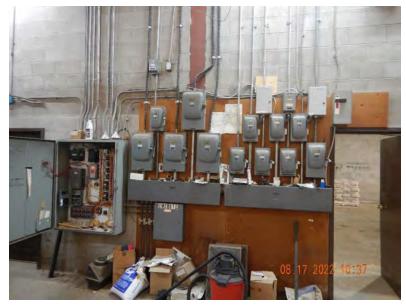
Figure 9: Existing Distribution

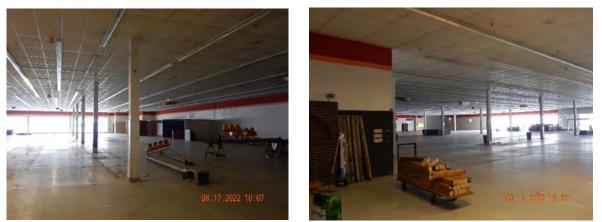
Figure 102: K-Mart Lighting

The K-Mart side of the building consists entirely of T8, 2 lamp fluorescent fixtures which are surface mounted. Approximately 50% of the lamps in this area of the building appear to be burnt out and no-longer working. Similar to the warehouse side, the existing light fixtures are original to the building and are past their reasonable life expectancy.

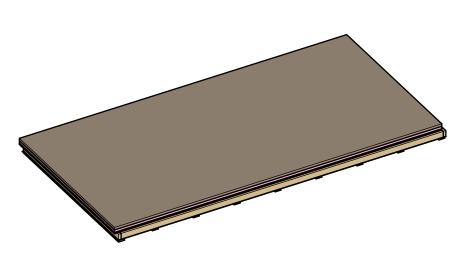
Top View

Installed and Finished Panel

Overview of panel and site-installed XPS and roofing

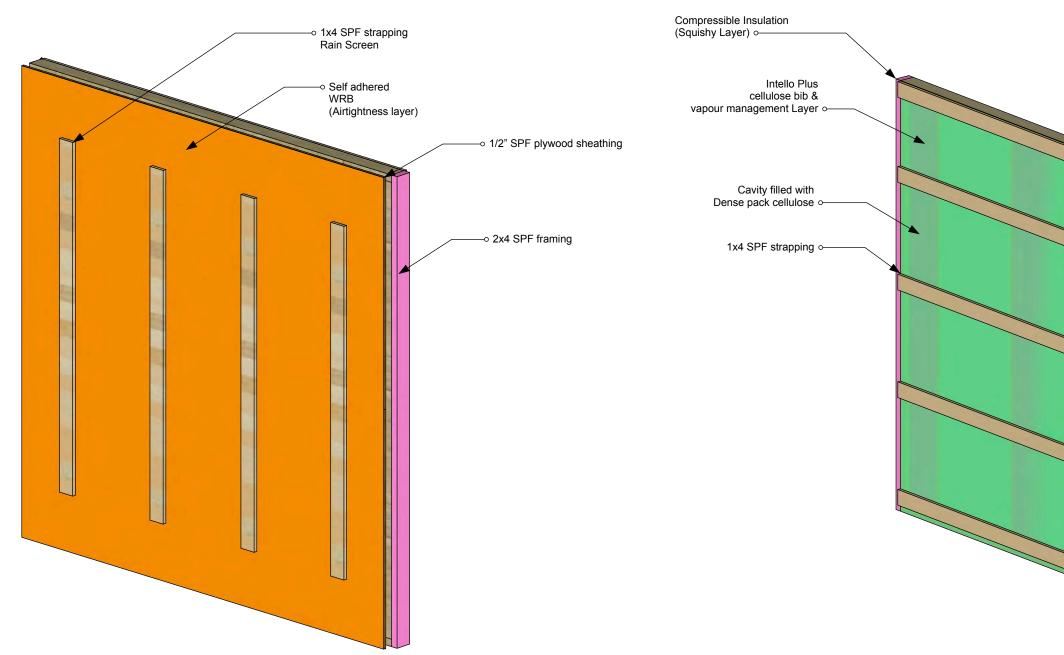
Panel - Overview

Panel schematic with all membranes in place

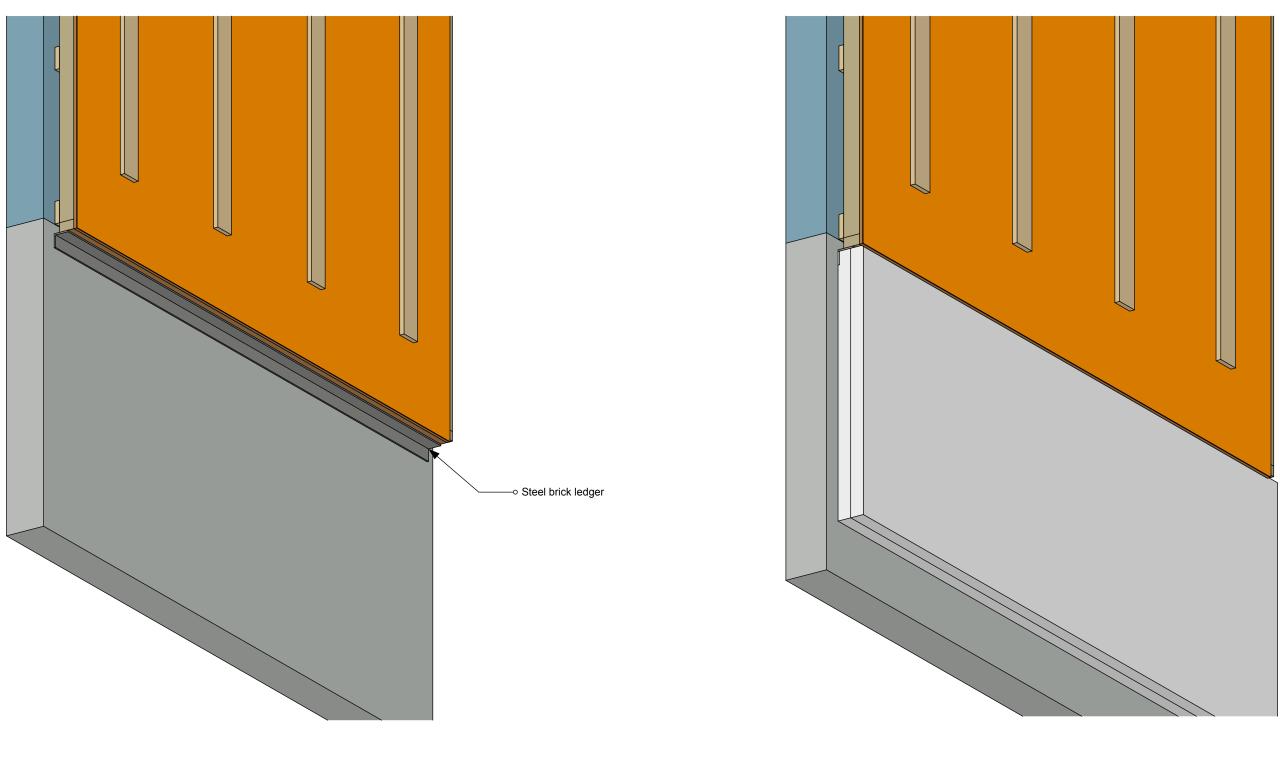
BEFORE SITE INSULATION

AFTER SITE INSULATION

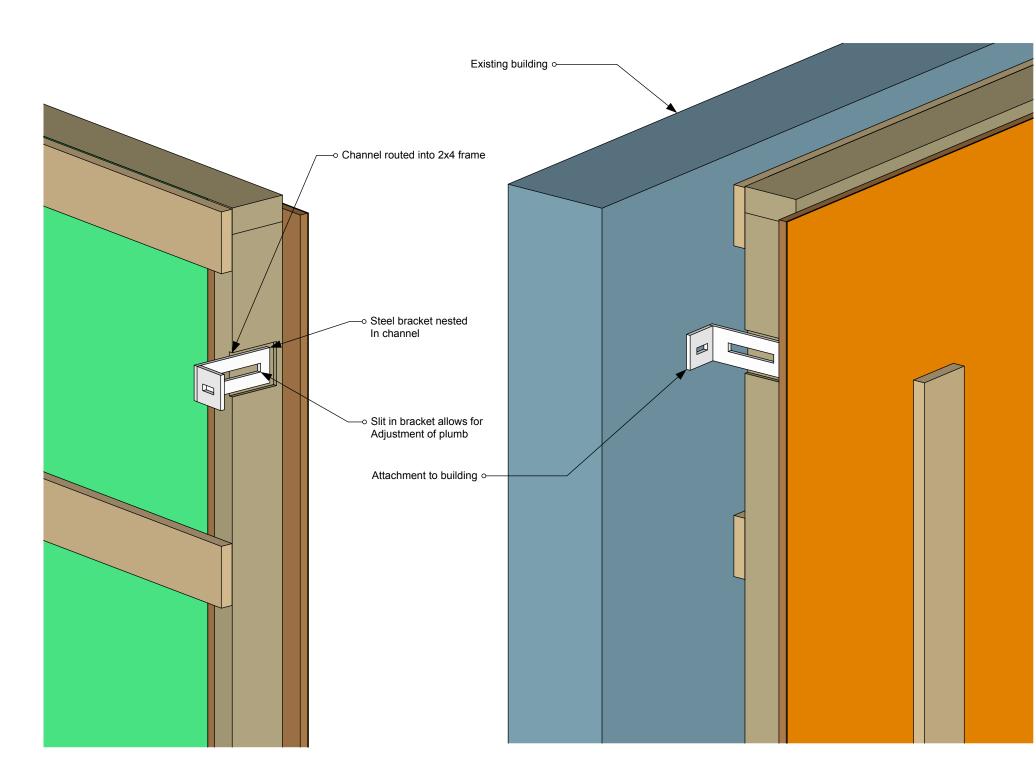
INTERIOR VIEW

EXTERIOR VIEW

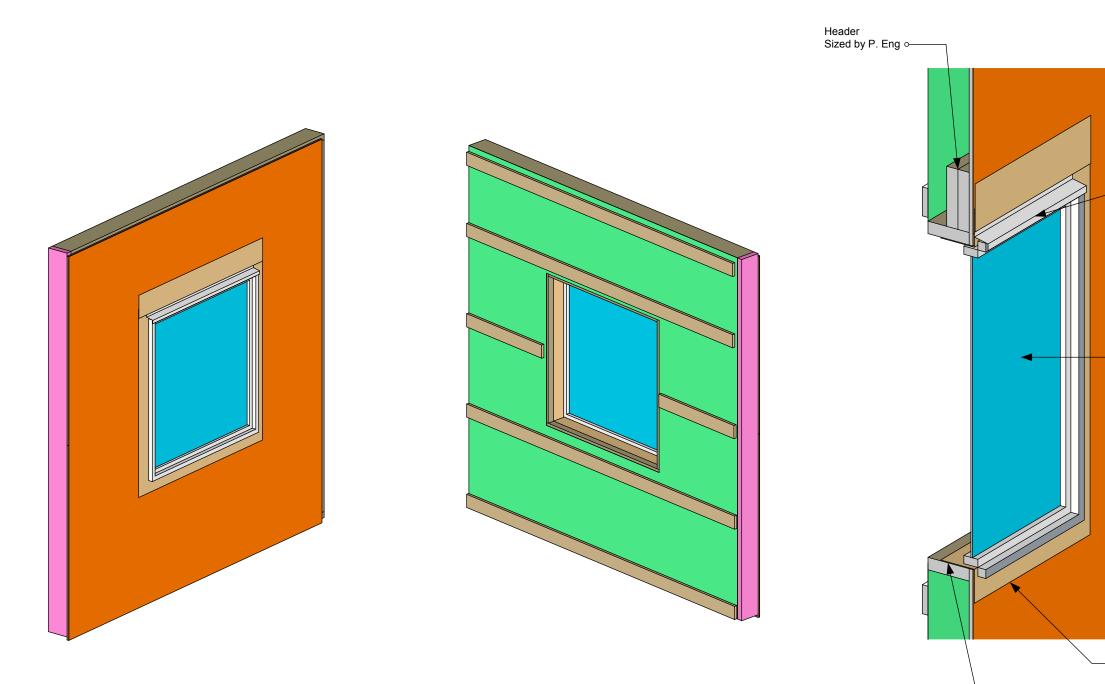
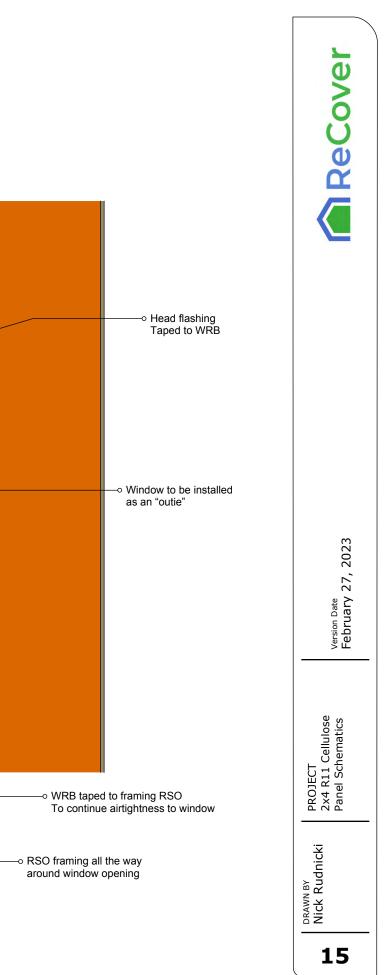
Window Panel

PANEL EXTERIOR VIEW Window installed in factory Window installed as an "outie" to minimize how much window sill there is exposed to the rain

PANEL EXTERIOR VIEW

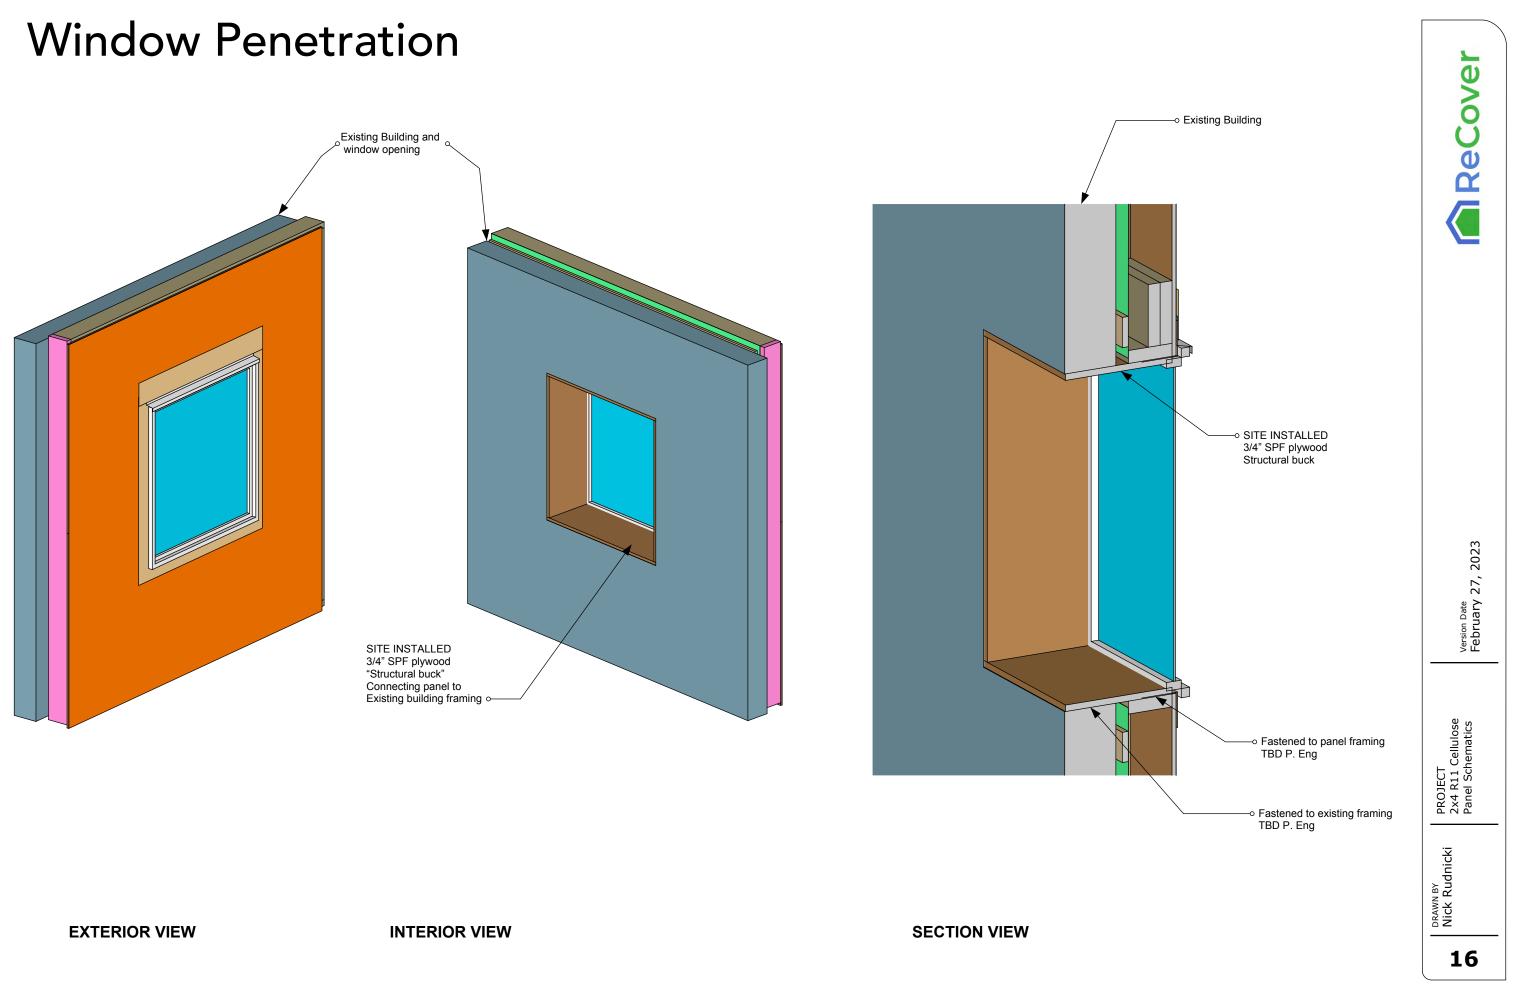
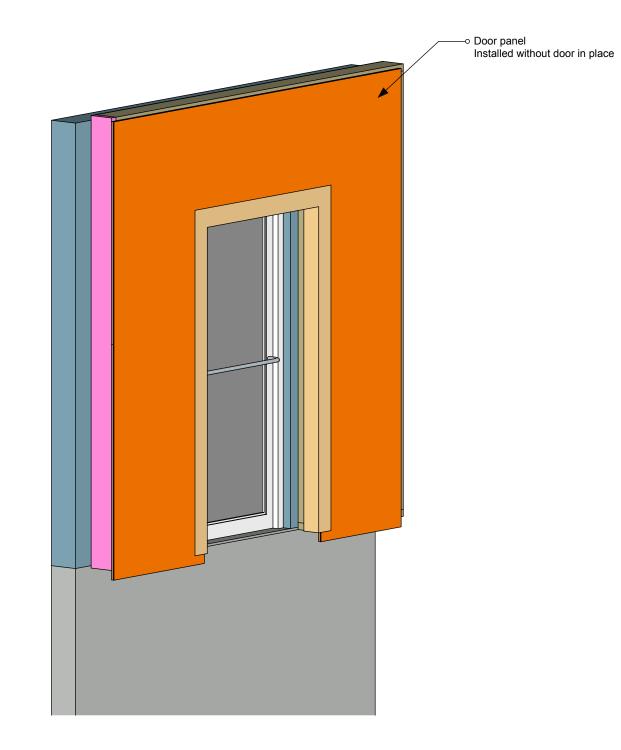
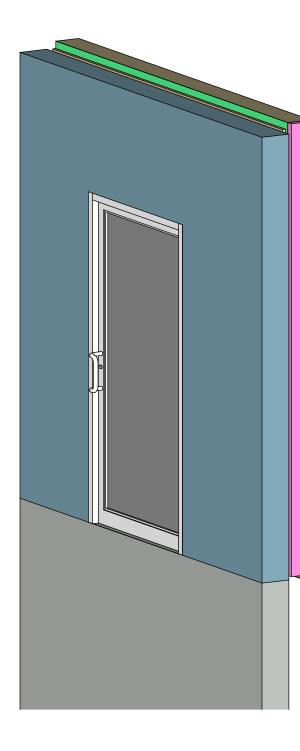
Door Penetration Panel

EXTERIOR VIEW

INTERIOR VIEW

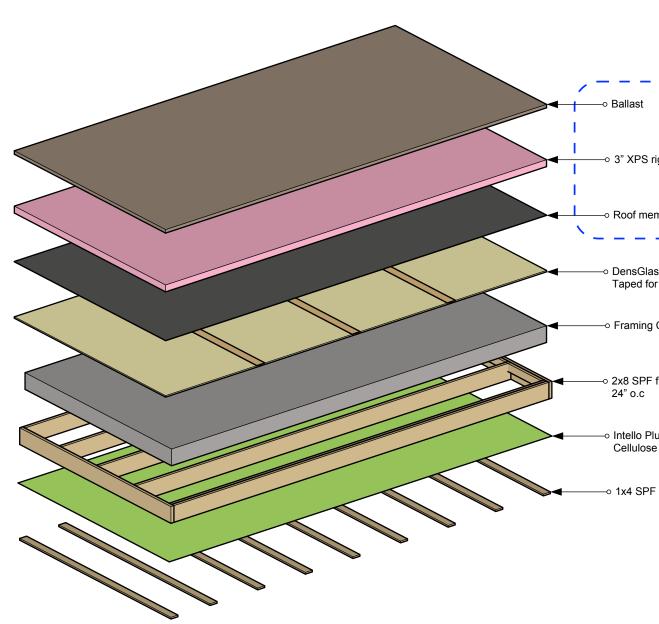
Exploded View

SITE INSTALLED	ReCover
nbrane ss Sheathing r air tightness Cavity filled with dense pack cellulose framing	^{version Date} February 27, 2023
us bib and vapour management membrane strapping	PROJECT 2x8 R38 Cellulose XPS Inverted Roof Panel
	DRAWN BY Nick Rudnicki

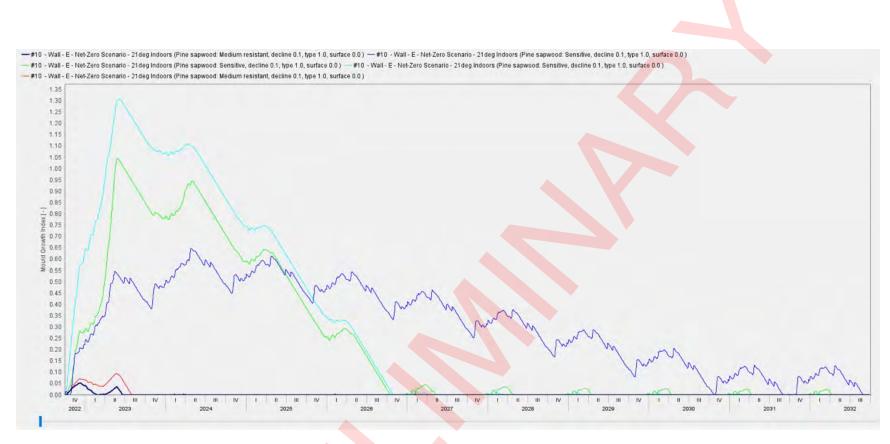
Figure 7 – WUFI[®] output for wall assembly: VTT mold growth index simulation over 10-year period studied for post-retrofit East wall assembly's plywood and cellulose layers

(blue: outer plywood; green: center plywood; light blue: inner plywood; red: outermost cellulose element; black: other cellulose element)

The North, South, and West orientations experience acceptable VTT results according to WUFI, with the green VTT light being presented. However, the East orientation's simulation outputs a yellow VTT light for the mold growth index for the center and inner plywood layers. In the center plywood, the mold growth index remains below 1.1, while the inner plywood's index remains below 1.4. In all orientations, the cellulose cavity's "Medium resistant" sensitivity class allows for a green VTT light. These results are similar for both the painted and unpainted interior finish simulations in the East orientation. Results of the VTT simulations for the layers simulated in the East post-retrofit wall assembly (painted interior) are presented in **Figure 7**.

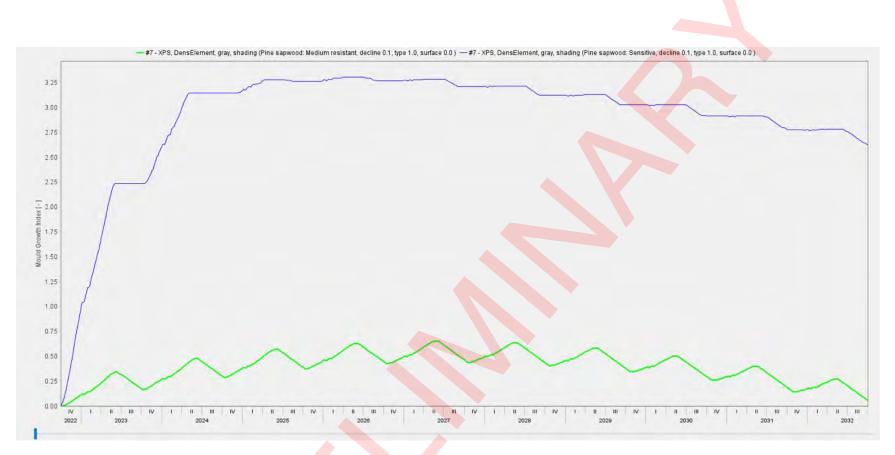
Figure 19 – WUFI® output for DensElement roof assembly (shaded): VTT mold growth index simulation over 10-year period studied for post-retrofit roof assembly's cellulose layer (outermost cellulose element simulated) (green: "medium resistance" sensitivity class; blue: "sensitive" sensitivity class)

For mold-related durability, a VTT simulation was conducted to simulate the mold growth index at the outermost element of the cellulose layer. Using the "Medium resistant" sensitivity class and "Almost no decline" inputs, the VTT simulation indicates a green VTT traffic light (<0.7) for the wood members (approximated using the cellulose layer) within the cellulose cavity (**Figure 19**, shaded roof results). It is worth noting, however, that if medium resistance mold resistance is not imparted to the wood members within the cellulose cavity and the "Sensitive" sensitivity class is used, a mold growth index of approximately 3.4 (red) is obtained.

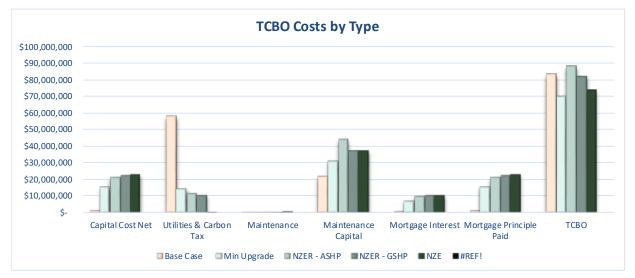
60 Year Cost of Ownership Comparison

Cost as a Perce	ntage of TCBO			
Capital Cost Net	1.9%	22.8%	24.2%	27.3%	31.5%
Utilities & Carbon Tax	70.0%	21.2%	13.3%	12.9%	0.7%
Maintenance	0.3%	0.4%	0.5%	0.5%	1.6%
Maintenance Capital	26.2%	44.2%	50.1%	45.9%	50.9%
Building Insurance	0.7%	0.8%	0.6%	0.7%	0.8%
Property Tax	0.0%	0.0%	0.0%	0.0%	0.0%
Mortgage Interest	0.9%	10.6%	11.3%	12.7%	14.6%
ТСВО	100.0%	100.0%	100.0%	100.0%	100.0%
