# PANELIZED DEEP RETROFITS OF MUNICIPAL BUILDINGS

## Sir John Colborne Recreation Centre for Seniors Case Study Report

Issue Date: September 30, 2023

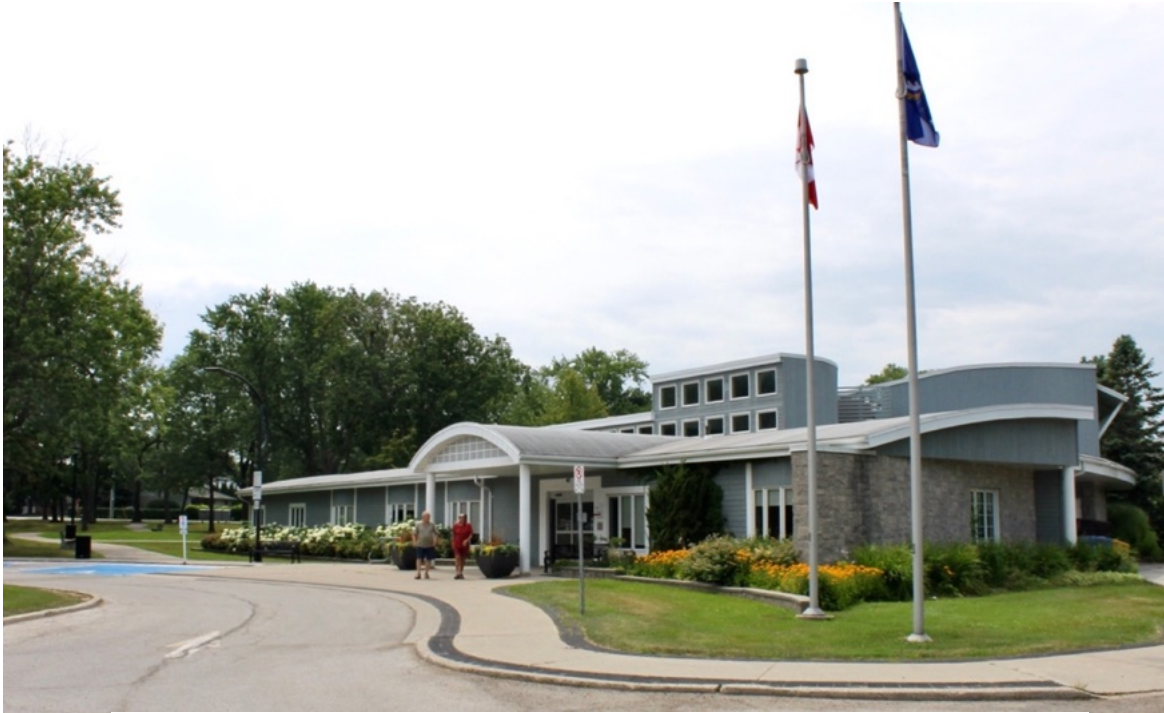
Figure 1 Sir John Colborne Centre

The Sir John Colborne Centre is a one-storey building with a gross floor area of 852m<sup>2</sup> (9,171sq. ft) constructed in 1989.

The Sir John Colborne Recreation Centre for Seniors is a small, single-storey community centre building located at 1565 Old Lakeshore Road in Oakville, Ontario. The structure is owned and operated by the Town of Oakville and currently used primarily as a seniors' recreation centre with various multi-purpose activity rooms and a large auditorium space. Based on available architectural drawings, the building was determined to be constructed circa 1989. A photo of the building exterior is shown in Figure 1.

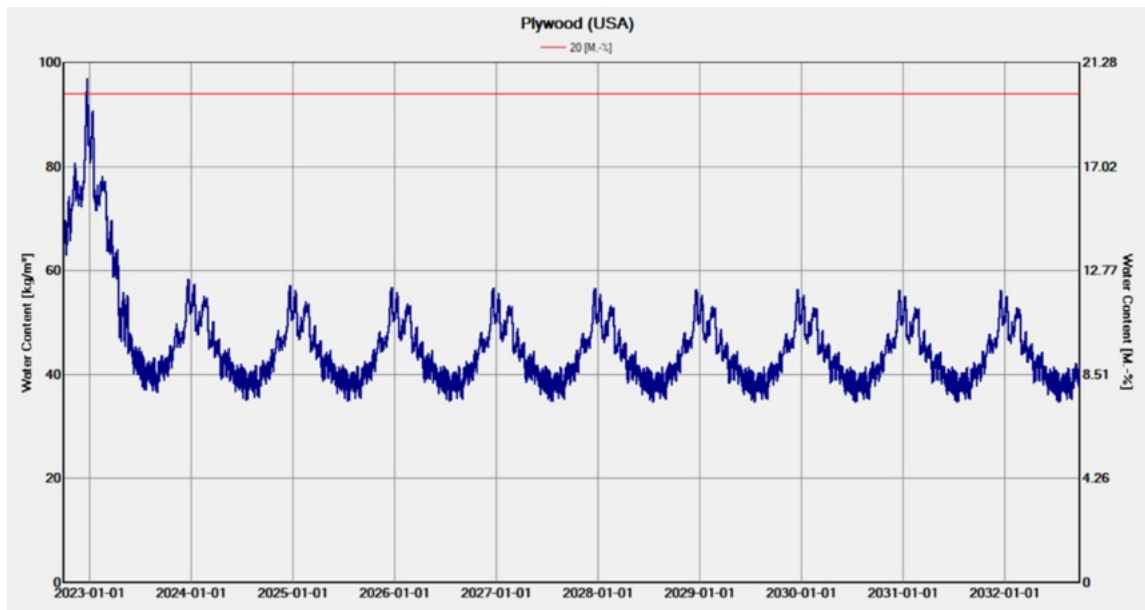
Figure 16 WUFI output – panel on west CMU wall (inner plywood layer)

Simulations were run for each orientation of each assembly for a 10-year period post-retrofit. All assemblies displayed cyclical seasonal moisture fluctuations consistent with expectations for buildings in the Ontario climate. Specifically, moisture content peaks in winter, with the greatest peak occurring in the first year post-retrofit, and spikes decrease in subsequent years. A moisture spike that exceeds 20% in one winter does not typically damage the building if drying occurs in the summer. Spikes above 20% that persist for several years indicate a potential for mould and eventual decay.

The analysis indicates that assemblies where panels are installed on CMU can walls manage moisture well. The moisture content in these follows a pattern like the one in Figure 18.

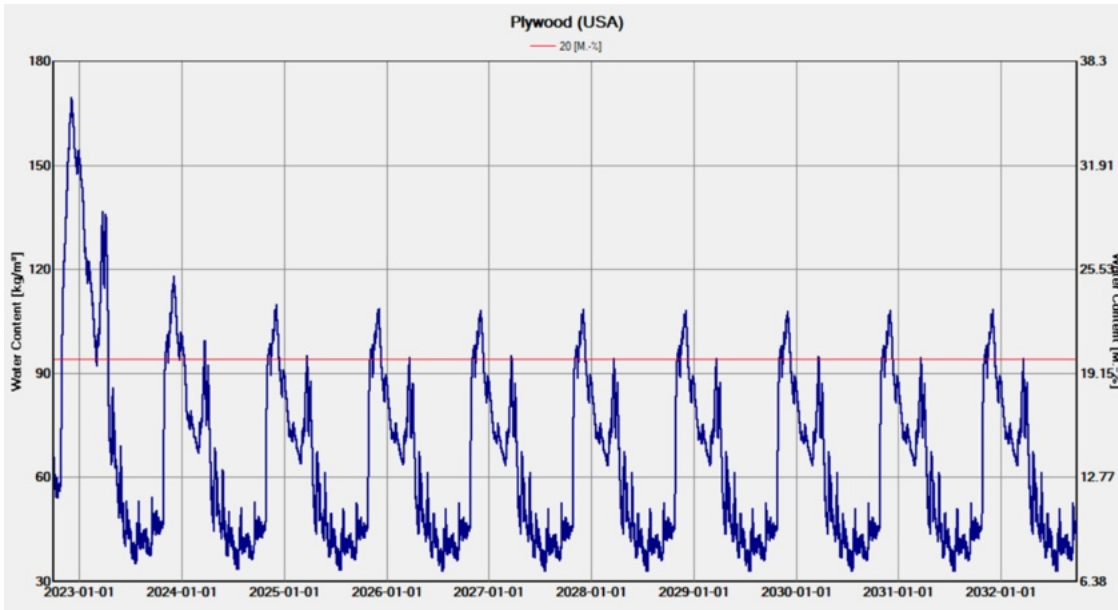
Figure 17 WUFI output - panel on northeast timber wall (outer plywood layer)

The assemblies where panels are installed on wood-framed structure demonstrate less drying capacity. Panels installed on the north and east facing wood framed walls demonstrate the highest risk. These follow the typical pattern of a high spike in year one post-retrofit; however, the annual peaks exceed 20% moisture in all ten years of the analysis. An example of this pattern is shown in Figure 19.

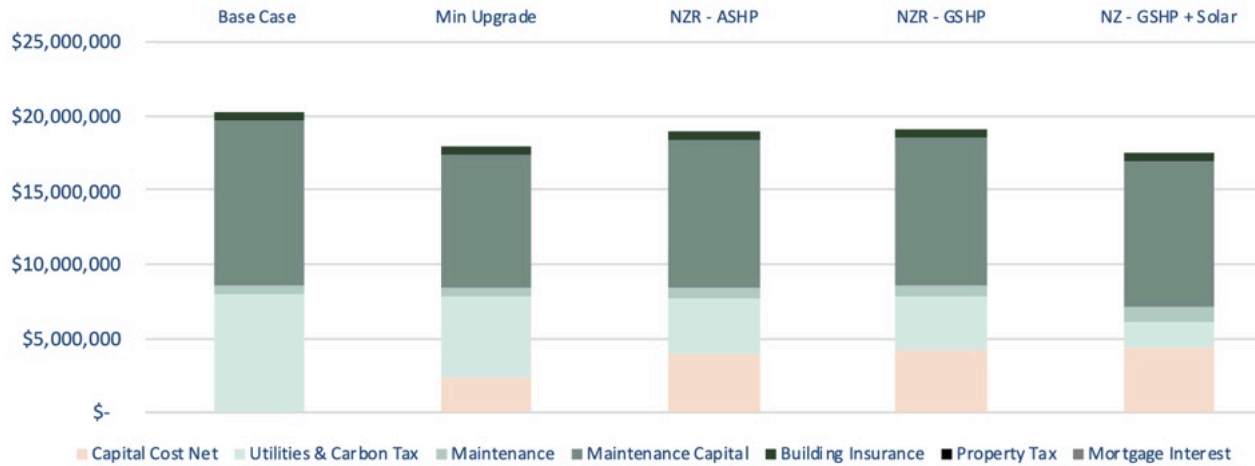
Figure 21 TCBO Comparison

The existing building has the lowest TCBO for the first 36 years, but the Net Zero Energy scenario has lower costs for the remaining life of the building. Operational savings exceed the retrofit costs by 36 years.

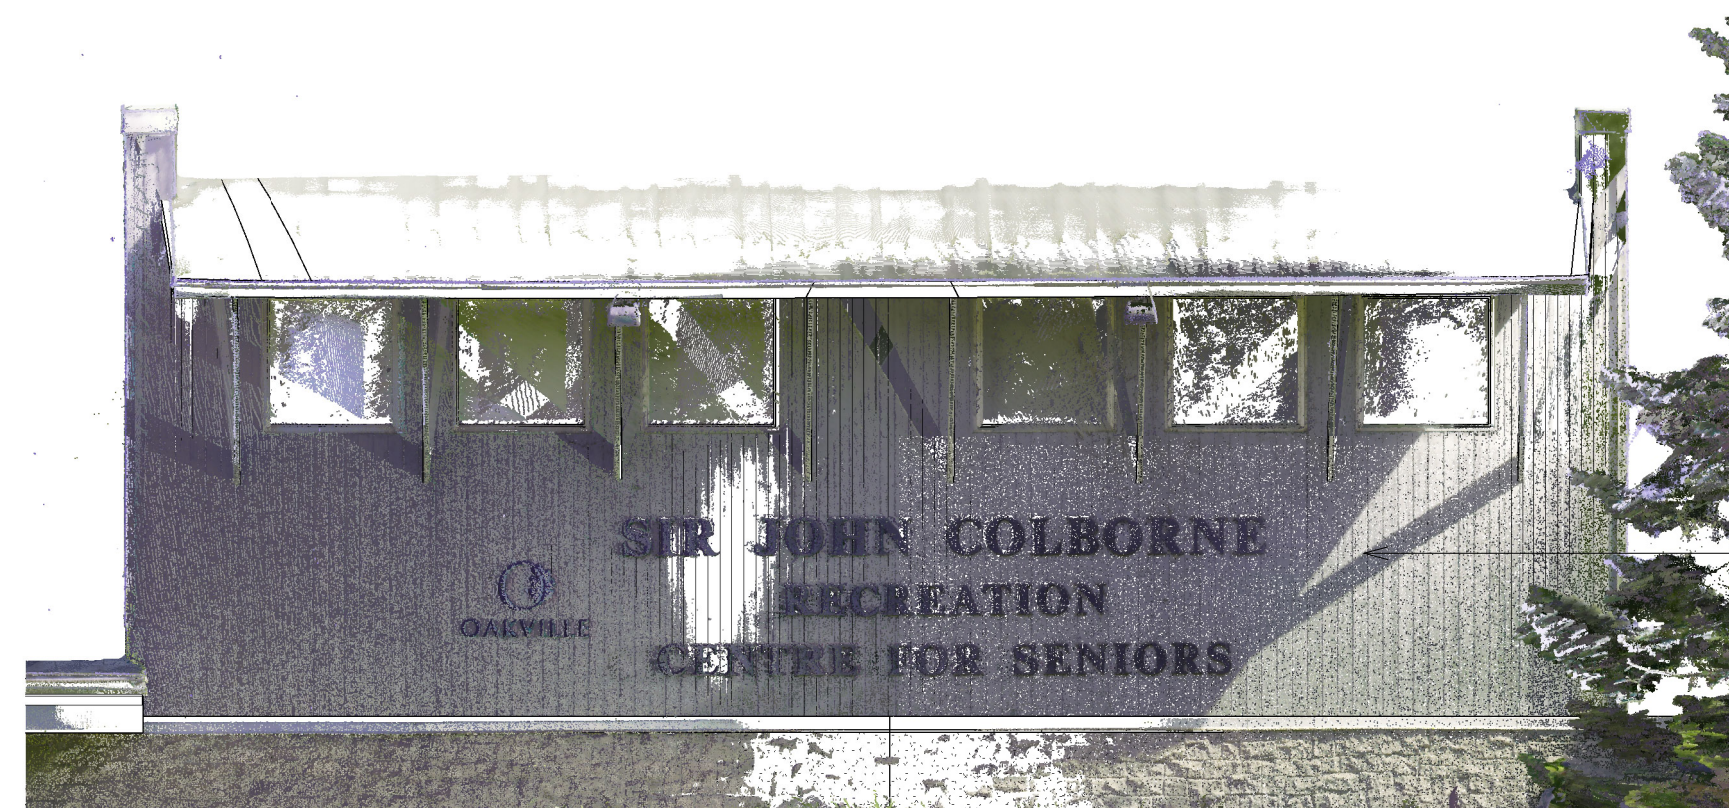
③ SECTION 1  
 3/16" = 1'-0"

BUILDING SIGN ON CURVED WALL

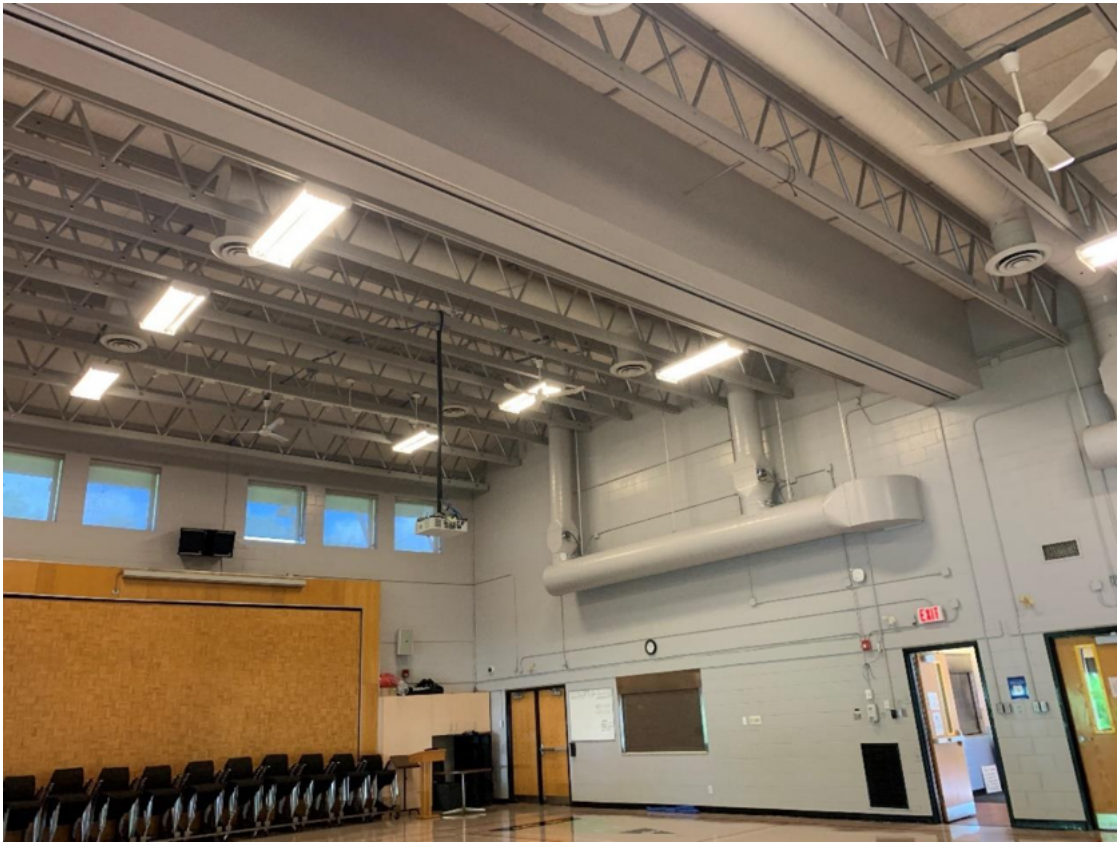
*Figure 3: Roof area A parallel chord trusses.*

Roof area A consists of pre-engineered open web trusses which span approximately 40'-3 1/2" [12281mm] between load-bearing concrete masonry unit (CMU) walls on each side of the auditorium. The trusses consist of parallel timber top and bottom chords, with pinned tubular steel web members and are spaced at 3'-10 1/2" c/c. A photo of the existing auditorium roof structure is shown in Figure 3. The roof features a wave-like profile in this area of the building, with the roof trusses spanning perpendicular to the roof slope. All trusses in this area consist of perpendicular flat top and bottom chords. The roof slope is achieved by varying the elevation of the top chord and sloping the structural deck between adjacent trusses.

As the design of this style of open-web joist with hybrid wood and steel construction is proprietary, it is difficult to accurately quantify the capacity of the trusses without original design drawings or fabrication drawings. It is likely that the trusses were designed to nearly 100% capacity in 1989. Accordingly, it is recommended that if roof panels are added in this area, they shall be designed to span between bearing walls independent from the existing structural trusses.

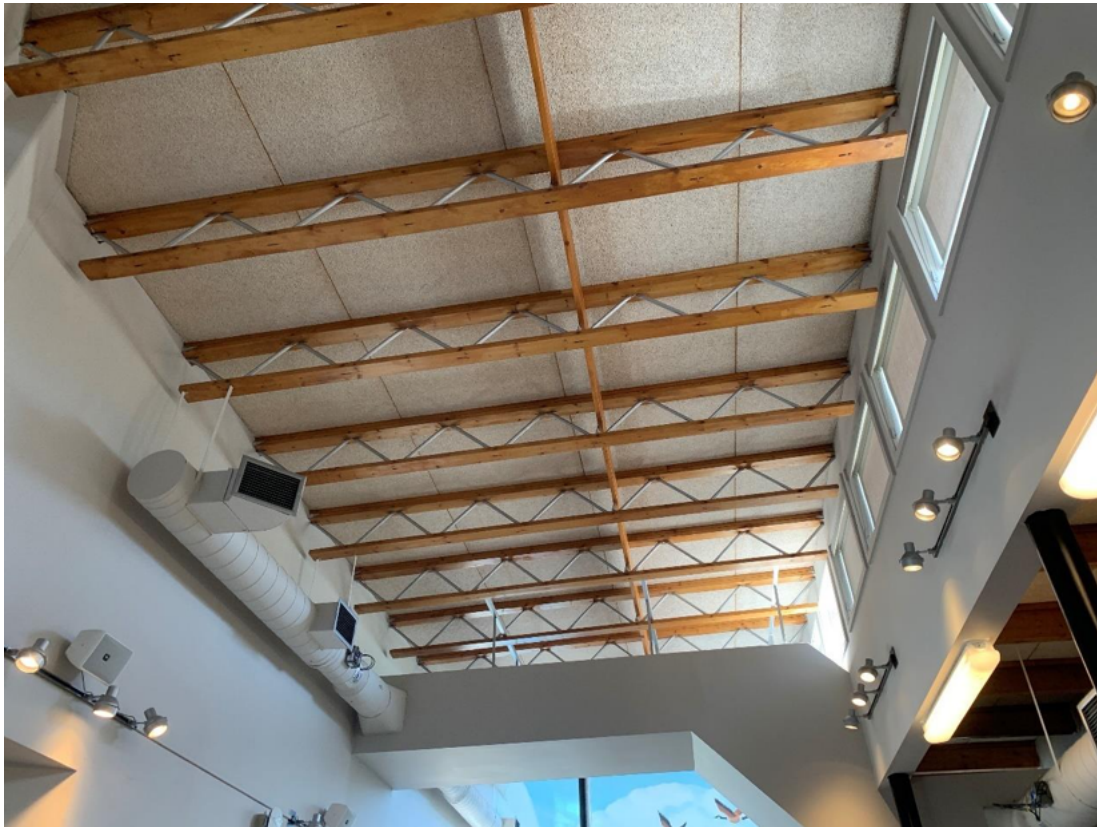
*Figure 4: Roof Area B structure*

Roof area B consists of pre-engineered open web trusses which span approximately 13'-7½" [4153mm] between load-bearing concrete masonry unit (CMU) walls on each side of the auditorium. The trusses consist of parallel timber top and bottom chords, with pinned tubular steel web members and are spaced at 3'-10½" [1181mm] c/c. A photo of the existing auditorium roof structure is shown in Figure 3. The roof features a wave-like profile in this area of the building, with the roof trusses spanning perpendicular to the roof slope. All trusses in this area consist of perpendicular flat top and bottom chords. The roof slope is achieved by varying the elevation of the top chord and sloping the structural deck between adjacent trusses.

As the design of this style of open-web joist with hybrid wood and steel construction is proprietary, it is difficult to accurately quantify the capacity of the trusses without original design drawings or fabrication drawings. It is quite likely that the trusses were designed to nearly 100% capacity in 1989. Accordingly, it is recommended that if roof panels are added in this area, they shall be designed to span between bearing walls independent from the existing structural trusses.

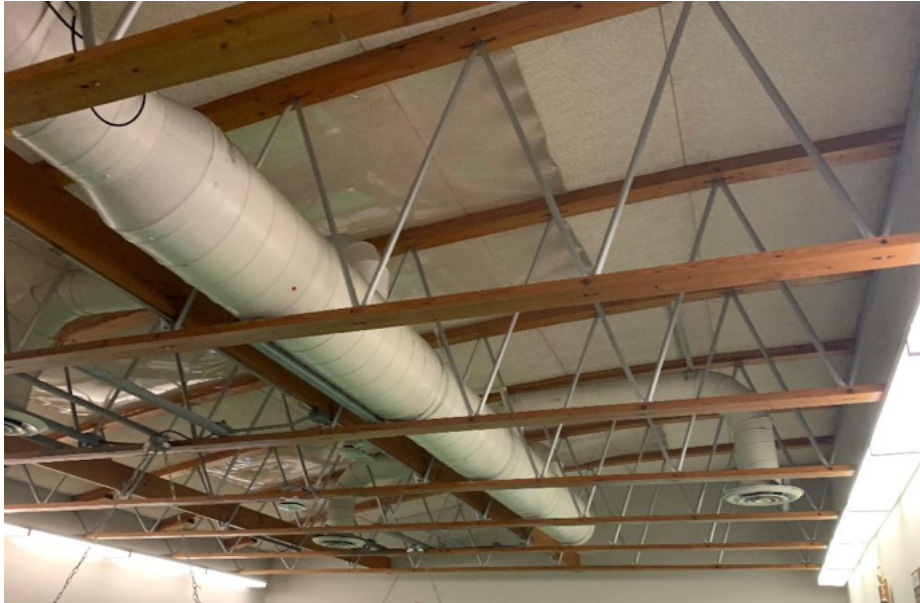
Figure 5: Roof Area E structure.

Roof area E consists of pre-engineered trusses that span approximately 25'-4" between load-bearing stud walls. The trusses consist of a flat timber bottom chord, arched timber top chord, and tubular steel webbing similar to other trusses in the building.

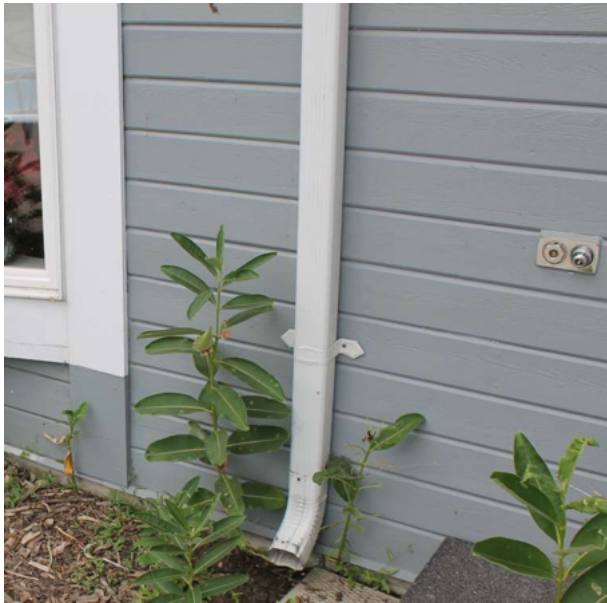
Figure 1 Downspout

Downspouts and gutters provide drainage for the roof system.

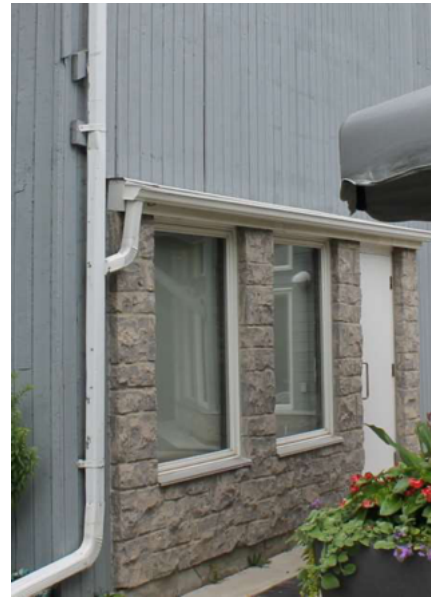
Figure 2 Roof drainage system

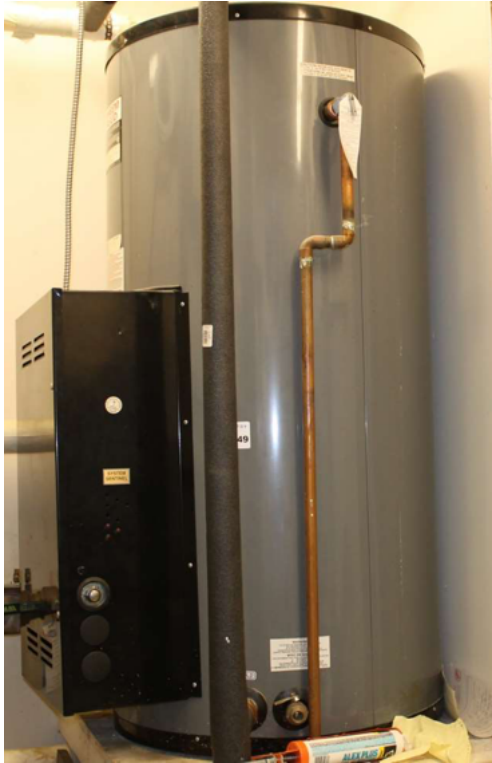
Figure 3 Electric Water Heater

The existing hot water service is provided by an 85-gallon electric water heater. The domestic hot water loop includes an expansion tank and the building has a water meter.

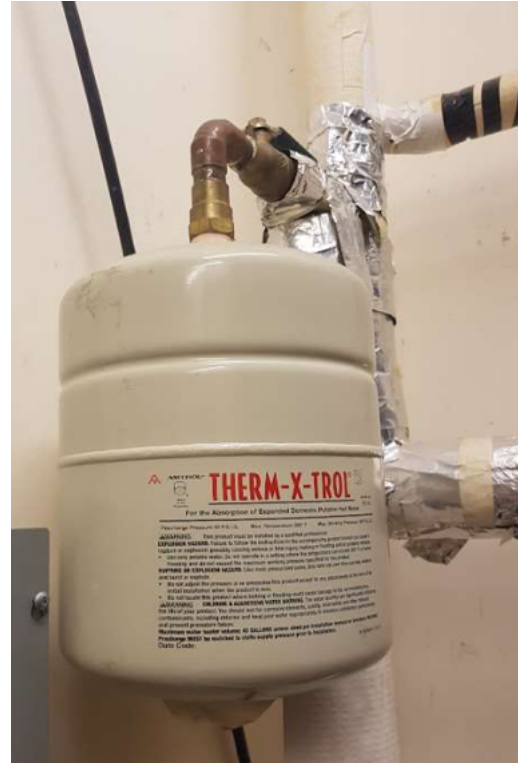
Figure 4 Expansion Tank

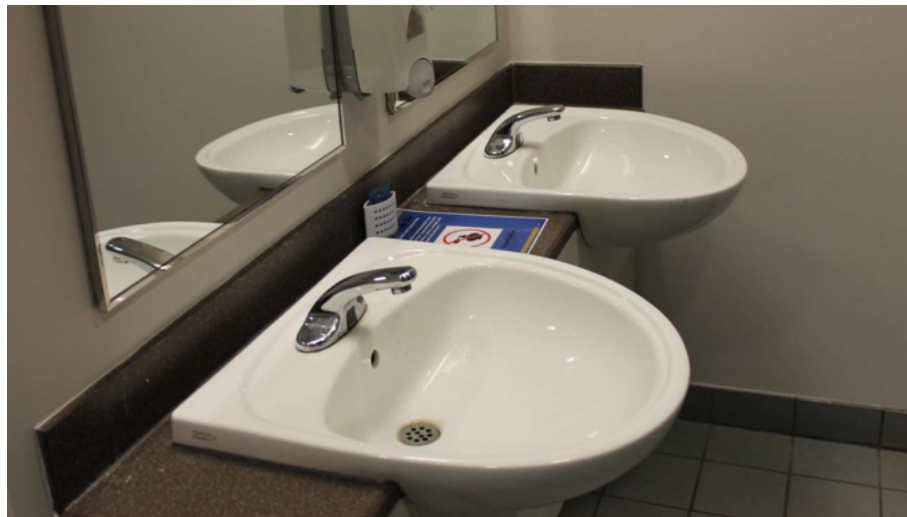
Figure 5 Touchless sinks in men's washroom

The north side of the building includes a men's and women's washroom with a total of six stalls and five touchless faucets with sinks. There is also a single occupancy staff washroom in the office area. A water station has been installed in the main lounge area.

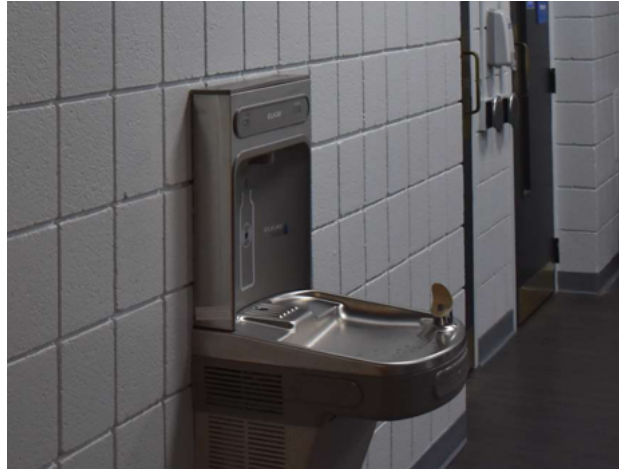
Figure 6 Typical Water Fountain in Facility

Stainless steel water fountains are installed throughout the building.

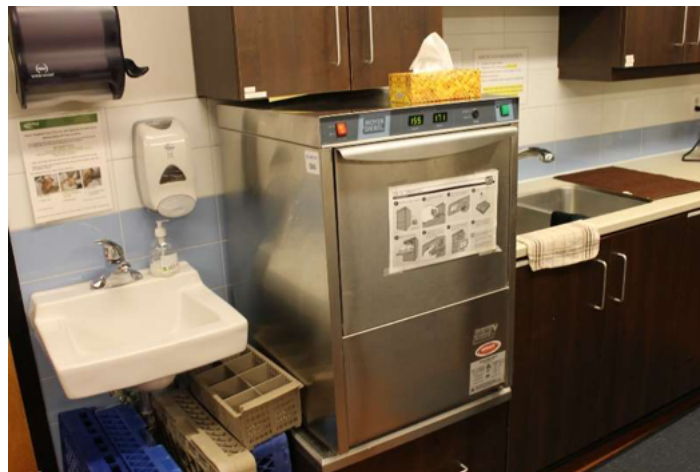
Figure 7 Dishwasher in Kitchen

The kitchen area consists of a commercial dishwasher, two commercial fridges, two coffee machines, a freezer, two sinks, and a residential washer/dryer.

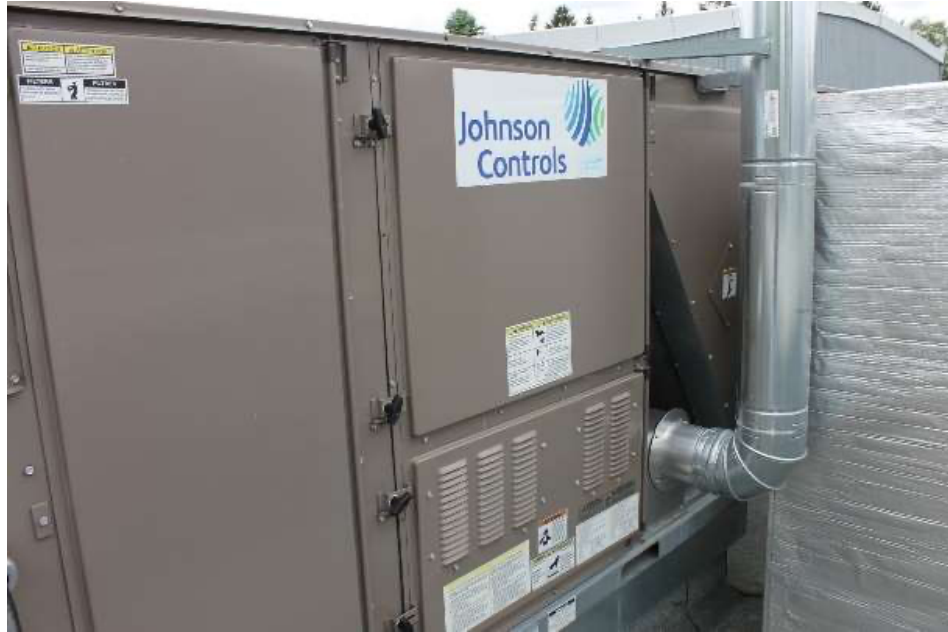
*Figure 12 Rooftop unit*

Space heating and cooling is provided through packaged VAV systems served by two natural gas fired rooftop units. The majority of the building has individual thermal zones for each room with the exception of the auditorium which has been split into four zones.

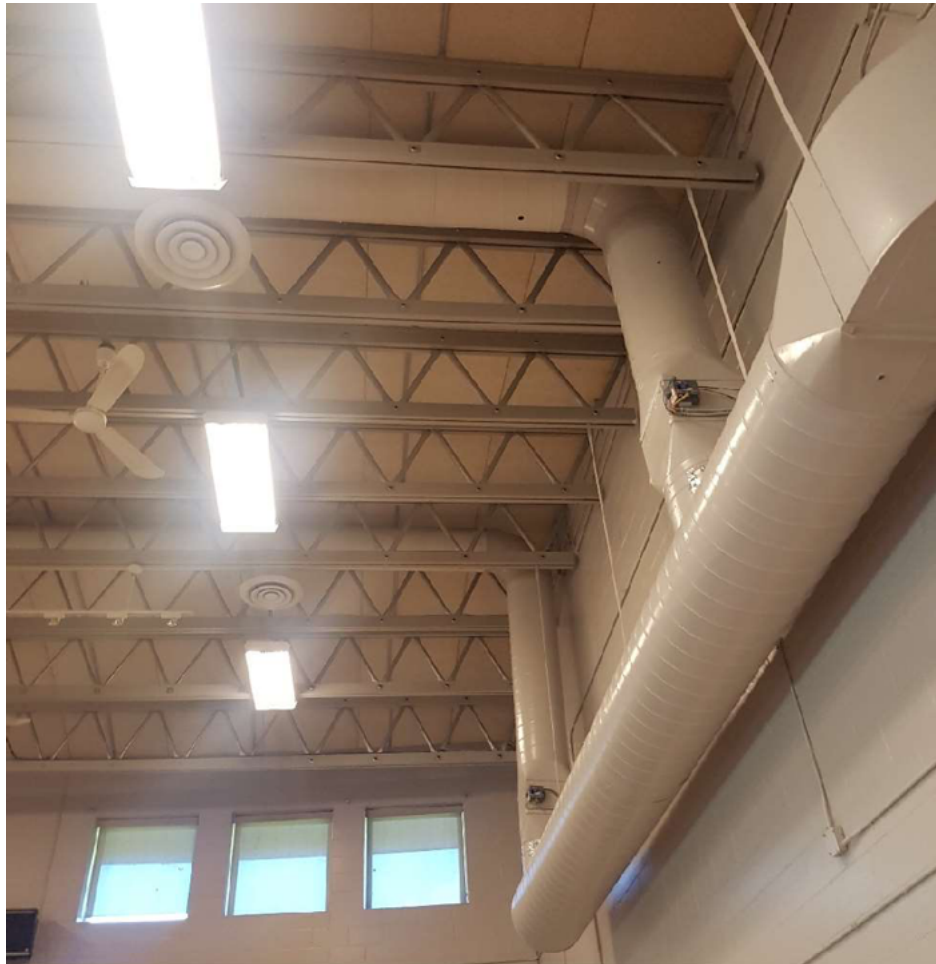
*Figure 13 Auditorium VAV system*

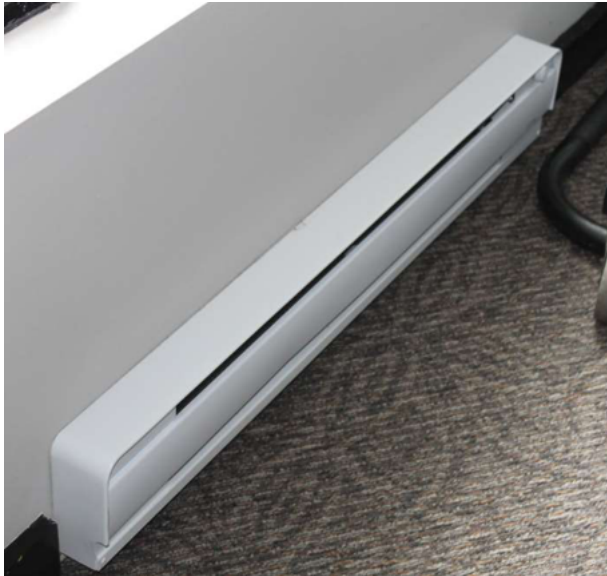
Figure 14 Electric Baseboard

Electric baseboards have been installed in the south side rooms and southeast offices following occupant complaints of being cold. An electric fireplace has also been installed in the main lounge area.

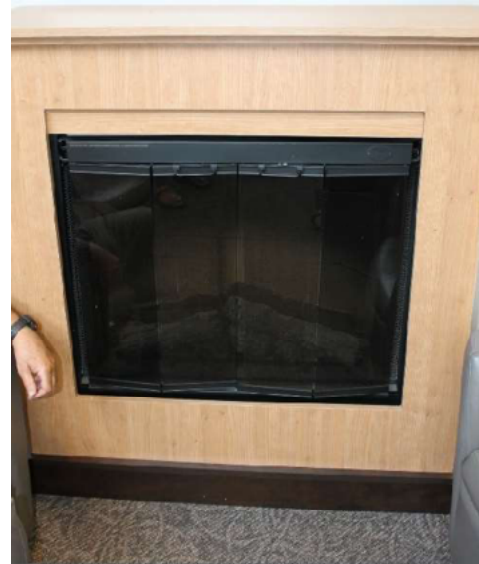
Figure 15 Electric Fireplace in Lounge Area

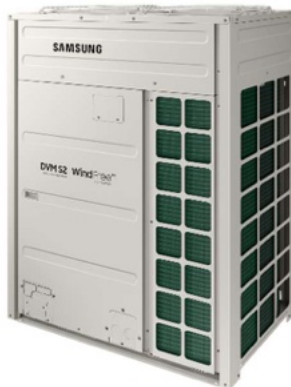
Figure 19 Air Source Cold Climate VRF Heat Pump

The natural gas rooftop units and baseboard heaters will be replaced with a VRF system to heat and cool the entire building.

The VRF system would include refrigerant piping from the condensing units to a branch controller which will then distribute the piping to fan coils units. The fan coils would then tie into the existing ductwork and air would be distributed to each zone. Each fan coil would be hooked up to a thermostat, thus having one fan coil per zone.

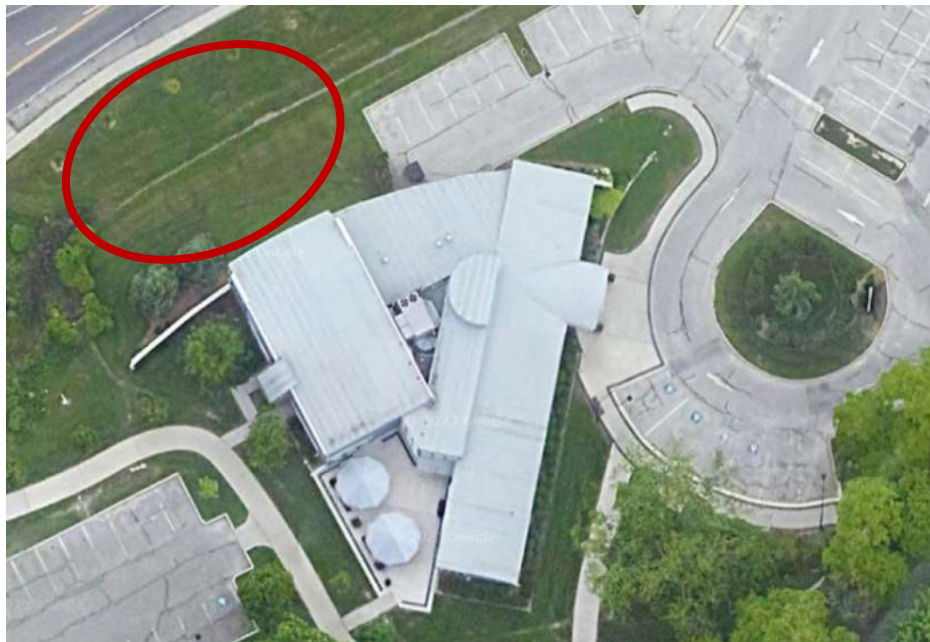
*Figure 23 Proposed Borehole Location*

The boreholes would most likely be located on the north side of the property, refer to Figure 32. However, further analysis must be conducted to confirm the system design.

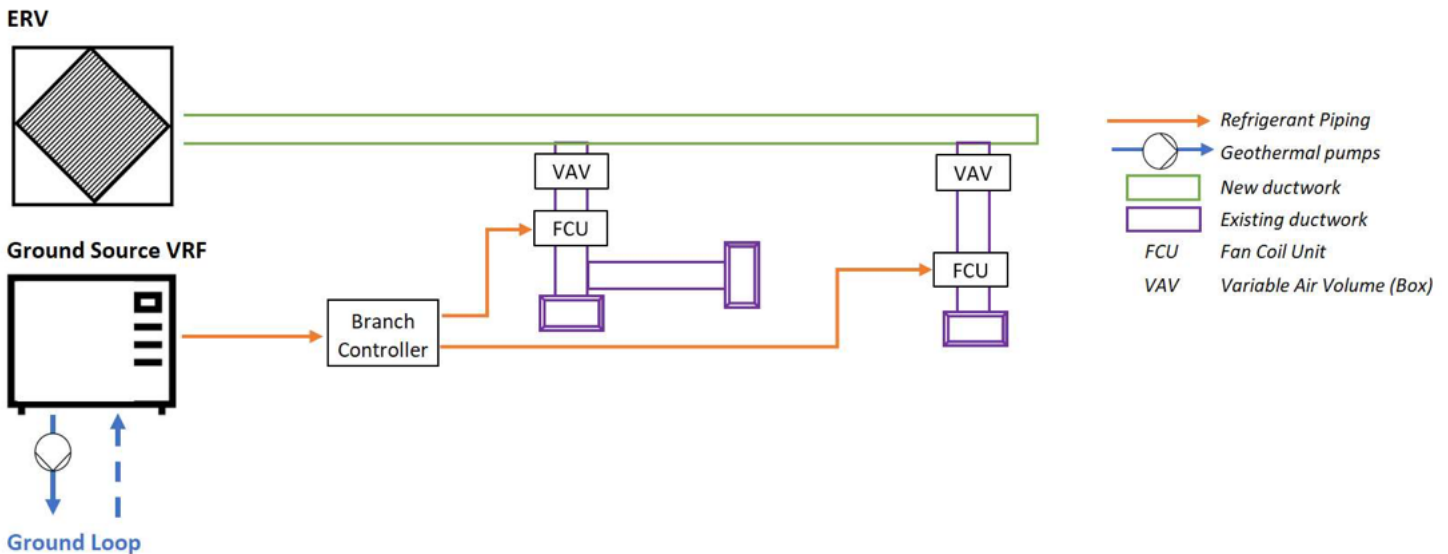
Figure 24 Ground Source VRF System Schematic

- (2) Nominal 10-ton ground/water source VRF condensing units with branch controllers
- (15) 0.5 kW Electric duct heaters
- (15) VAV boxes (100 cfm average)
- Ground Source Circulation Pumps (includes standby pumps)
  - (2) Ground loop circulation pumps, approximately 50 gpm, 2 hp (0.85 bHP) each with VFD
- Fan Coils
  - (2) 2-ton fan coils
  - (3) 1.5-ton fan coils
  - (1) 1-ton fan coils
  - (3) 0.5-ton fan coils
- (1) 350 L/s (750 cfm) ERV with ECM motors and dual cores
- (1) 450 L/s ERV (950 cfm) with ECM motors and dual cores
- (1) 80 gallon packaged heat pump water heater

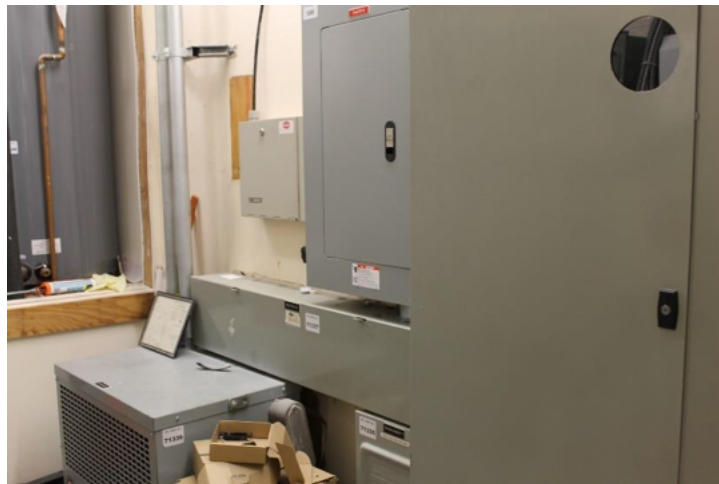
Figure 3: Main 600V Splitter and panels

The existing main distribution is original to the building and consists of a main disconnect, a main 600V splitter and multiple branch circuit panelboards throughout the building. There is also a 120/208V system fed from the 600V system via a step-down transformer. Based on the photos provided, the main distribution equipment appears to be in okay condition. No maintenance logs are available to determine if any work has been completed done throughout the years. It appears the main distribution equipment is near its end of life.

The main building disconnect is a 80% rated 400A fused disconnect switch fused at 300A. All other disconnects for panels, motors etc. are also fusible disconnects. Visually the disconnects appear to be in okay condition. Based on the photos provided of the main electrical room, it appears the room is nearing capacity and additional space may be required to add on additional electrical distribution in the future.

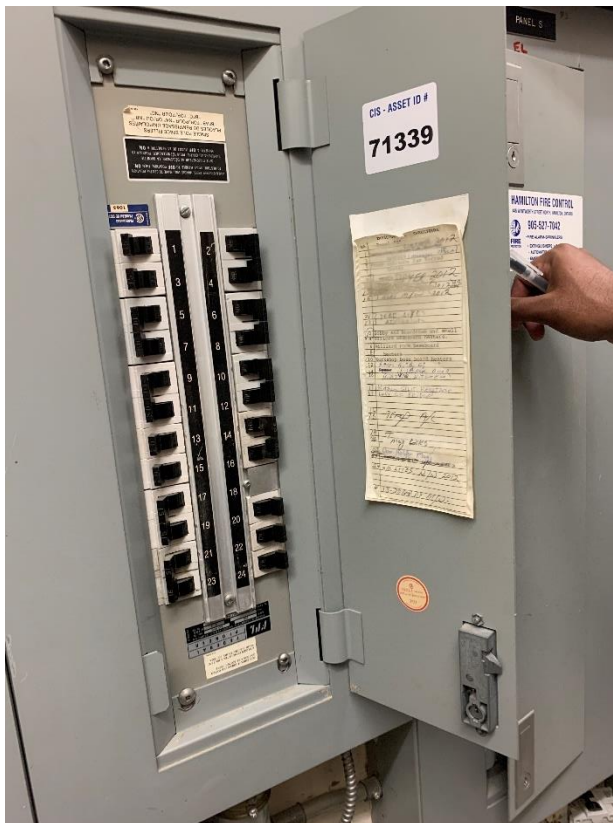
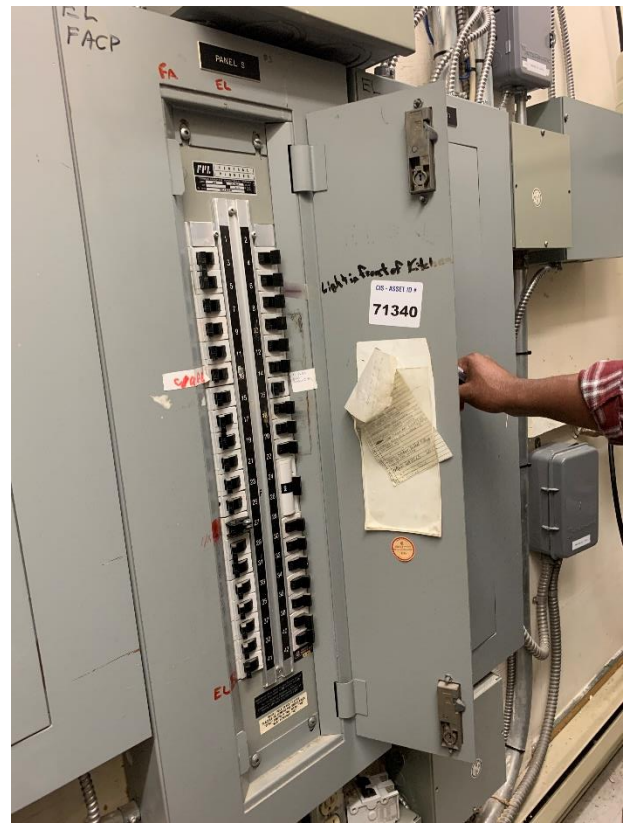
Several 120-208V and 347-600V branch circuit panelboards exist throughout the building servicing all areas. All panelboards appear to be original to the building and range from okay to good condition. No mini breakers are present in the existing panelboards. Based on the photos provided, there is extremely limited breaker space available for additional equipment. Depending on the scope of electrical changes, additional distribution may need to be added. Some panels appear to have breakers installed that are no longer in use, which could be removed to allow room for new distribution and branch circuits.

Figure 4: Branch Circuit Panelboard

Figure 5: Branch Circuit Panelboard

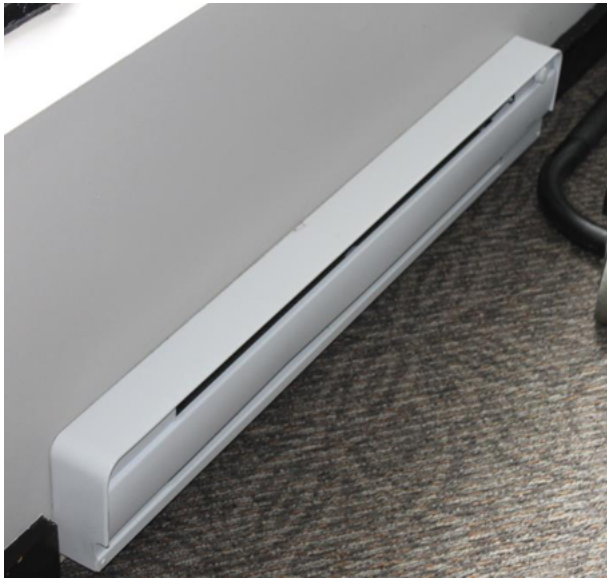
Figure 6: Existing Baseboard Heater

Electric baseboard heaters are located throughout the building perimeter to support the main heating system which consists of several rooftop units and a VAV system. The baseboard heaters do not appear to be original to the building. The heaters are in good condition and well within their life expectancy. There is also an electric fireplace in the lounge although this does not appear to be used often.

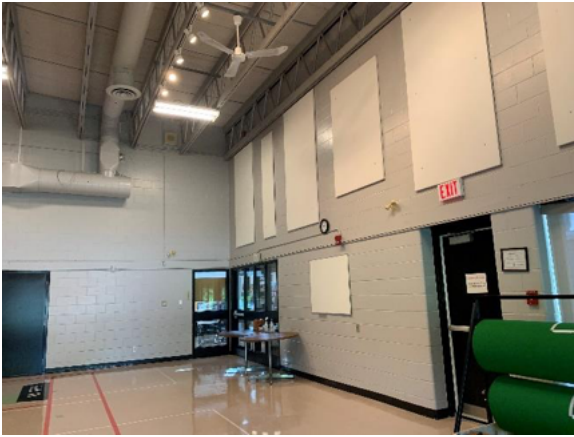
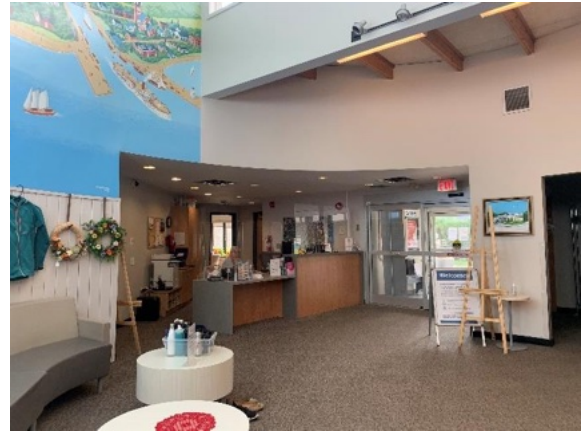
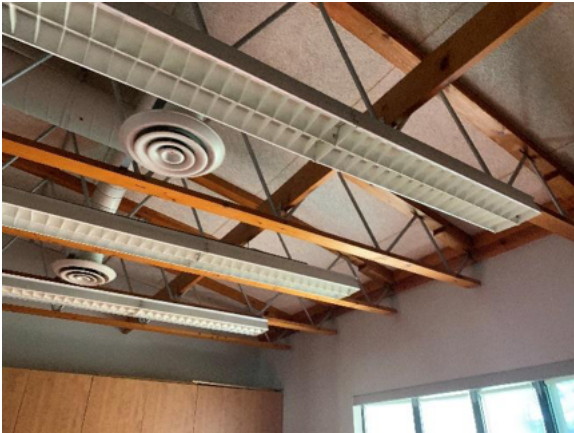
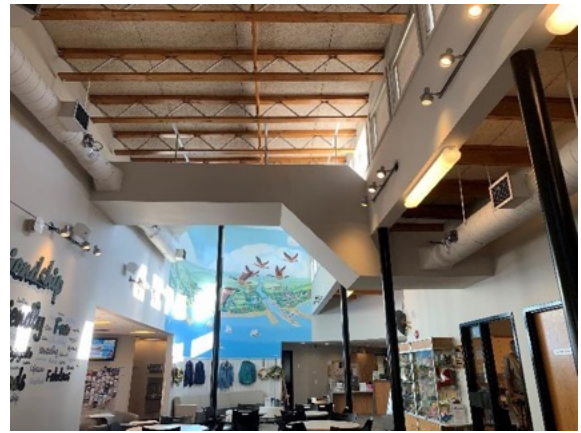
The building serves many different functions and as a result has many different types of lighting throughout. The majority of the fixtures are either rectangular or linear fluorescent fixtures with T8 lamps. The fixtures appear to be well-maintained and in okay to good condition depending on the area of the building. There are also multiple areas with track lighting and or downlights throughout the building. Most of the existing fluorescent lighting appears to be within its reasonable life expectancy. The estimated LPD for the areas with fluorescent lighting is 11W/m<sup>2</sup>.

Figure 8: Gymnasium Lighting

Figure 9: Lobby Lighting

Figure 10: Multipurpose Room Lighting

Figure 11: Lobby Track Lighting

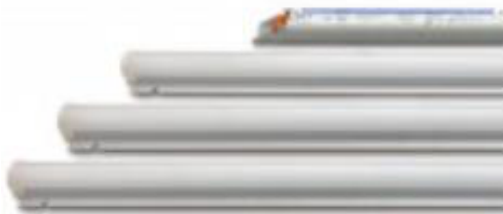
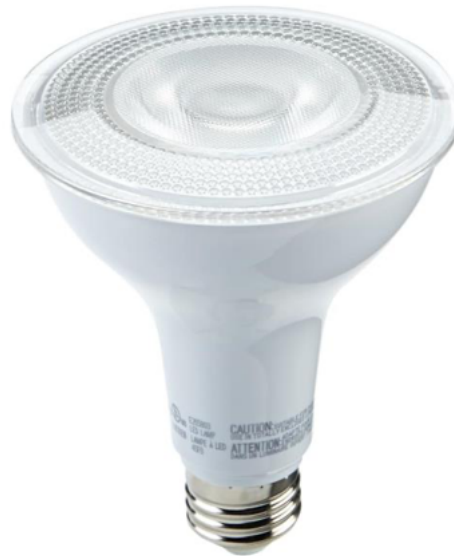
In the minimum acceptable scenario, all existing fluorescent lighting throughout the building should be upgraded to LED using LED lighting retrofit kits. These kits come complete with LED replacement lamps and ballasts so the existing fixtures throughout the building can be internally re-wired to work with LED lamps. This will allow the existing building lighting to remain in the same areas and will reduce maintenance. In the case of downlights and track lighting, new LED bulbs will be provided. New LED retrofit kits and bulbs will be provided on an as needed basis depending on the type of fixture. These changes will help lower the existing LPD by 40% to  $7\text{W}/\text{m}^2$ .

Figure 12: LED Retrofit Kit Tubes

Figure 13: LED retrofit Bulbs

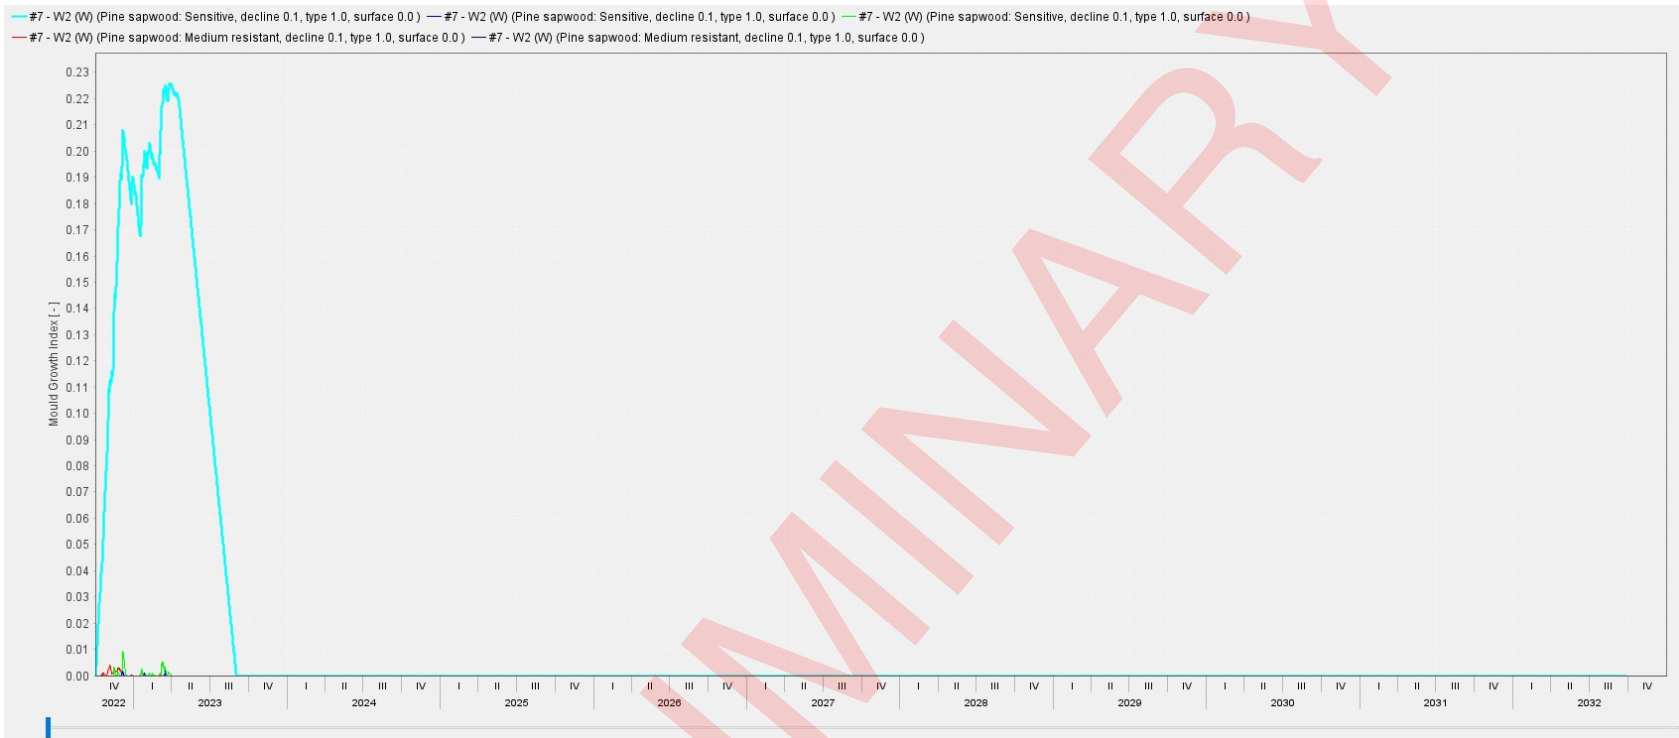
Figure 10 – WUFI® output for W2 wall assembly: VTT mold growth index simulation over 10-year period studied for post-retrofit Recreation Centre West wall assembly’s plywood and cellulose layers  
 (blue: outer plywood; green: center plywood; light blue: inner plywood; red: outermost cellulose element; black: innermost cellulose element)

For mold-related durability, a VTT simulation was again conducted to simulate the mold growth index at the specified locations within the plywood layers as well as the outermost and innermost elements of the cellulose layer. Using the same assumptions as per the W1 wall assembly's simulations, the results of the W2 wall assembly VTT simulation indicate a green VTT traffic light in all locations simulated (**Figure 10**).

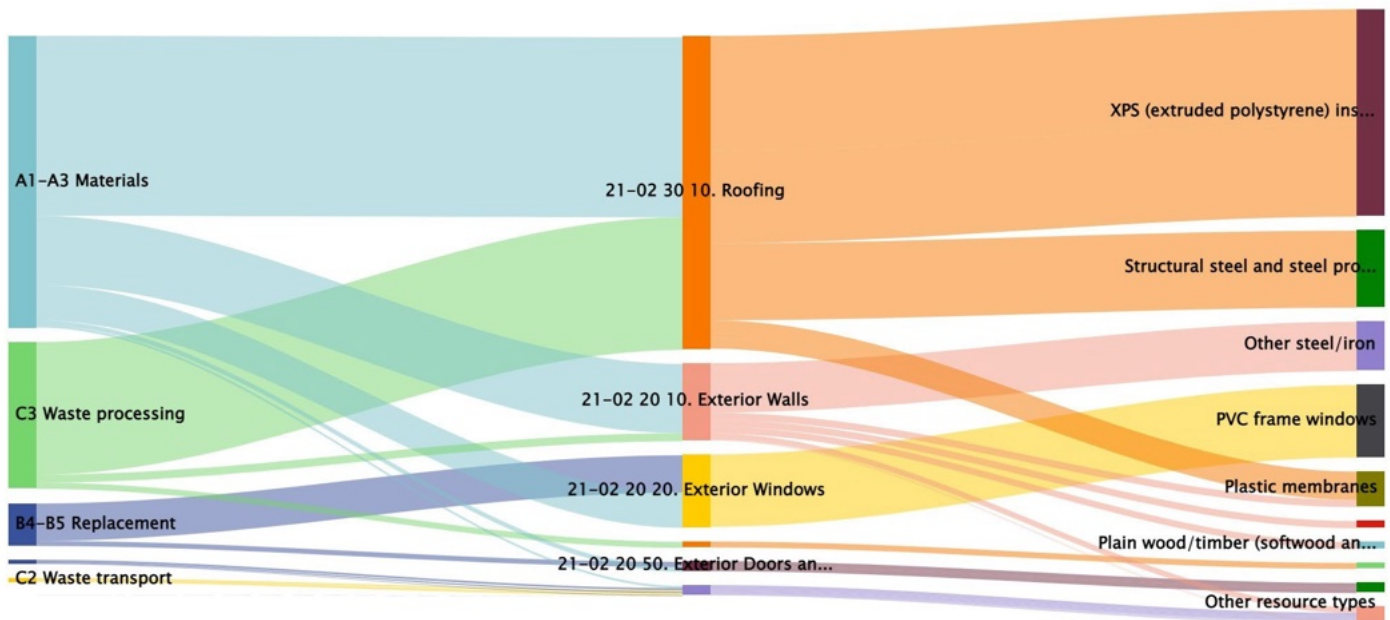
**Figure 1: Oakville retrofit design breakdown of the life cycle stages and the associated materials**

The major contributors to the GWP in this design are the metal roofing and cladding as well as the XPS foam roof insulation. The A1-A3 Materials stage contributed 60% of the total carbon emissions associated with this building as illustrated in Figure 1 & 2. The biogenic carbon of this building offsets 32% of the total A1-C4 carbon emissions. This storage is attributed to the wood products (73%) and cellulose insulation (27%) used in the assembly as shown in Figure 3. The results graphs below show the breakdowns of life cycle stages and impact categories associated with the building materials.

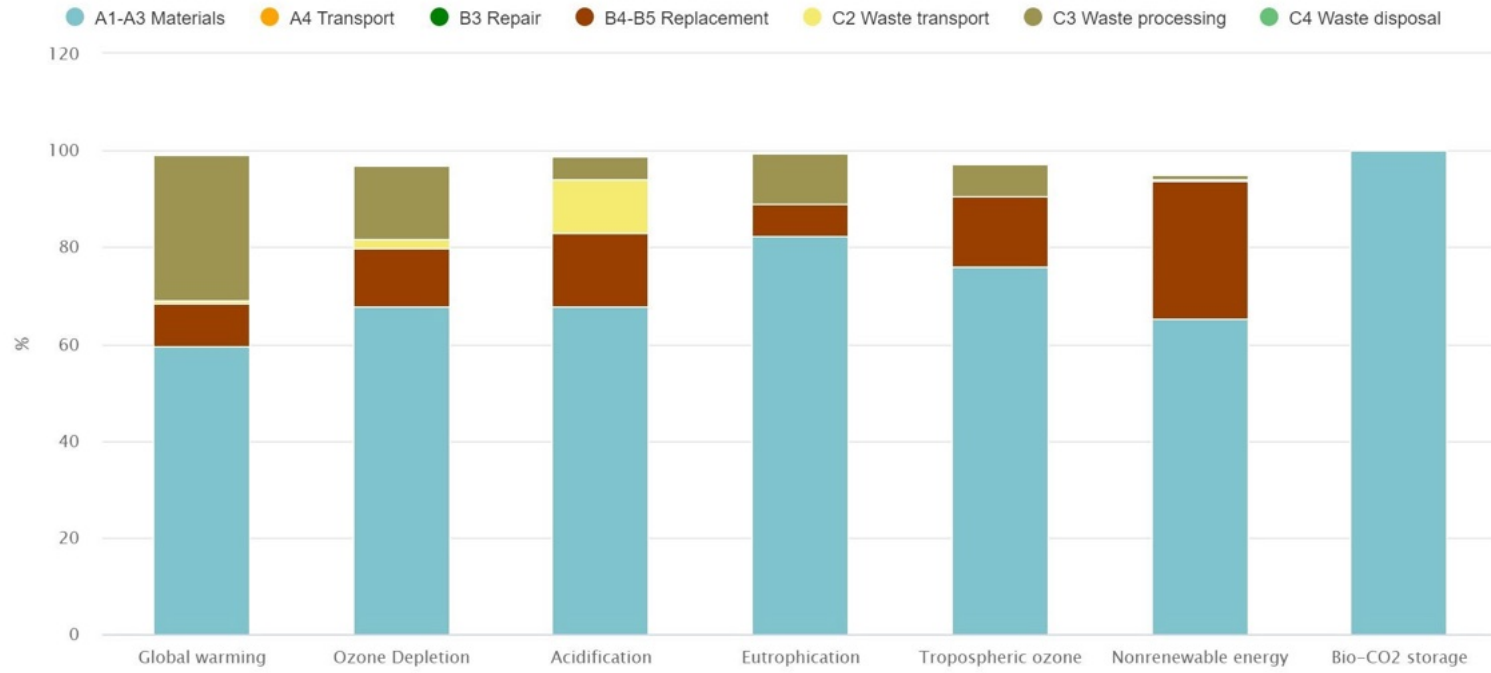
**Figure 2:** Oakville retrofit design breakdown of the life cycle impact categories and the associated life cycle stag
