# PANELIZED DEEP RETROFITS OF MUNICIPAL BUILDINGS

## Sir John Colborne Recreation Centre for Seniors Case Study Report

Issue Date: September 30, 2023

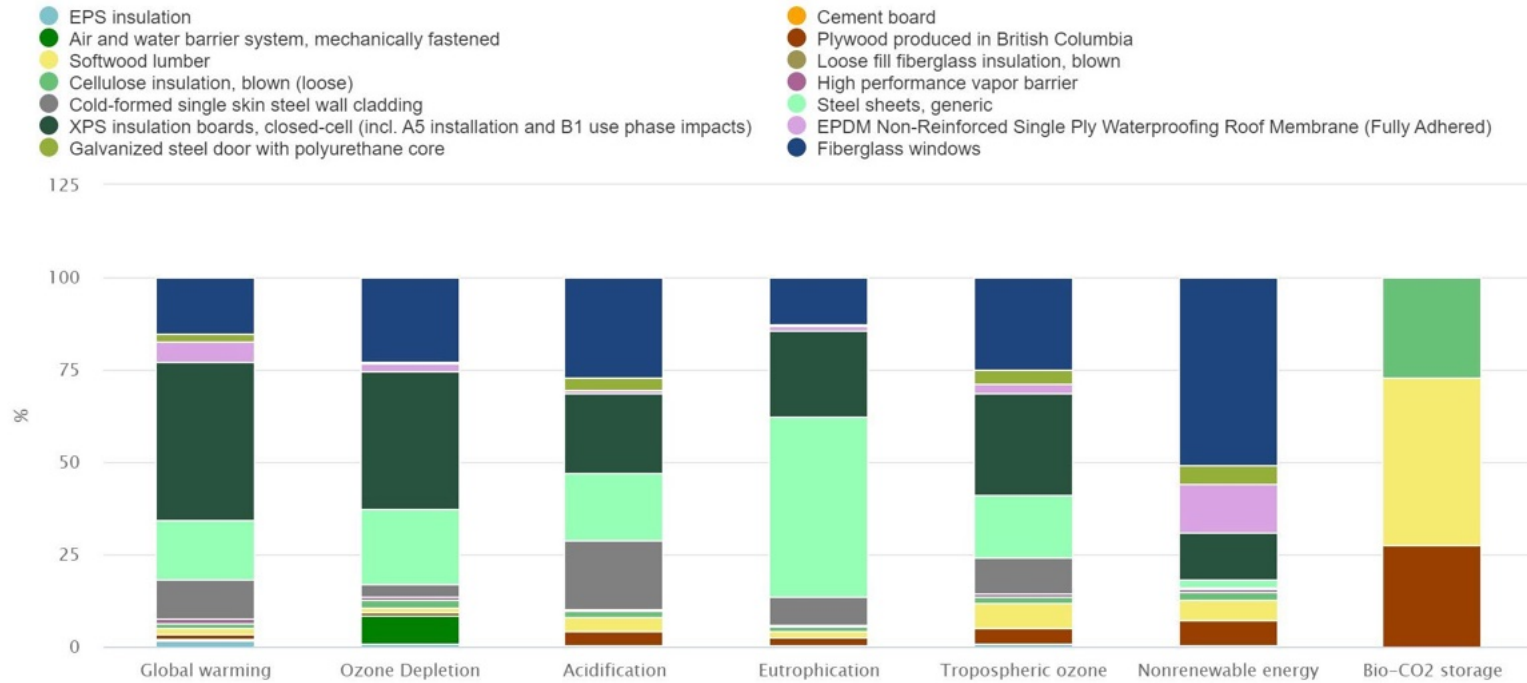
**Figure 3:** Oakville retrofit design breakdown of the life cycle impact categories and the associated materials
