### Wall Panel Schematics

Cellulose - R28 - 2x10 - 1/2" Plywood

**ReCover Initiative**

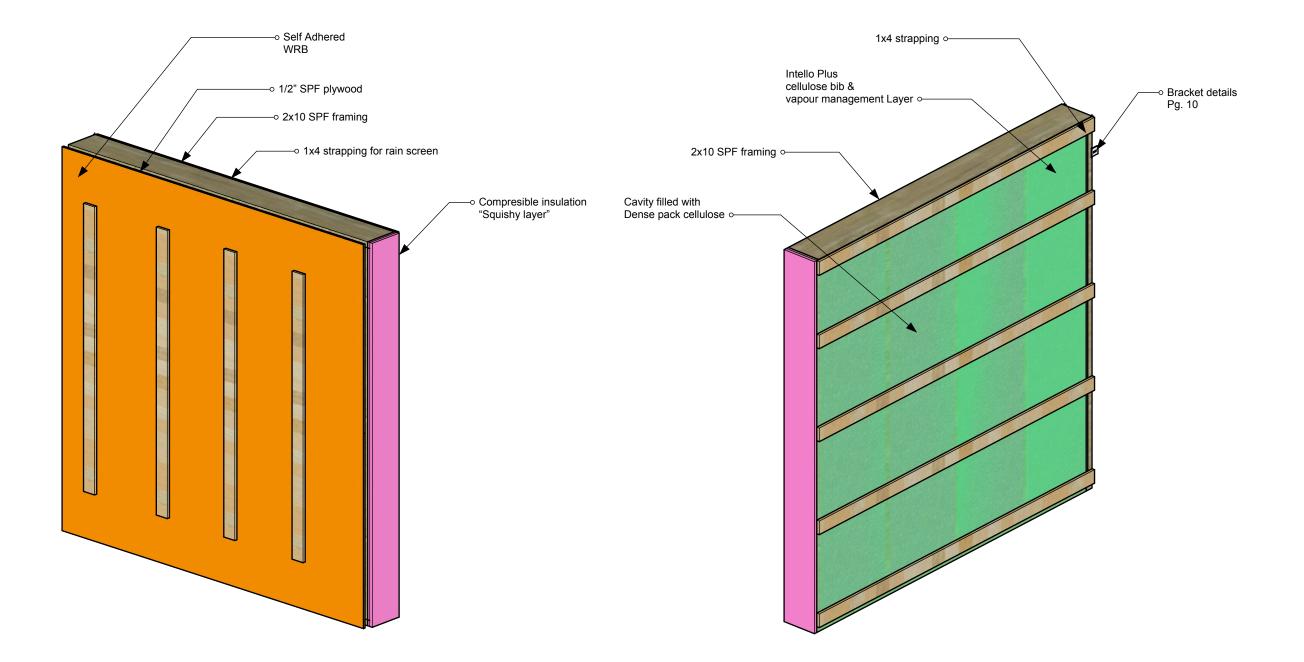
### **Basic Panel - Overview**

EXTERIOR VIEW INTERIOR VIEW

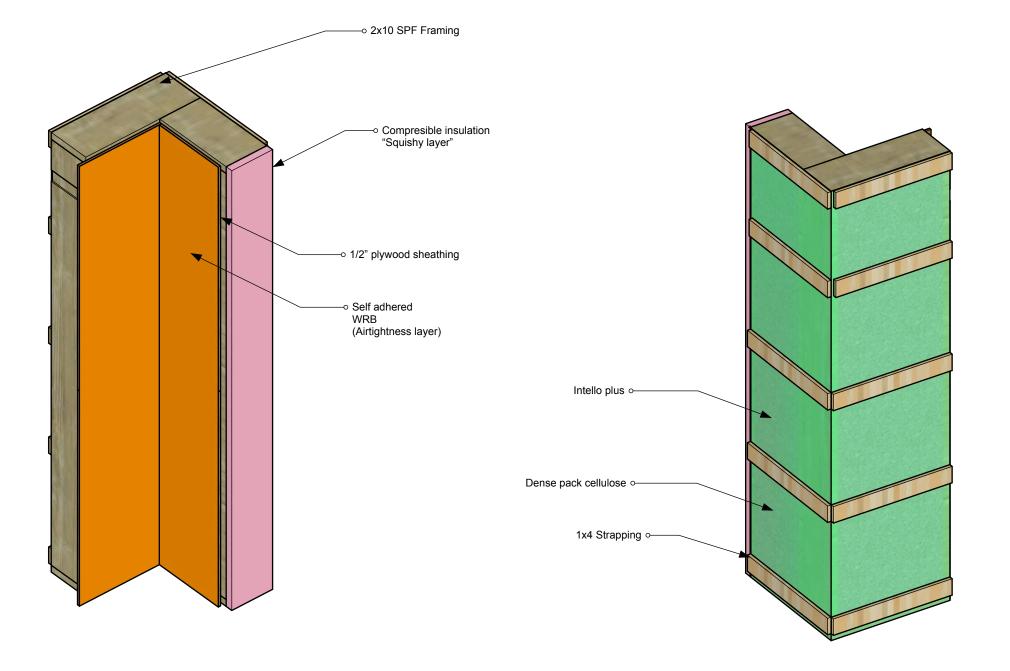
### Inside Corner Panel - Overview

EXTERIOR VIEW INTERIOR VIEW

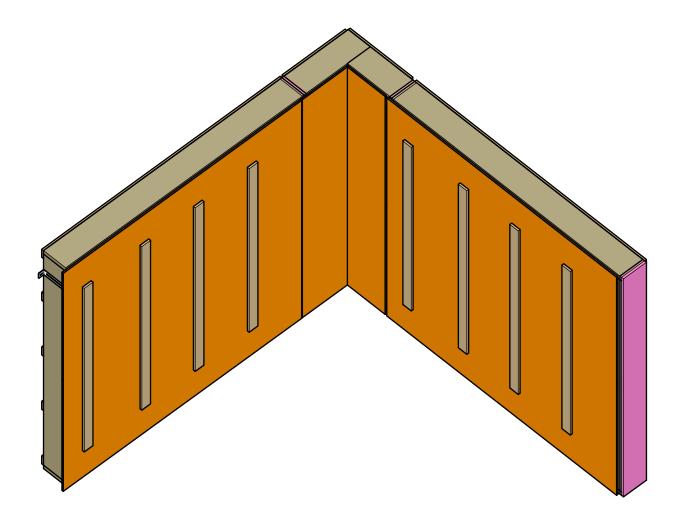
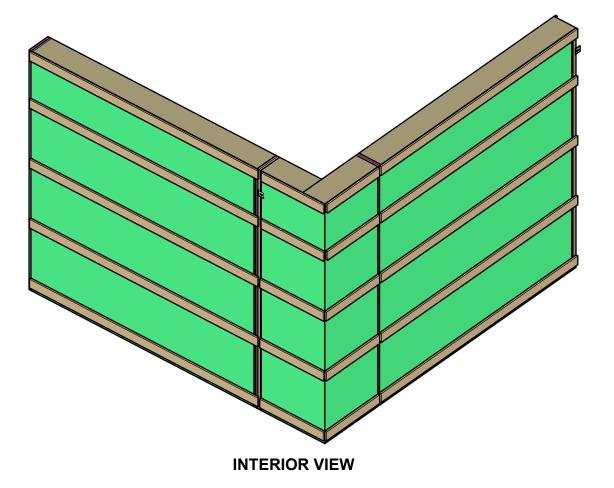
### Inside Corner Installed

**EXTERIOR VIEW**

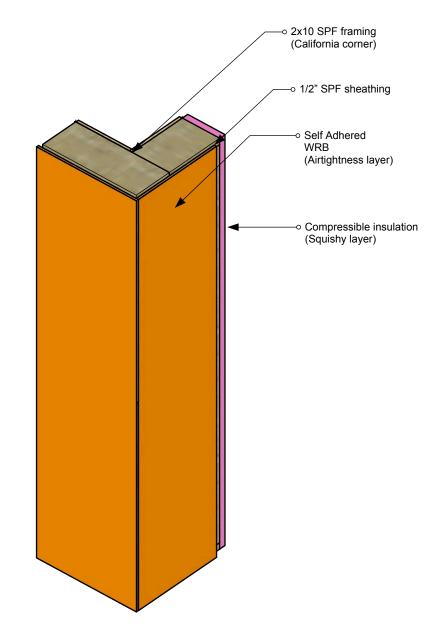
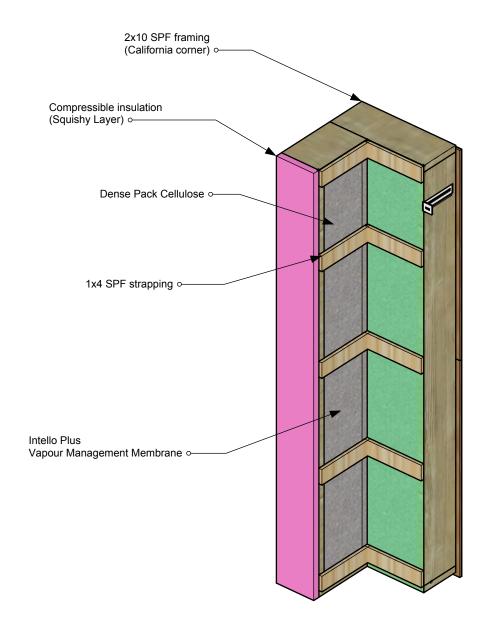
### Outside Corner Panel - Overview

EXTERIOR VIEW INTERIOR VIEW

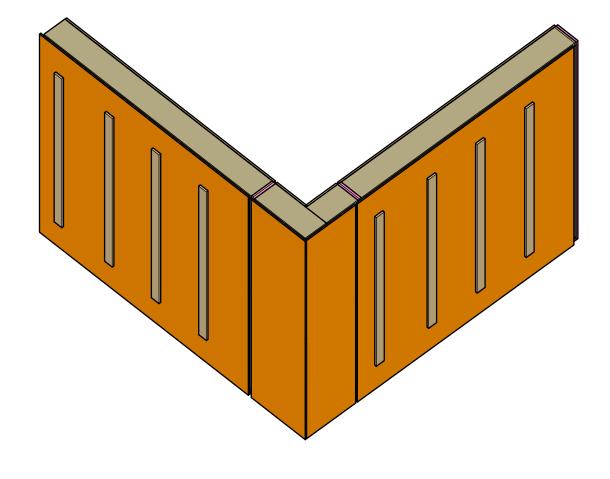
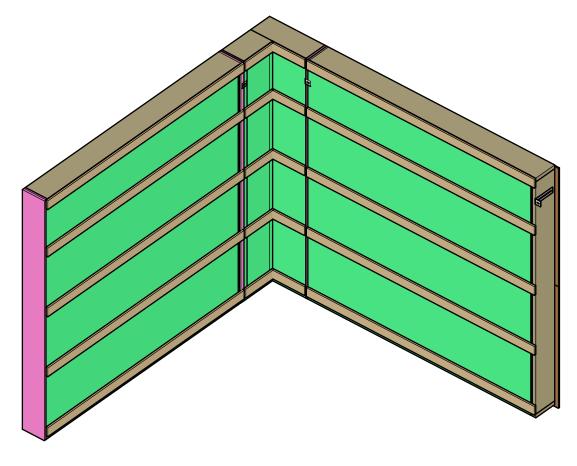
### Outside Corner Installed

**EXTERIOR VIEW**

**INTERIOR VIEW**

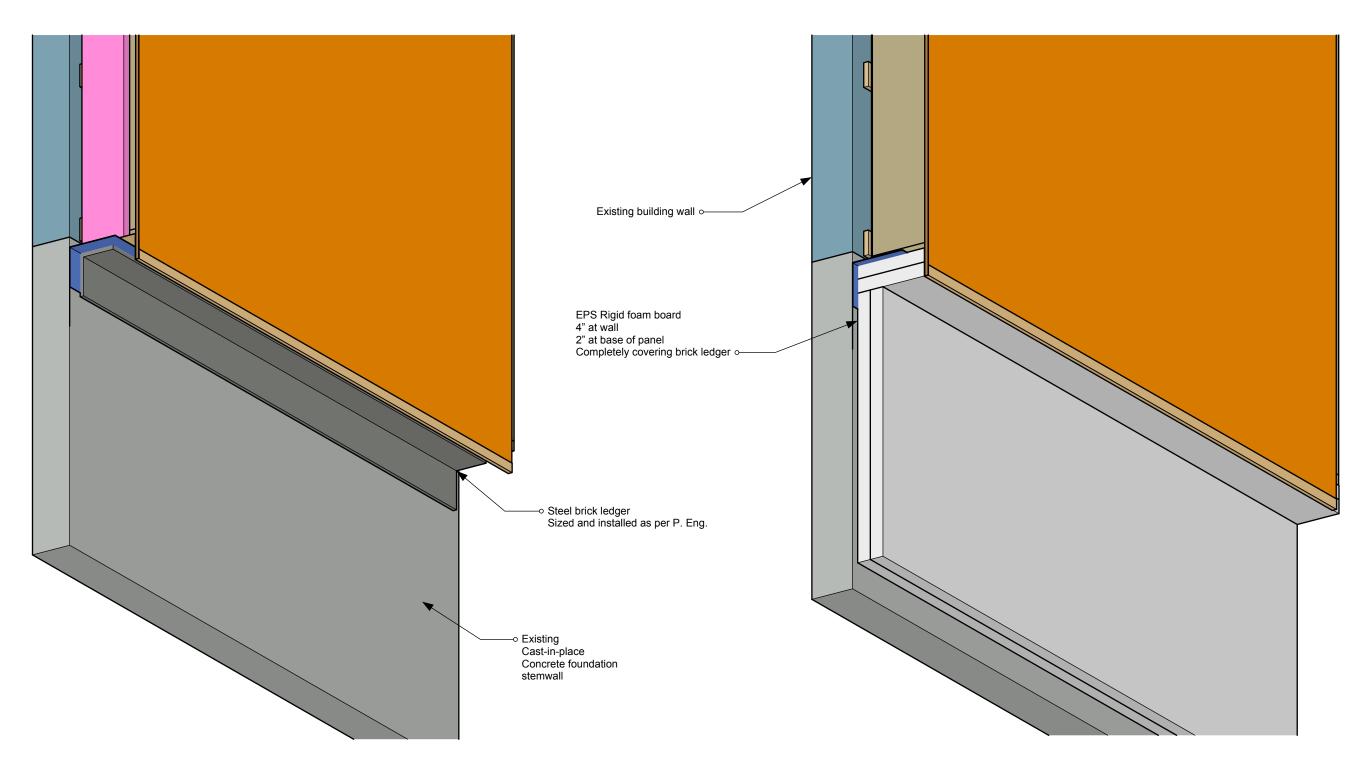
### Foundation Attachment - Brick Ledger

**BEFORE SITE INSULATION**

"Brick Ledger" style continuous ledger for panel support

**AFTER SITE INSULATION**

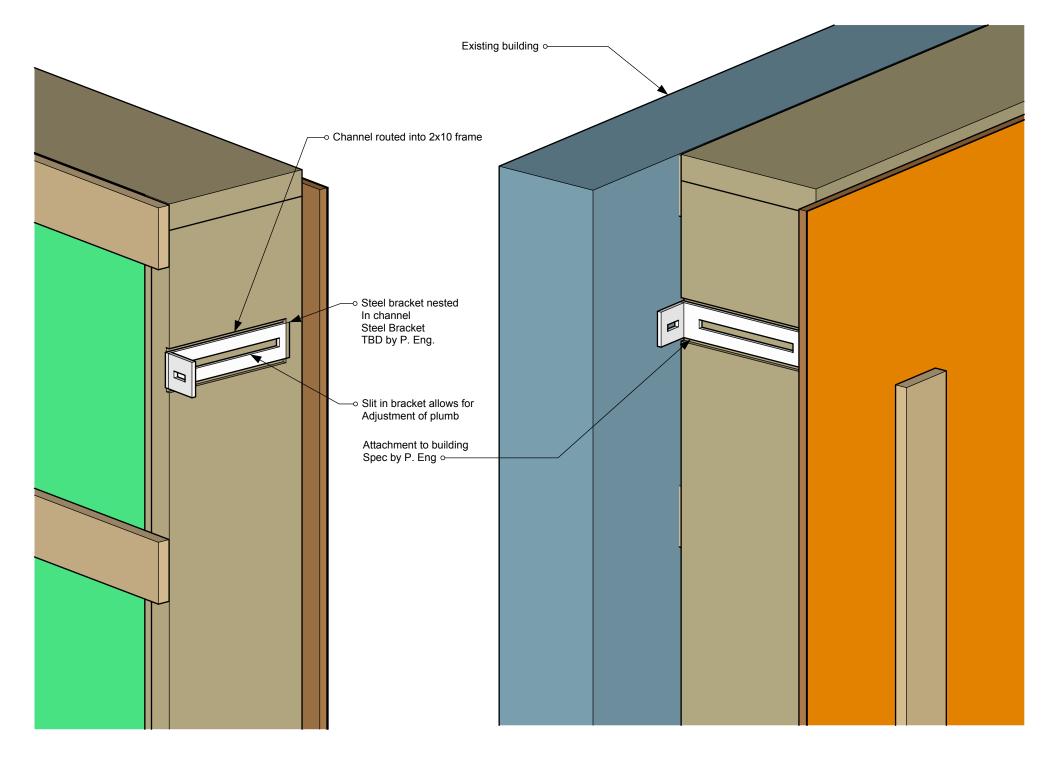
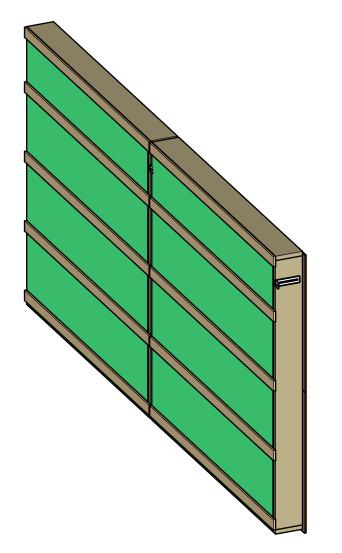
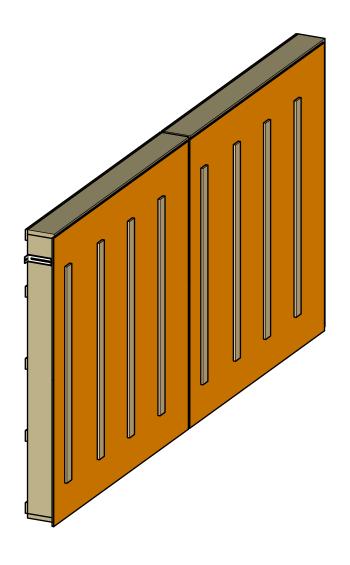
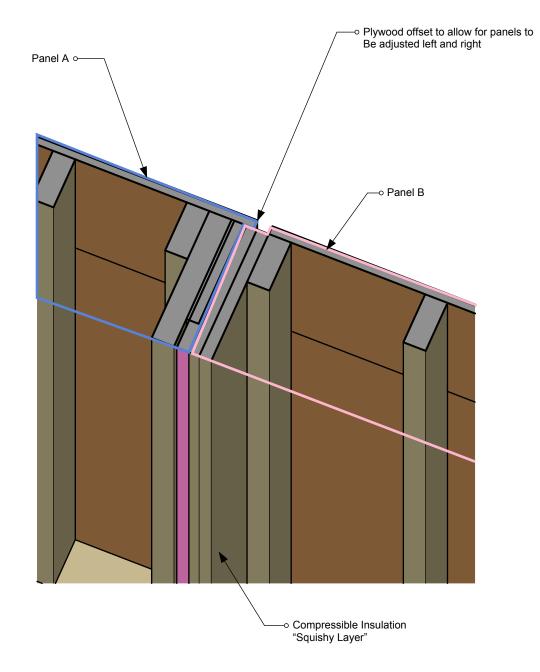
### Attach to Existing Building

Bracket to attach individual panels to existing

INTERIOR VIEW EXTERIOR VIEW

INTERIOR VIEW SECTION VIEW

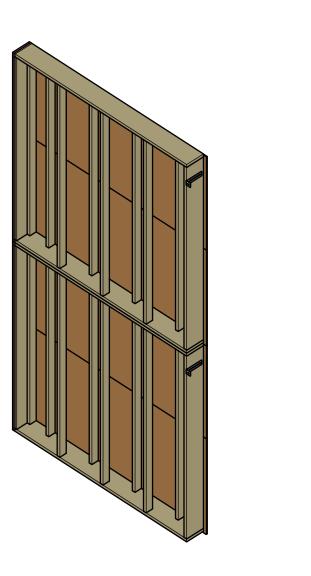
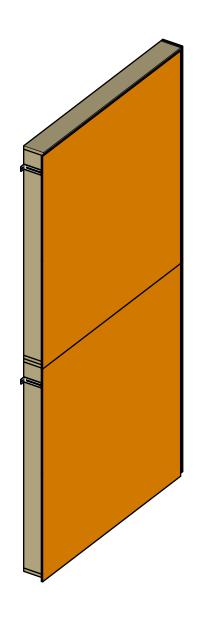
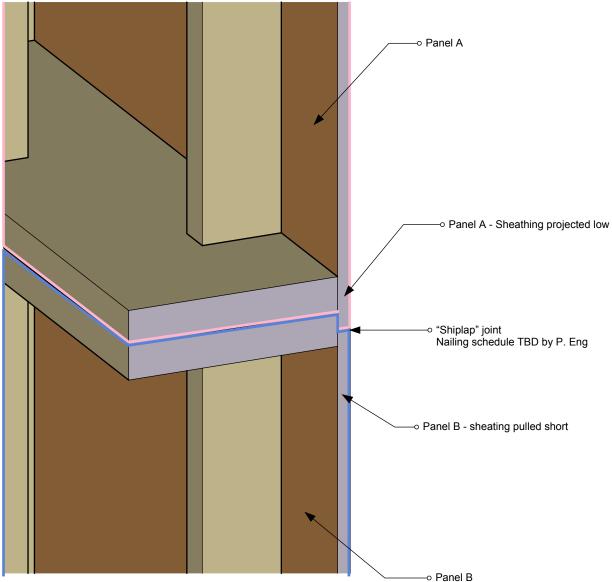
### Horizontal Wall Joins

INTERIOR VIEW EXTERIOR VIEW SECTION VIEW

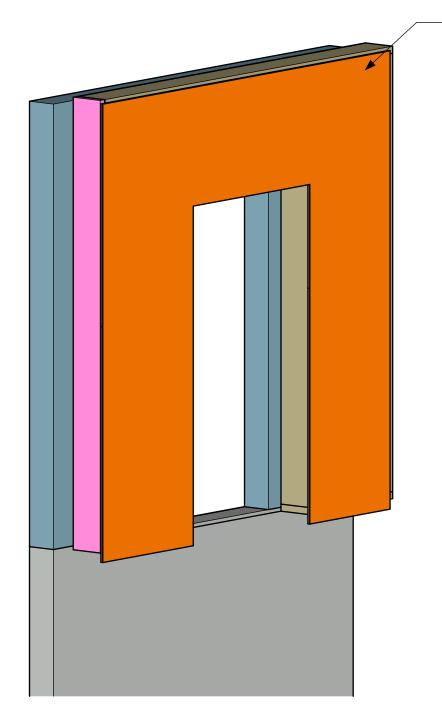
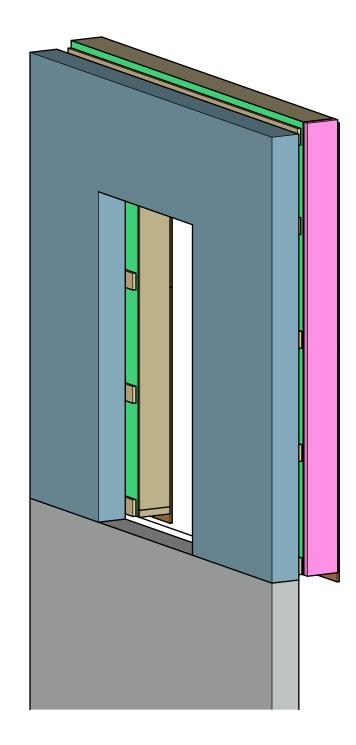
#### **Door Penetration Panel**

EXTERIOR VIEW INTERIOR VIEW

Door panel Installed without door in place

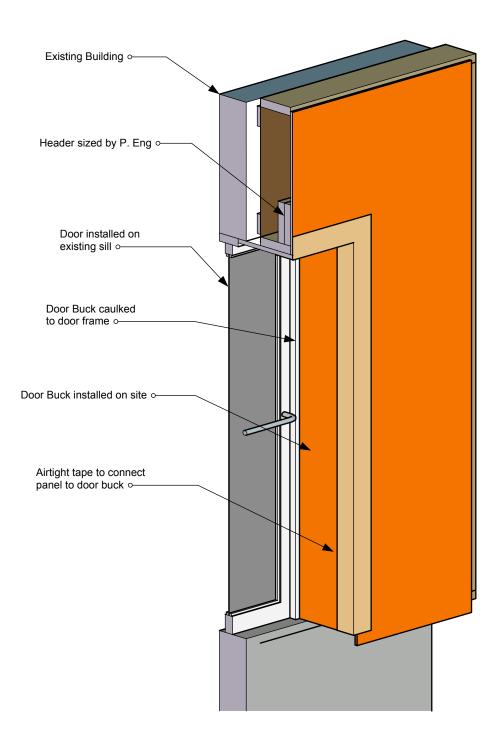
Door installed on existing sill

EXTERIOR VIEW INTERIOR VIEW

**SECTION VIEW**
