Roof Panel Schematics

Cellulose Inverted Roof - R38 - 2x8 - DensGlass

ReCover Initiative

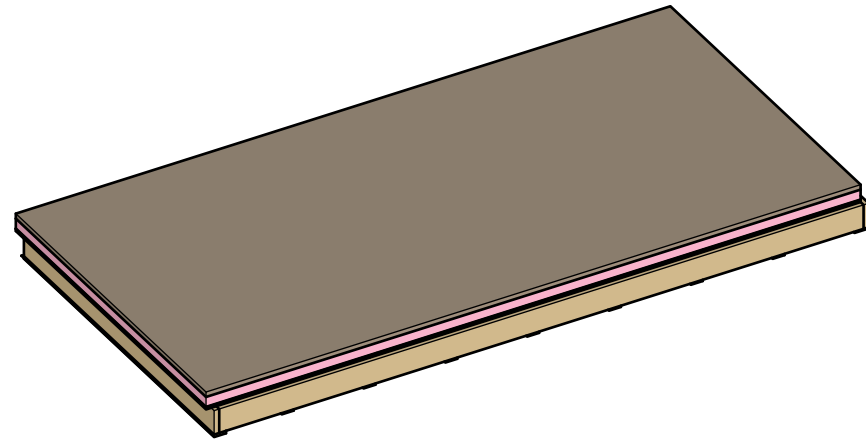
Top View

Installed and Finished Panel

Overview of panel and site-installed XPS and roofing

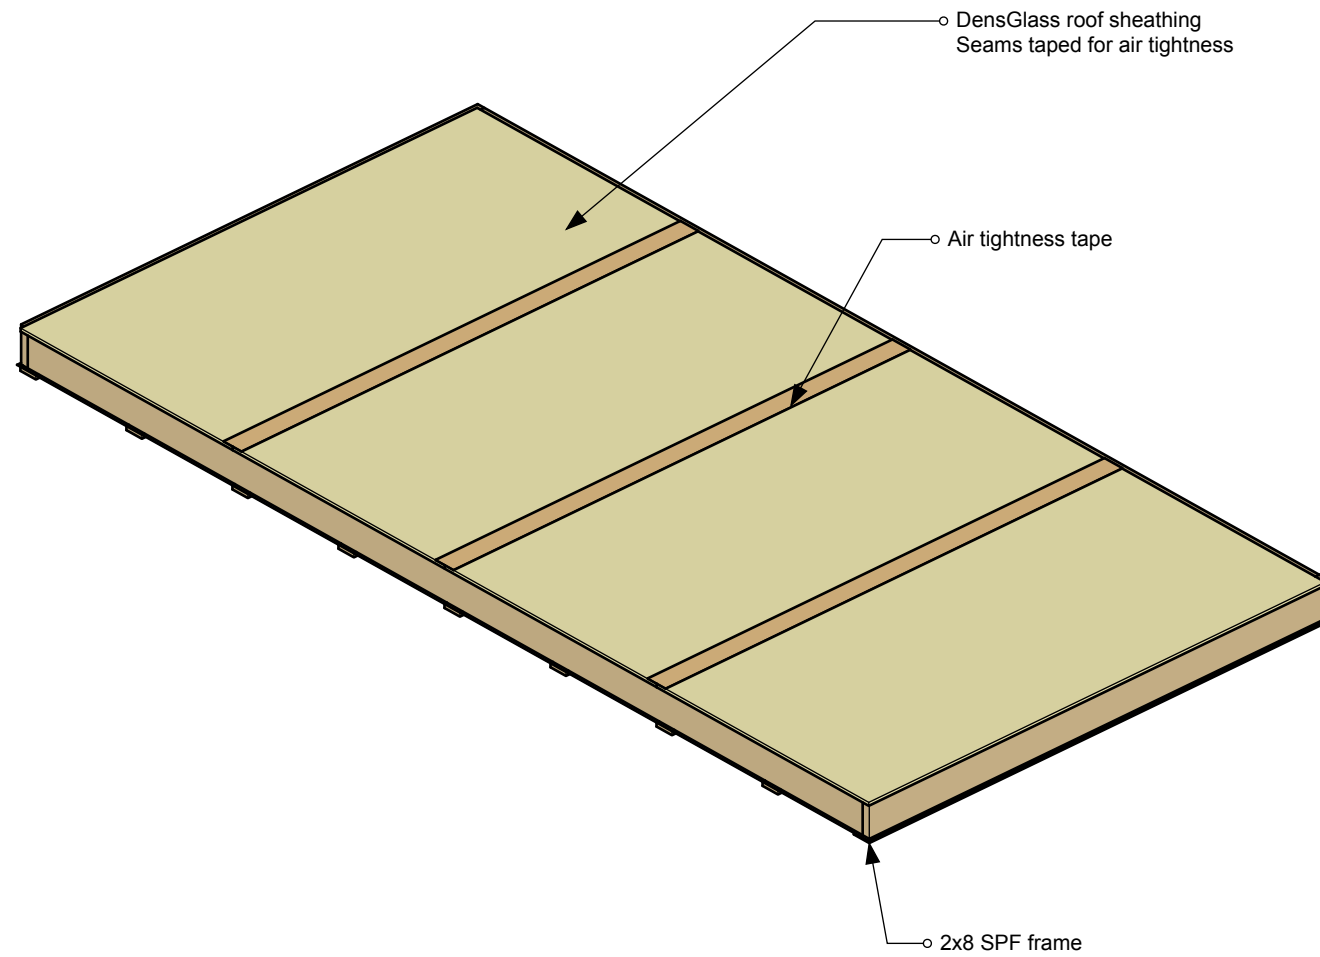
Top View

Just the Panel Overview

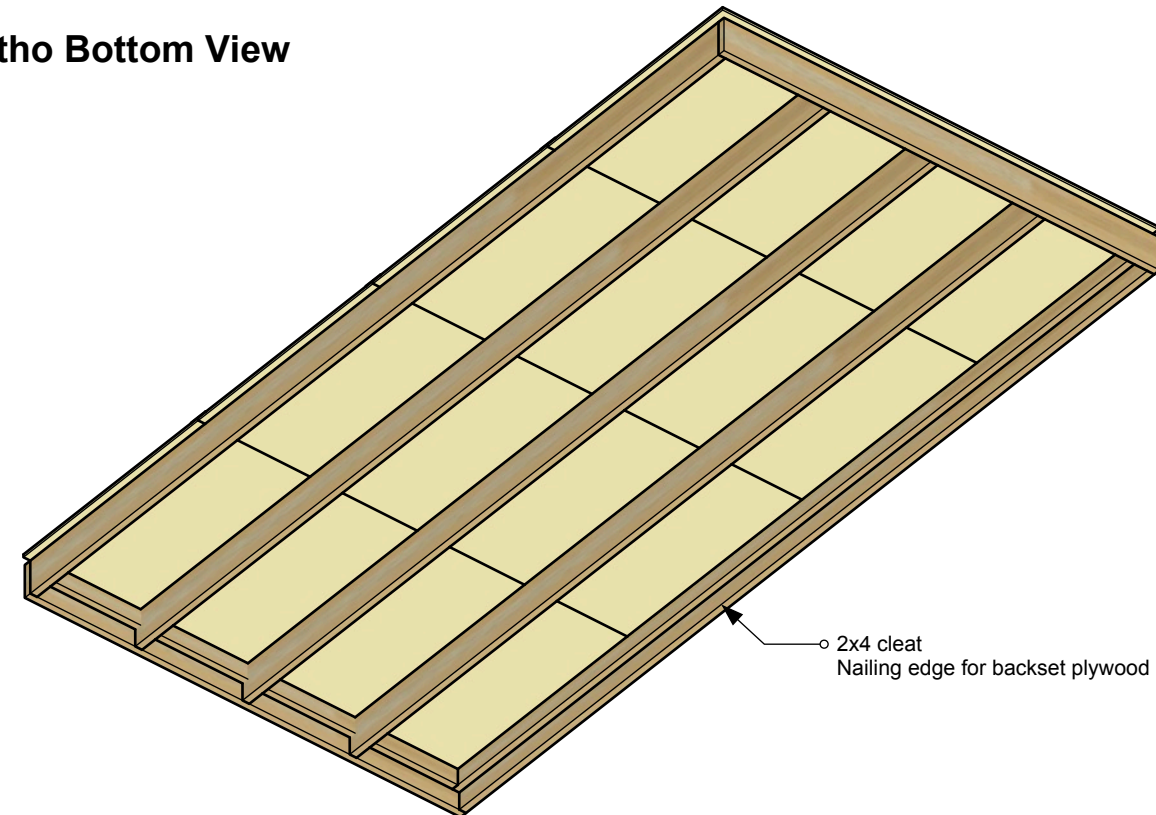
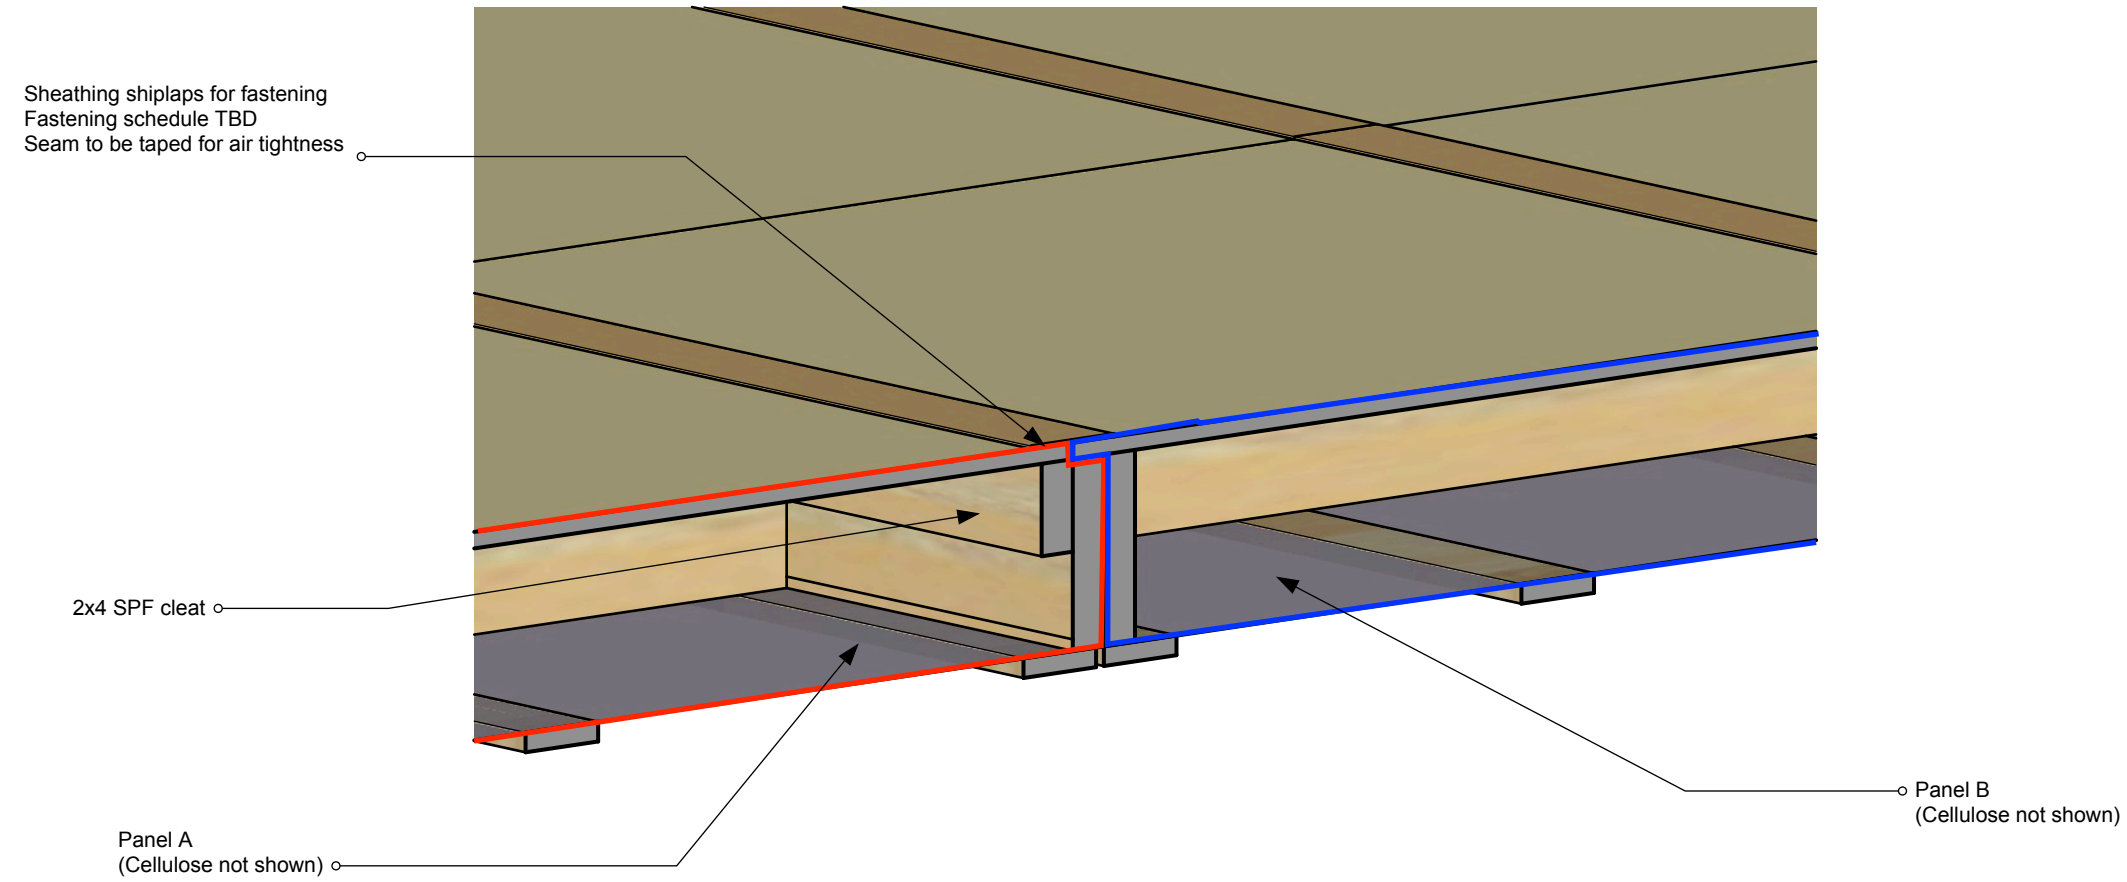
Seam Joining Detail

How Panels Join Together on Site
